DAMAGE ASSESSMENT REPORT

AUTOMOTIVE ENGINEERING & MGT DIVISION Ref: CS3/SPF18022678/R1vbs2
ACCIDENT CLAIM SECTION (SPORE POLICE FORCE) 1 MOUNT PLEASANT ROAD BLK 8 OLD Date: 18-01-2019
POLICE ACADEMYSINGAPORE 298333
ATTN: FRANKIE THAY Code: SPF

OPINION ON REPAIR COST FOR VEHICLE NO. SLF 909E

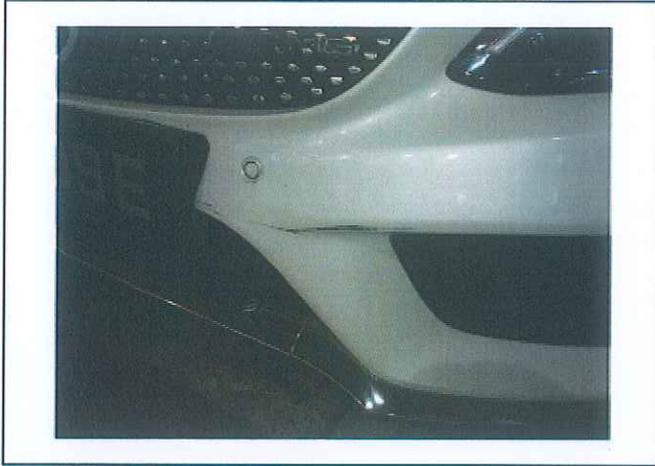
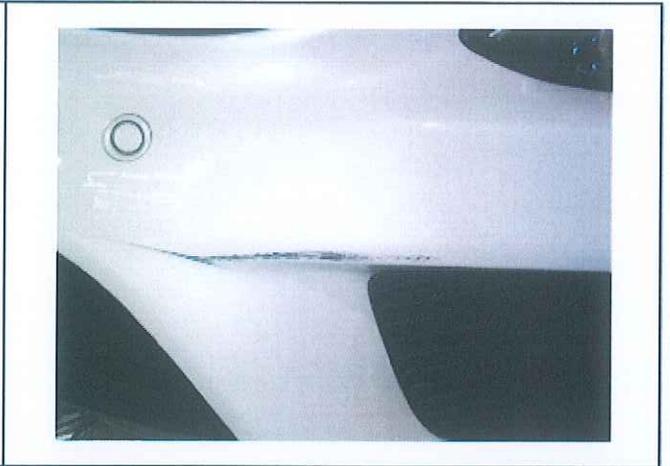
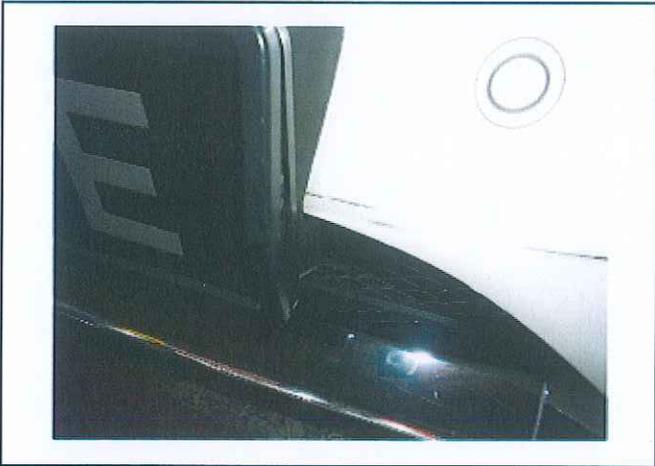
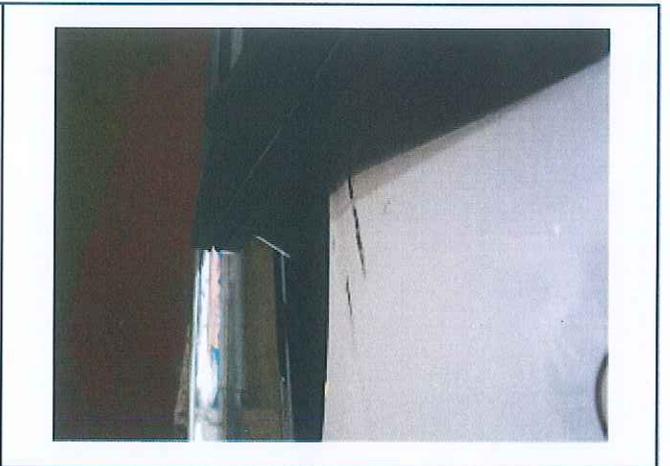
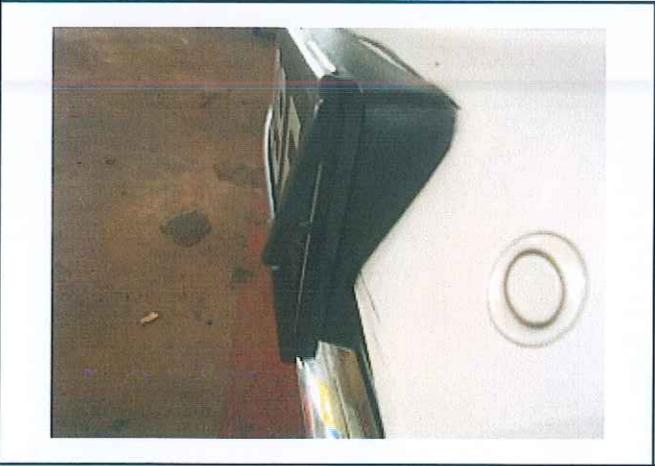
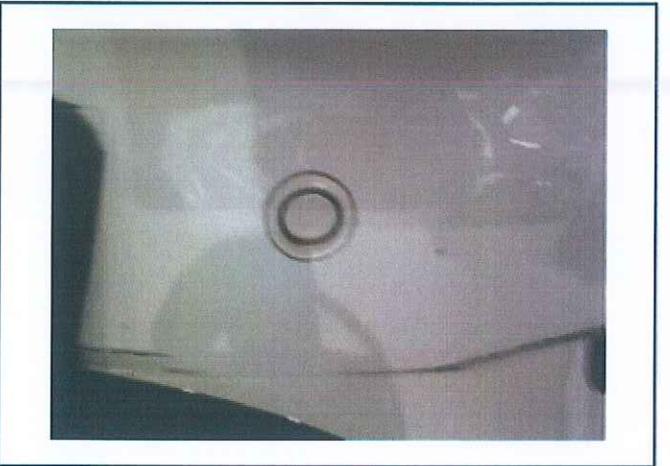
THE VEHICLE SUSTAINED DAMAGES AT THE FRONT N/S PORTION.
DAMAGES SEE DETAILS.

Qty	Description of Parts	Condition	Recommended (\$)
REPLACEMENT OF PARTS			
1	FRT BUMPER	SCRATCHED	1,485.00
8	FRT BUMPER CLIPS @ \$6.00	NECESSARY	48.00
	LESS 10% DISCOUNT		-153.30
			1,379.70
SPECIAL NETT ITEMS			
1	FRT NUMBER PLATE (SN)	CRACKED	35.00
1	FRT NUMBER PLATE BASE (SN)	DEFORMED	85.00
			120.00
LABOUR			
	REPLACE ACCIDENT DAMAGE PART.		250.00
	SPRAY PAINTING DAMAGE PARTS.		250.00
	REMOVE & REFIT FRONT REVERSE SENSOR.		60.00
			560.00
GRAND TOTAL			2,059.70
RECOMMENDED COST OF LUMP SUM REPAIRS (TO ITS PRE-ACCIDENT CONDITION)			1,650.00

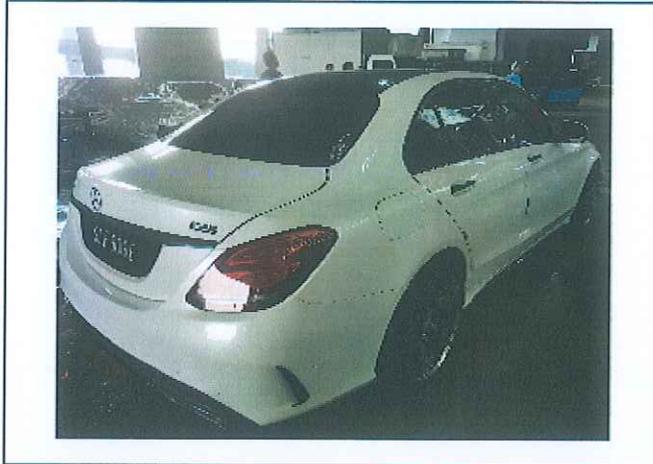
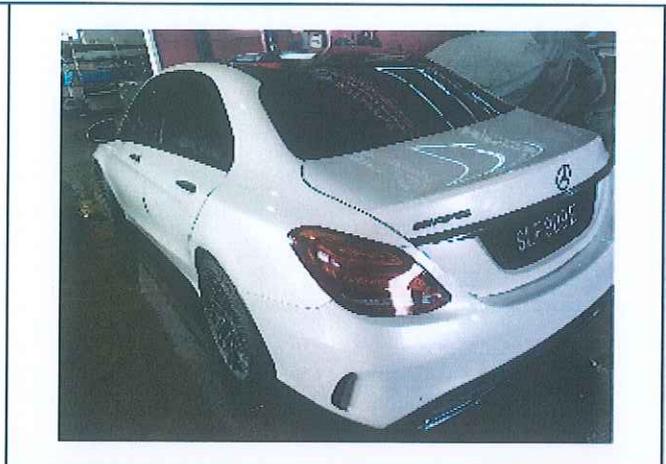
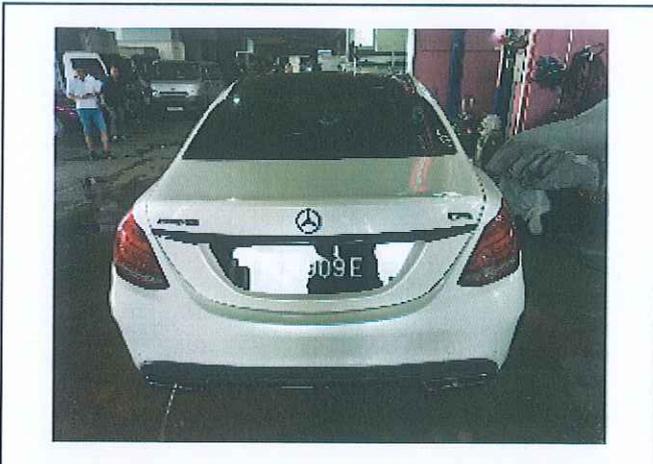
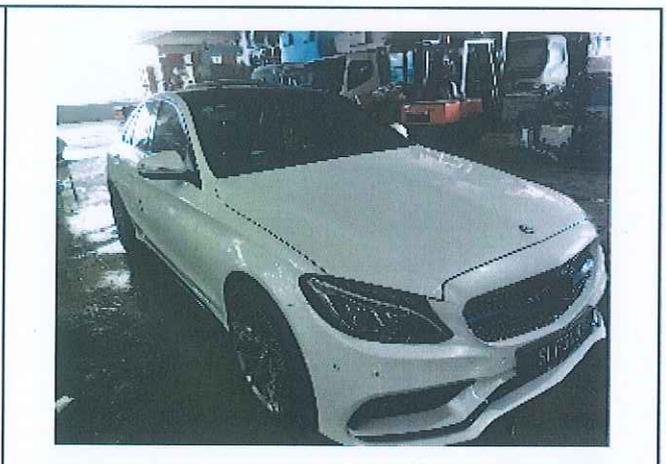
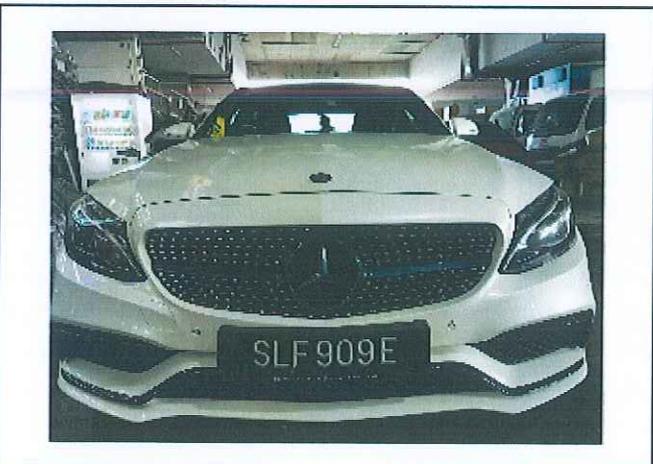
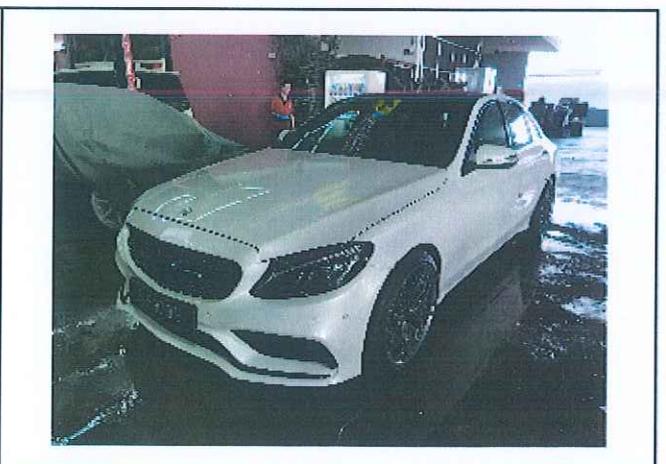
PHOTOGRAPHS FOR VEHICLE NO. SLF 909E

RE-INSPECTION
