Veh No: SHC 6642Y Yr Regt: 27 Feb, 2015

Make: KIA optima cc 1685

PRELIMINARY ADVICE OF VEHICLE NO. SHC 6642Y

VEHICLE DAMAGE INSPECTION REPORT

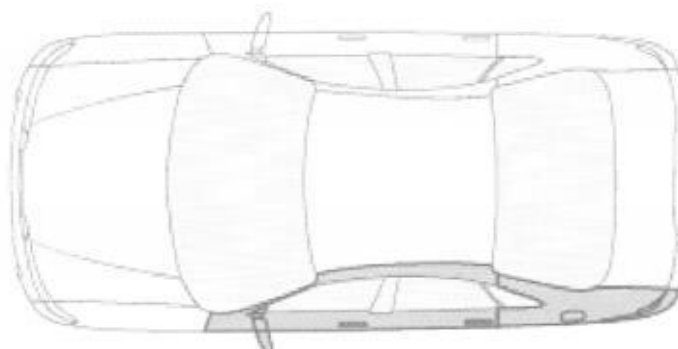
Damage Areas

Code	Description	Time Base 10 WU/h	Price = 50.00 SGD/h	
			WU	Price SGD
76000R00	RENEW L/F DOOR INCLUDES: R + R DOOR AND ALL NECESSARY ATTACHED PARTS, RENEW IF NECESSARY		16.0	80.00
77000R00	RENEW L/R DOOR INCLUDES: R + R DOOR AND ALL NECESSARY ATTACHED PARTS, RENEW IF NECESSARY		18.0	90.00
2207	L/SILL PANELLING REPAIR		20.0*	100.00
2583	REAR BUMPER REPAIR		20.0*	100.00
3485	L/R OUTER SIDE PANEL REPAIR		20.0*	100.00
Labour Cost			Hrs	WU
Panel / Mechanical Labour			9.40	94.0
Total of Labour				470.00

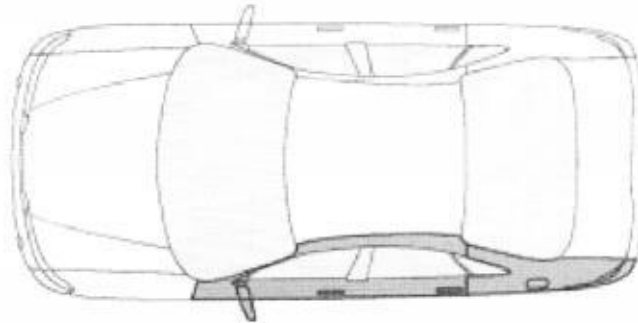
Damage Areas

Code	Description	Time Base 10 WU/h	Price = 50.00 SGD/h	
			WU	Price SGD
76000R00	RENEW L/F DOOR INCLUDES: R + R DOOR AND ALL NECESSARY ATTACHED PARTS, RENEW IF NECESSARY		16.0	80.00
77000R00	RENEW L/R DOOR INCLUDES: R + R DOOR AND ALL NECESSARY ATTACHED PARTS, RENEW IF NECESSARY		18.0	90.00
2207	L/SILL PANELLING REPAIR		20.0*	100.00
2583	REAR BUMPER REPAIR		20.0*	100.00
3485	L/R OUTER SIDE PANEL REPAIR		20.0*	100.00
Labour Cost		Hrs	WU	
Panel / Mechanical Labour		9.40	94.0	470.00
Total of Labour				470.00

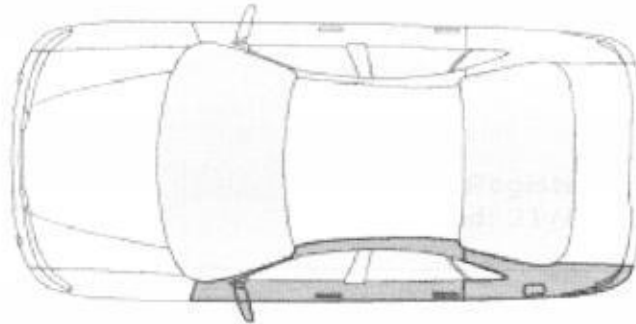
Damage Areas

Code	Description	Time Base 10 WU/h	Price = 50.00 SGD/h	
			WU	Price SGD
76000R00	RENEW L/F DOOR INCLUDES: R + R DOOR AND ALL NECESSARY ATTACHED PARTS, RENEW IF NECESSARY		16.0	80.00
77000R00	RENEW L/R DOOR INCLUDES: R + R DOOR AND ALL NECESSARY ATTACHED PARTS, RENEW IF NECESSARY		18.0	90.00
2207	L/SILL PANELLING REPAIR		20.0*	100.00
2583	REAR BUMPER REPAIR		20.0*	100.00
3485	L/R OUTER SIDE PANEL REPAIR		20.0*	100.00
Labour Cost		Hrs	WU	
Panel / Mechanical Labour		9.40	94.0	470.00
Total of Labour				470.00
