**ROAD TRAFFIC ACCIDENT INVOLVING VEHICLE NO. SJS 4650D AND SLF 7666J ALONG MALAYSIA CHECKPOINT TOWARDS SINGAPORE ON 30.12.2017 AT ABOUT 1745 HOURS**

Report No: 0036-18-HLm

Vehicle No. SJS4650D

## ACCIDENT VEHICLE SURVEY REPORT

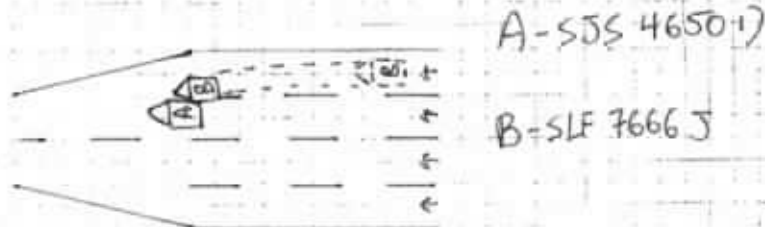
## SKETCH PLAN

Malaysia Check Point Toward Singapore.

On the above date and time, I was driving along Malaysia toward Singapore on the 2 lanes of a 4 lanes road. Somewhere before the check point, vehicle ahead of me slowed down and stopped due to heavy traffic flow.

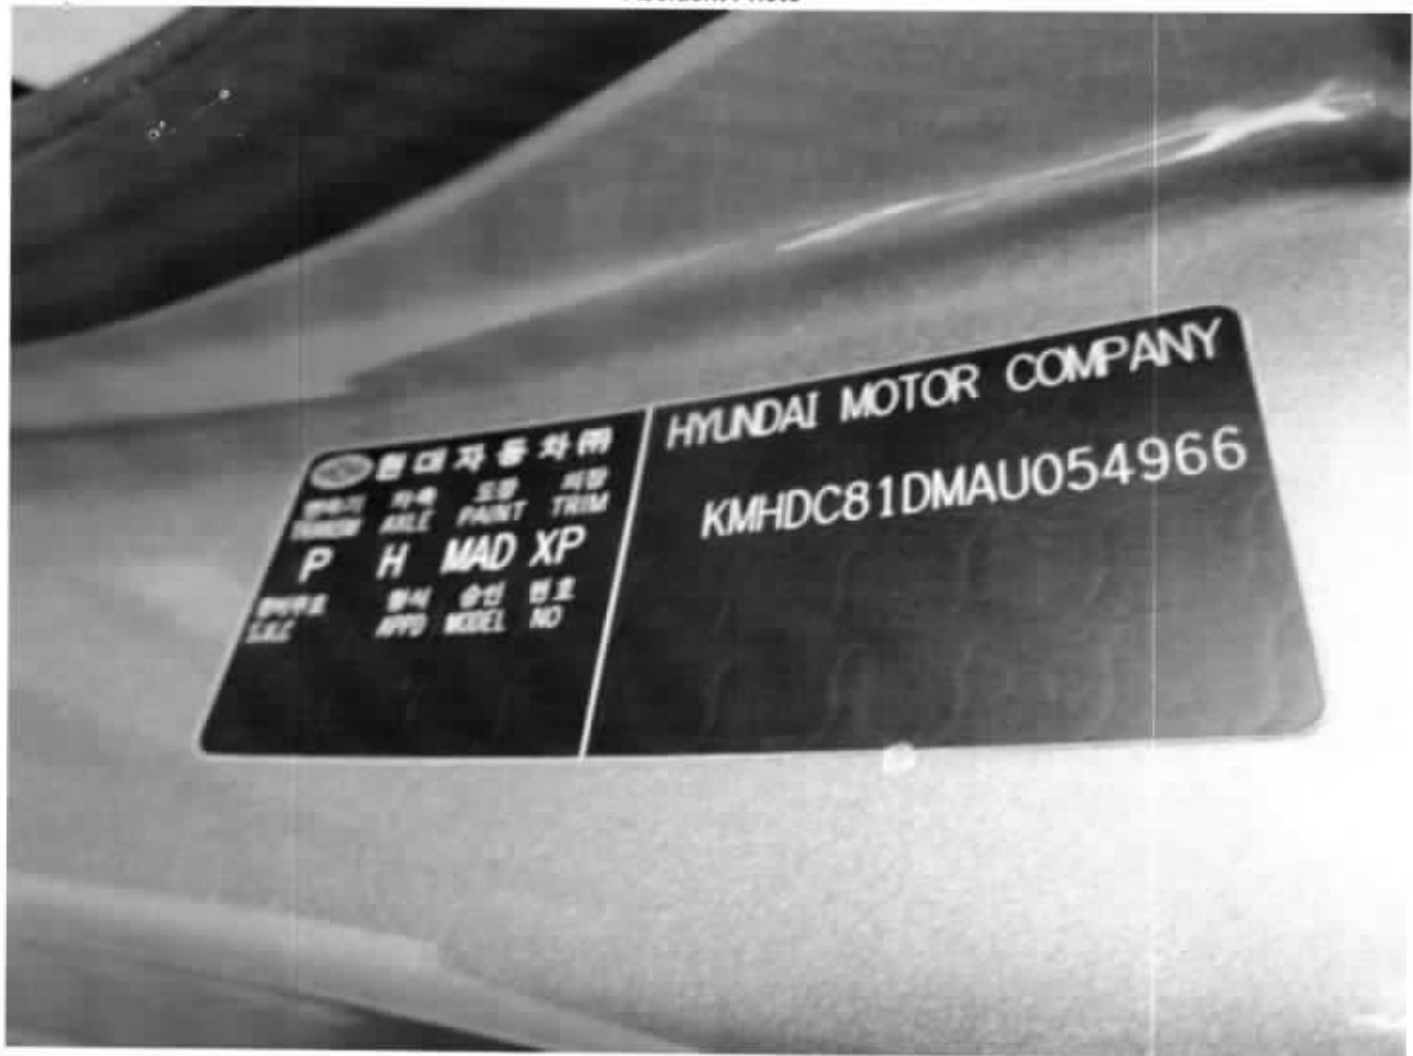
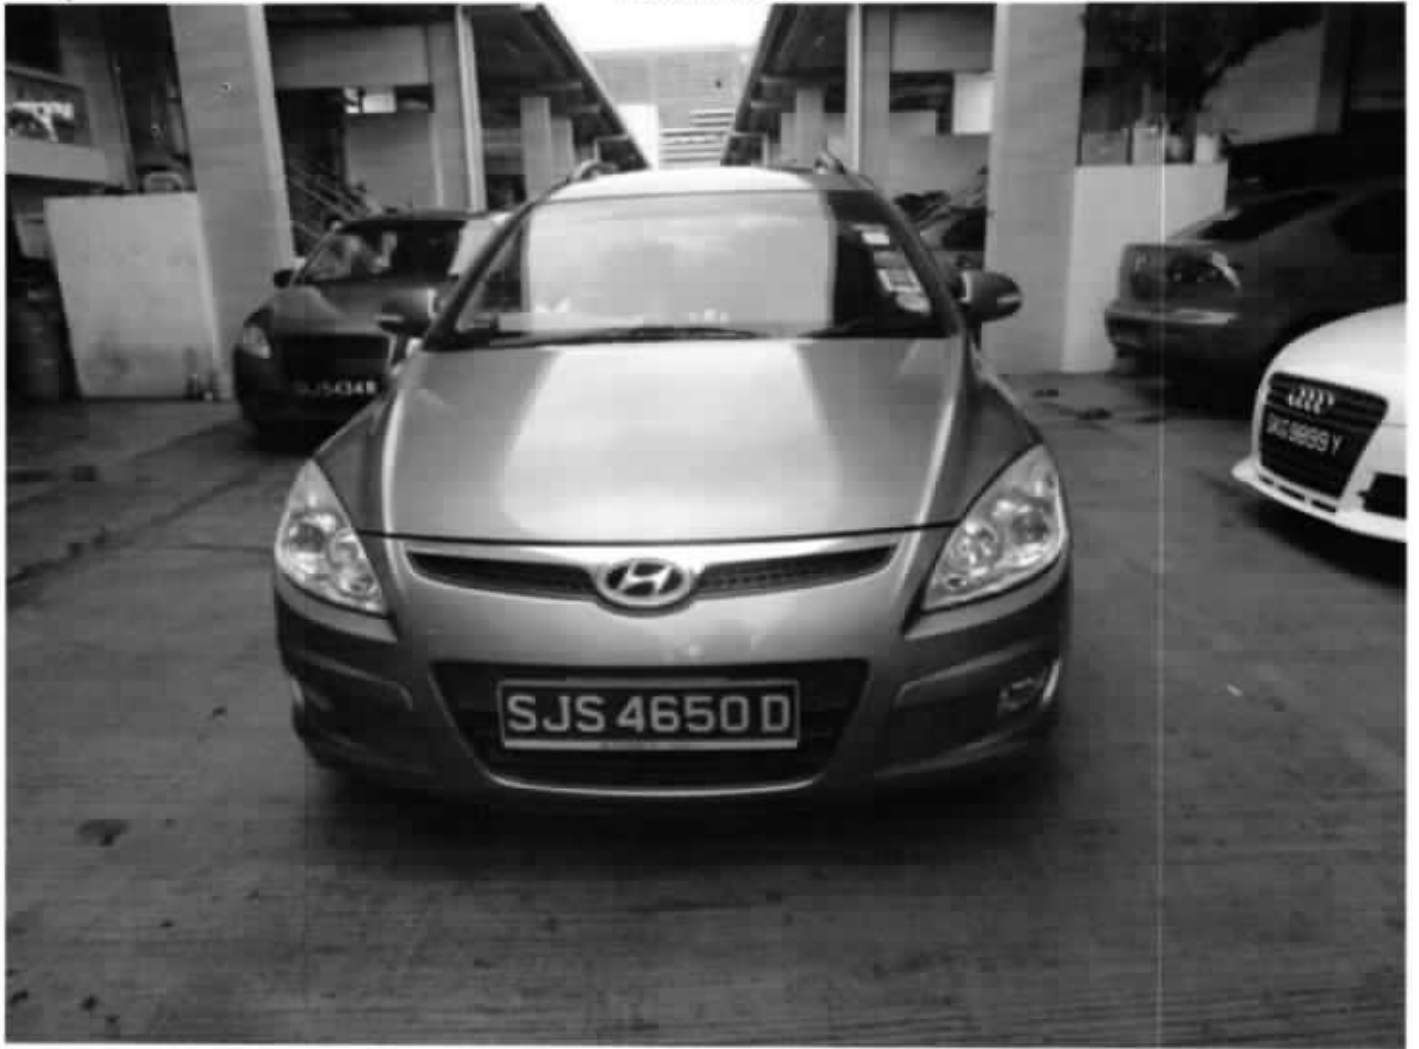
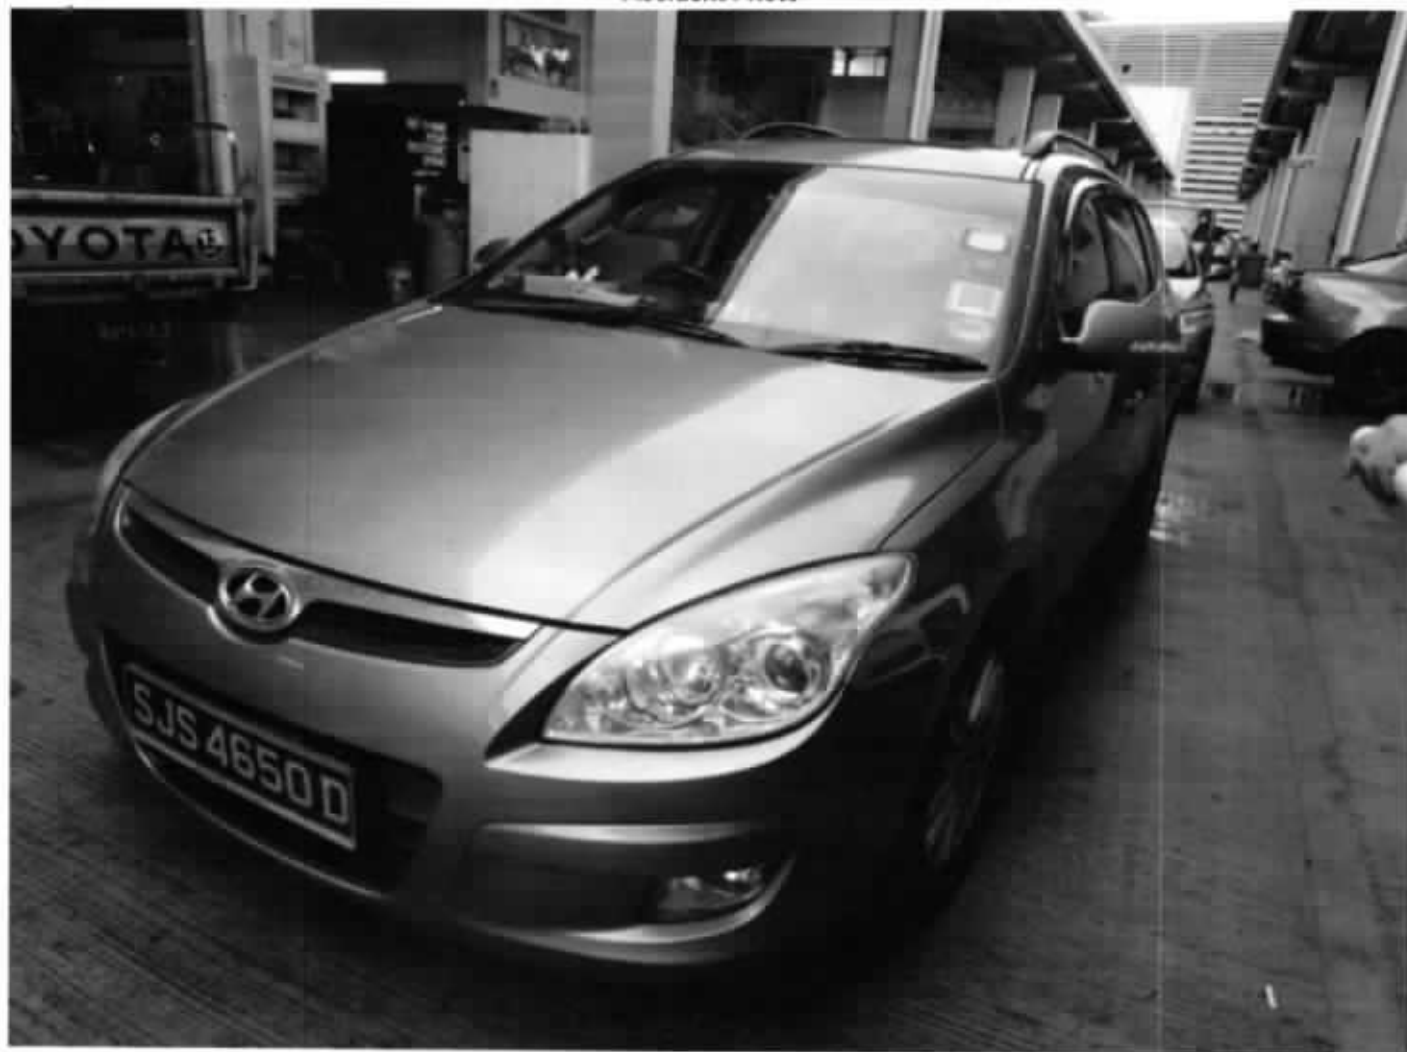
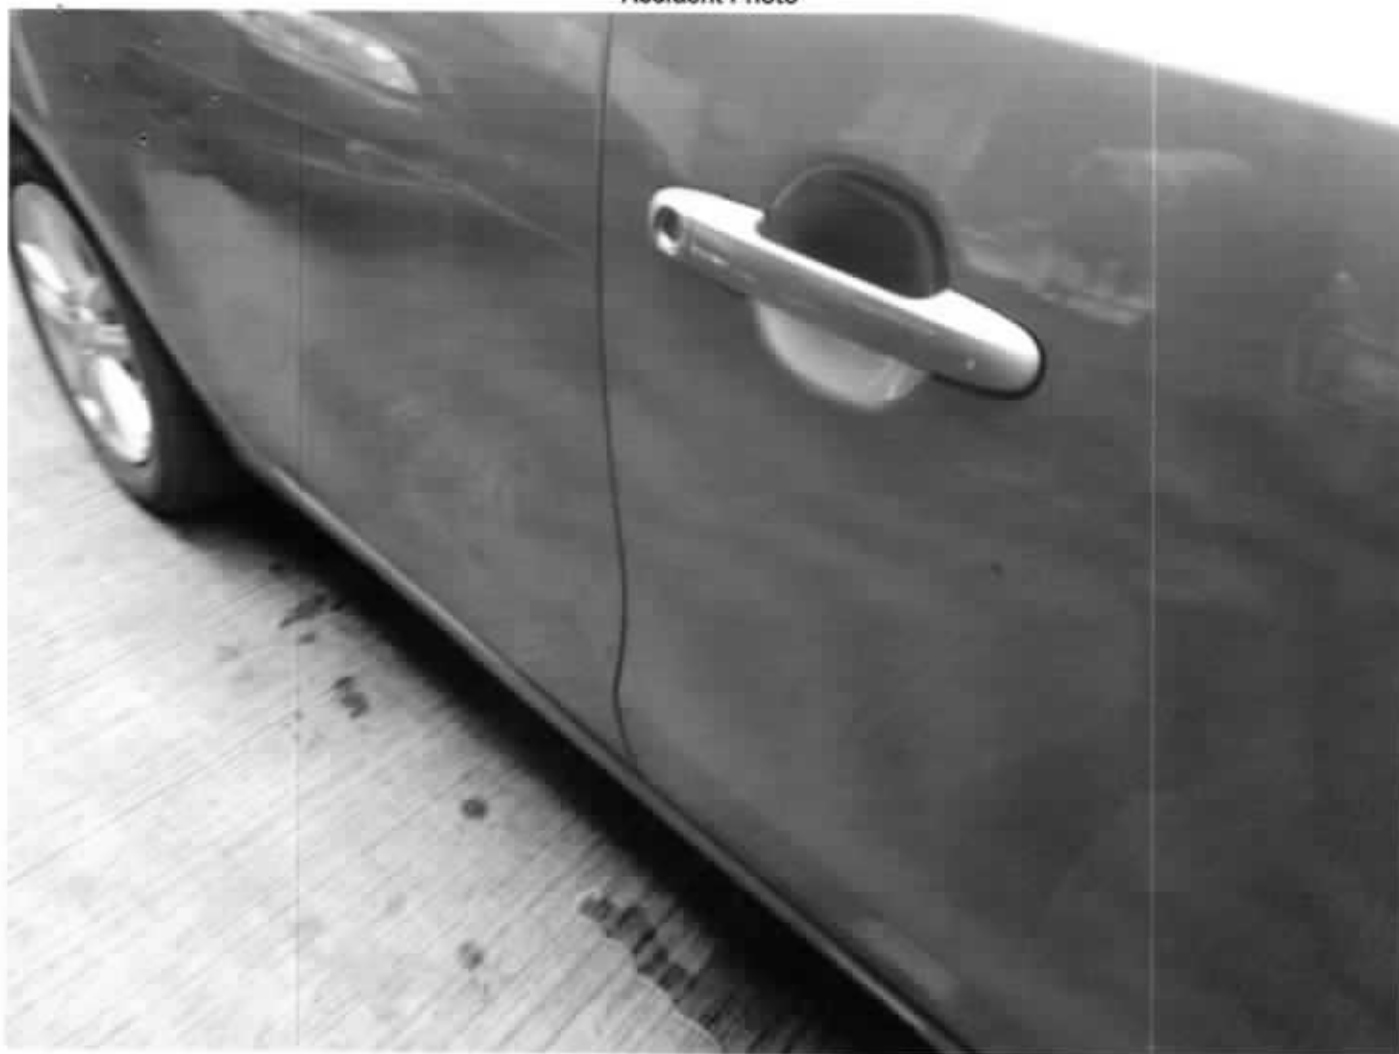
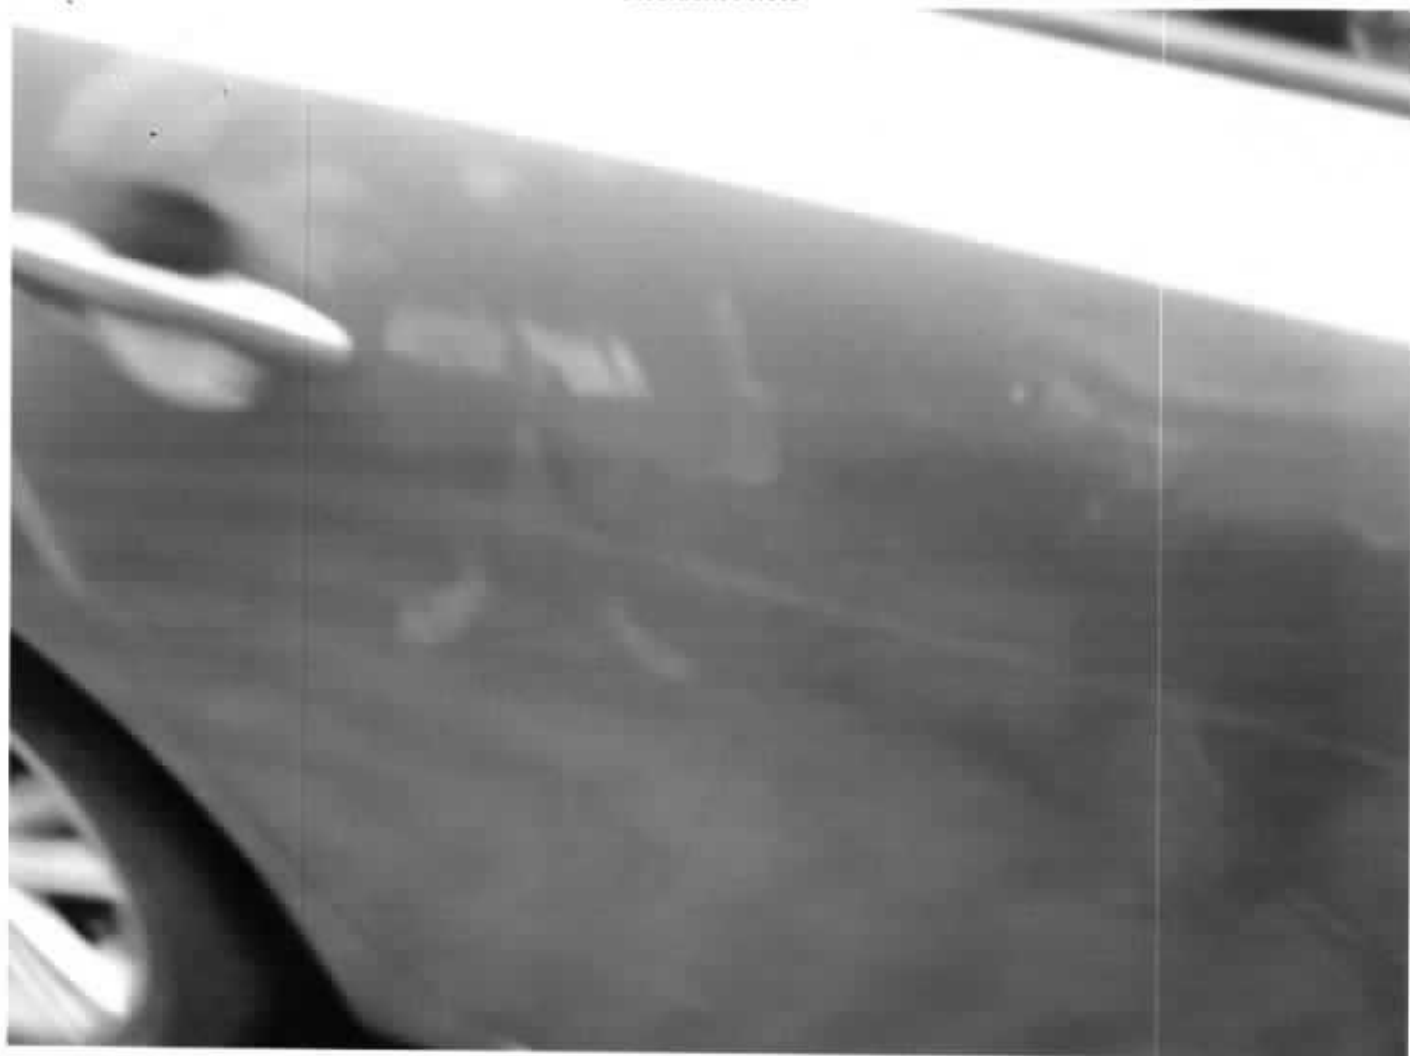
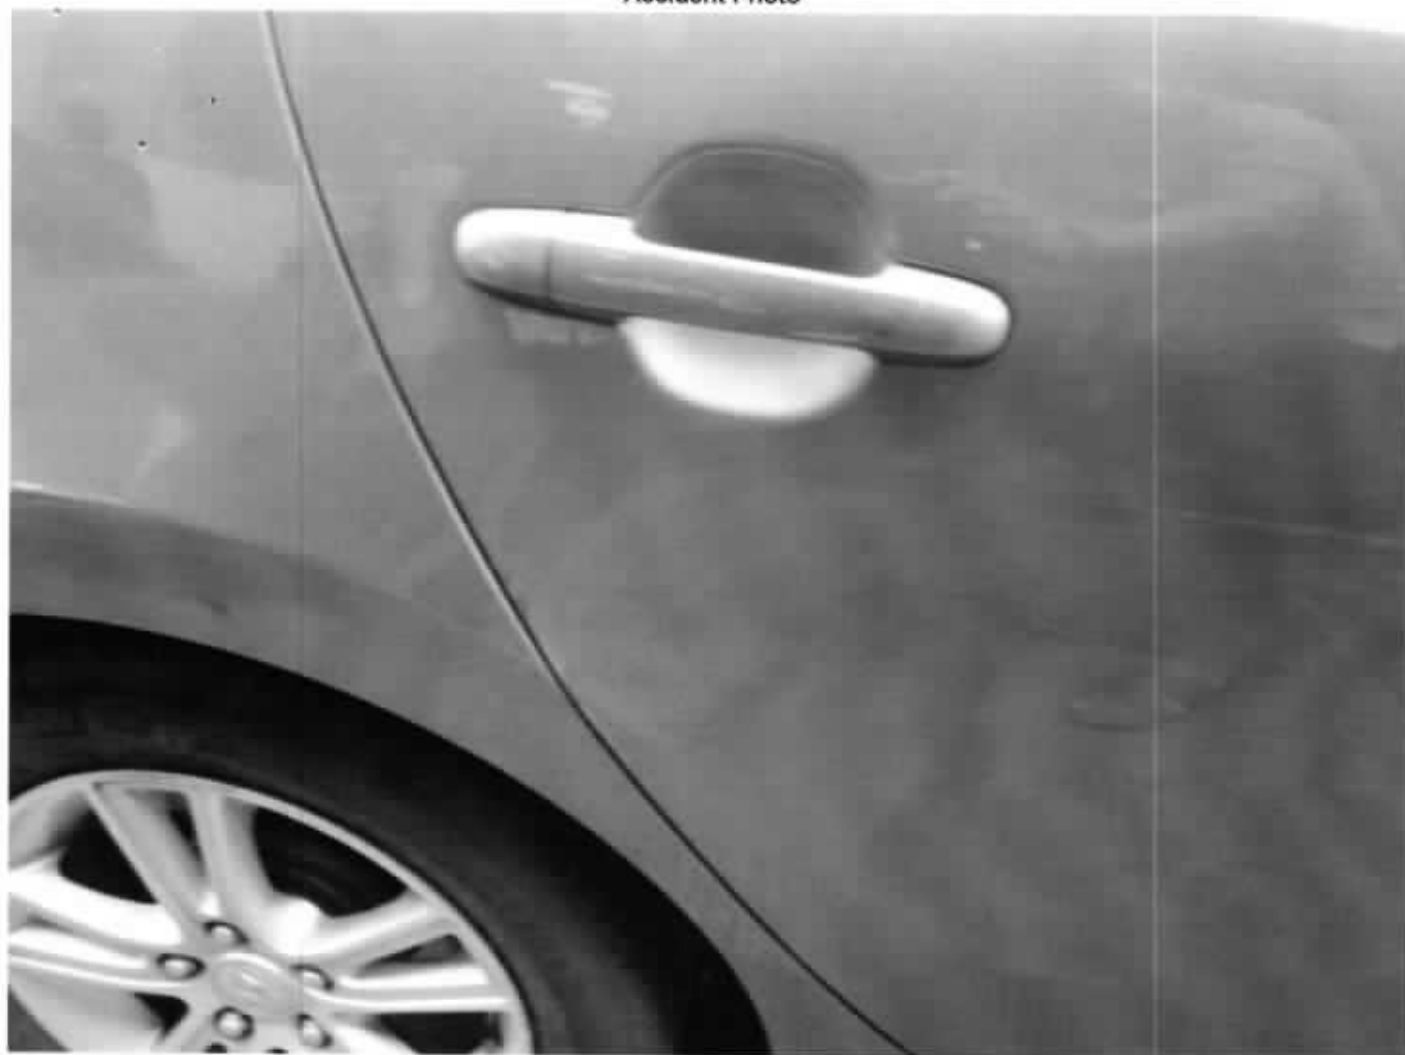
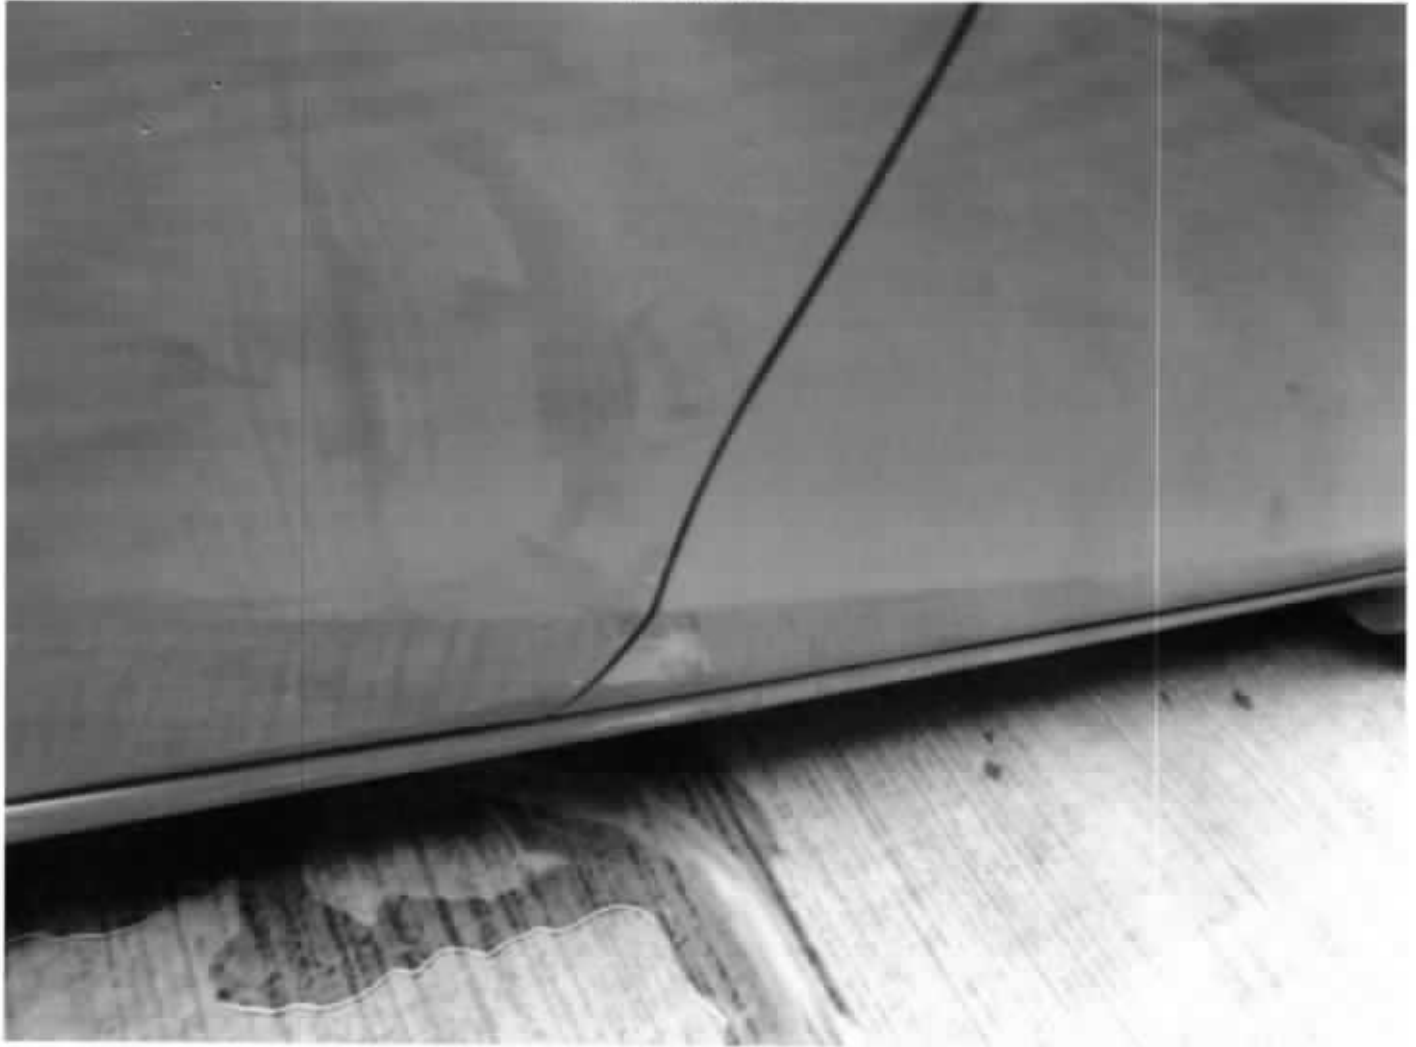
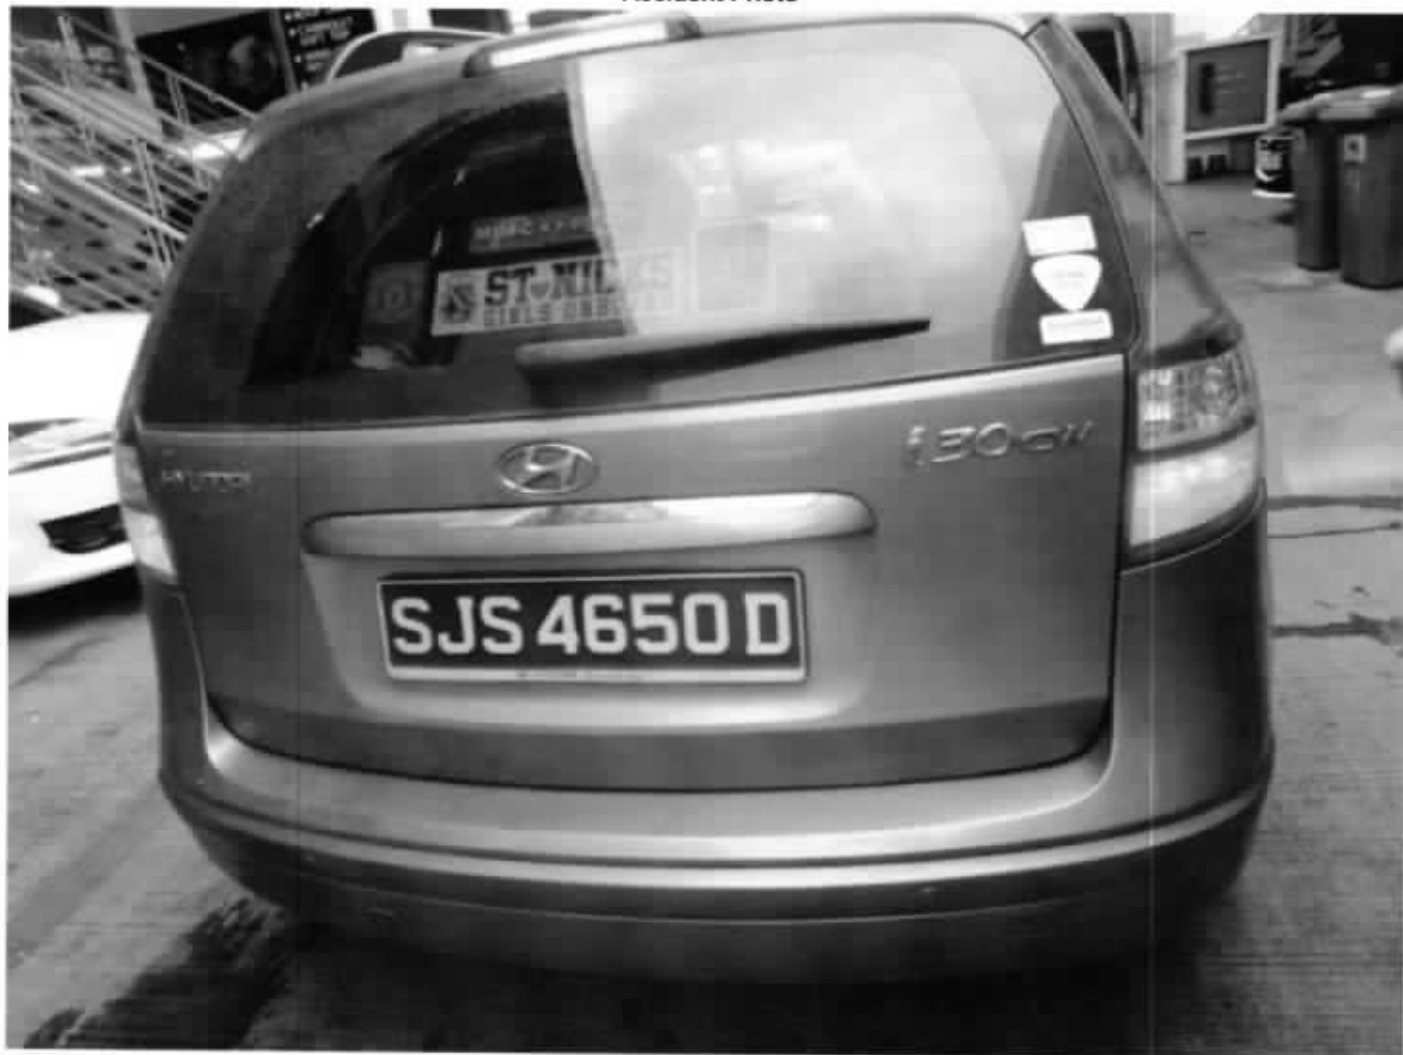
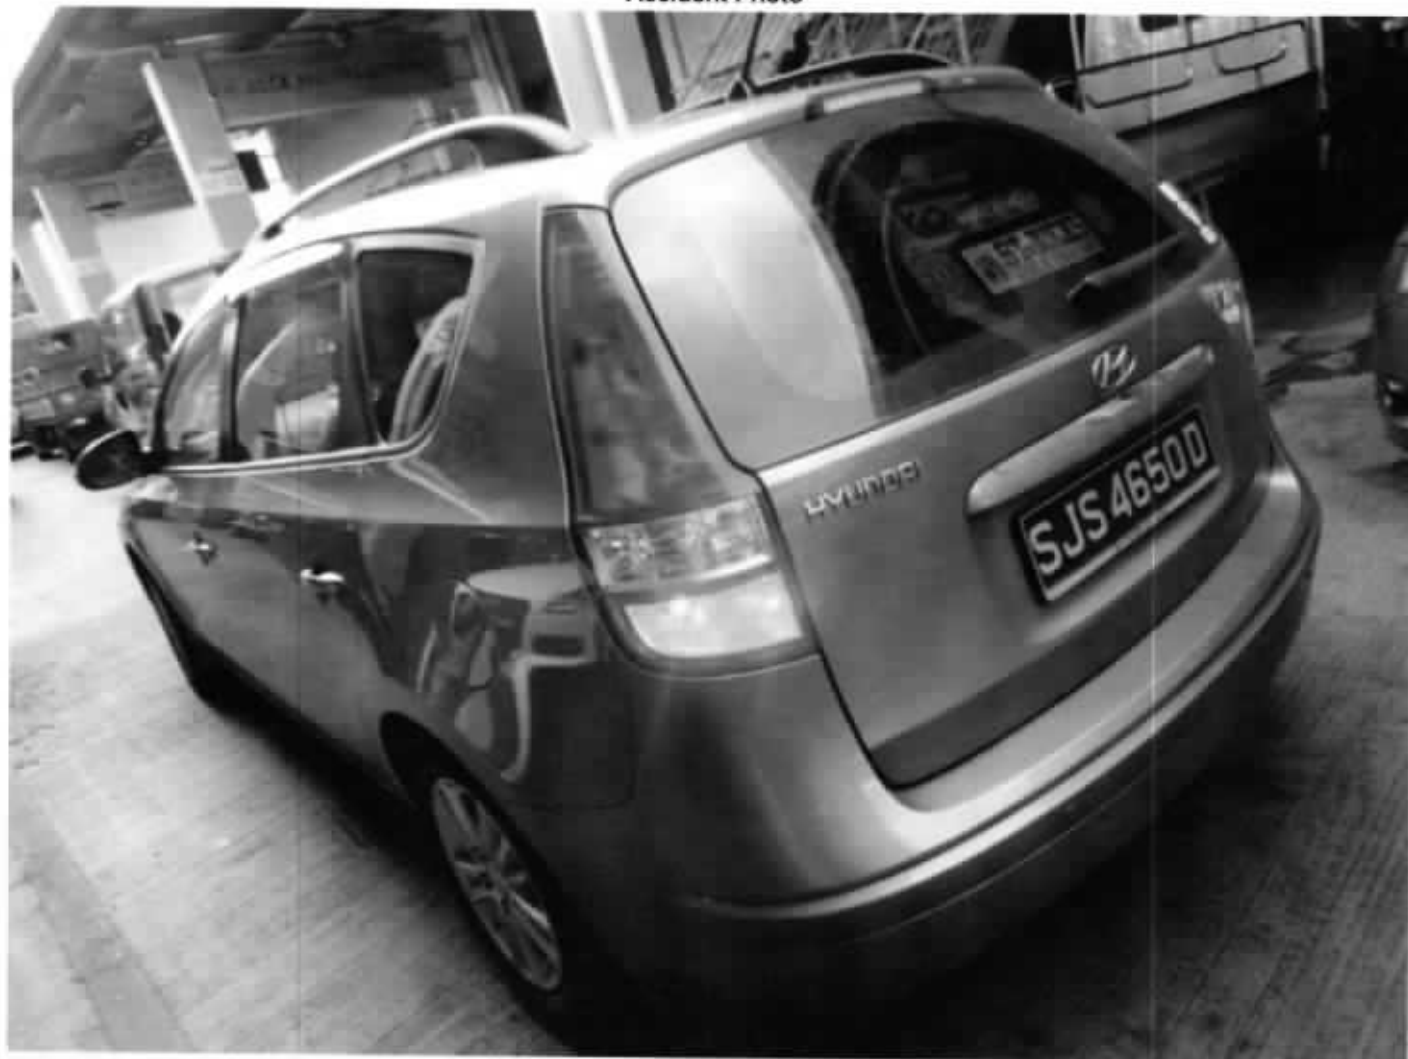
Accident Photo

Impact on the RH portion.

Hence, the recommended cost of repairs based on LUMP SUM repairs is : **\$7,200.00**  
and the recommended number of working days for the repairs is : **7**

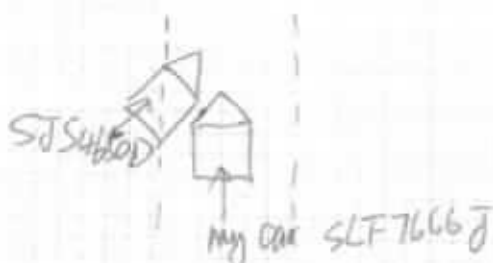
### SKETCH PLAN

My car was following the traffic in my own lane and another car trying to cut into my lane and some scratches happened.
