VEHICLE DAMAGE INSPECTION REPORT

Our File No: CS/SMO19008859/KQD3N2

Handling Insurer:	Sompo Insurance Singapore Pte. Ltd.	Policy No:	D19MTHCVE000175
Claimant Vehicle No :	SKZ1356A	Insured Vehicle No :	GBH9301G
Date of Loss:	09/04/2019	Nature of Claim:	TP
		Claim No:	CMTD1902068

Reg No:	SKZ1356A	Engine No:	CAXF82920
Make & Model:	VOLKSWAGEN JETTA GP, 1.4 TSI 90 HL HID 1634G5 (A)	Chassis No:	WVWZZZ16ZGM009070
Reg. Date:	11/01/2016 (Man. Year: 2015)	Odometer:	79601 km
Colour:	Metallic Grey		
Engine Capacity:	1390 cc		
Market Value/New Car Price:	N/A		
Sum Insured (S\$):	Market Value/New Car Price

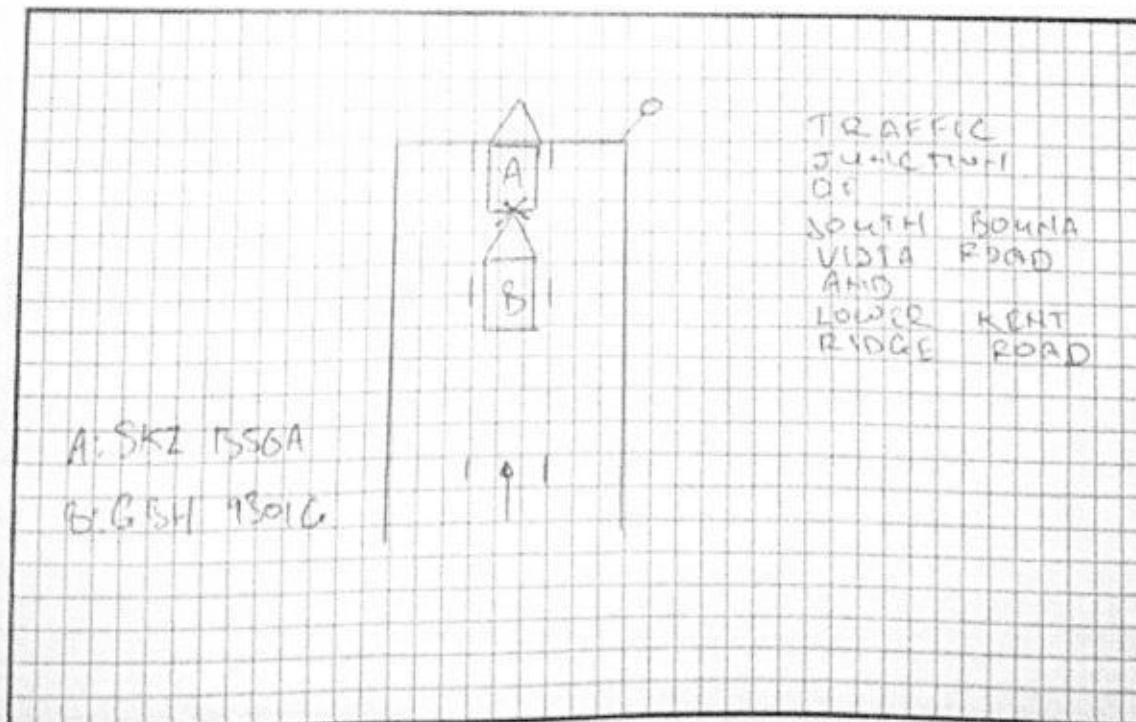
Sketch Plan

I was at traffic junction of South Bouna Vista Road and Lower Kent Ridge Road. I was on the middle lane of 3 lane road. Traffic light turned green and i started to moved off when vehicle GBH9301G from behind collided onto the rear of my car. Damages to my car were on the rear portion. No injuries were involved.
