Report No. : 495M1116.HH
Vehicle No. : SGT8921B

ACCIDENT VEHICLE SURVEY REPORT

ADJUSTMENT ON REPAIR COST FOR VEHICLE NO. SGT 8921B

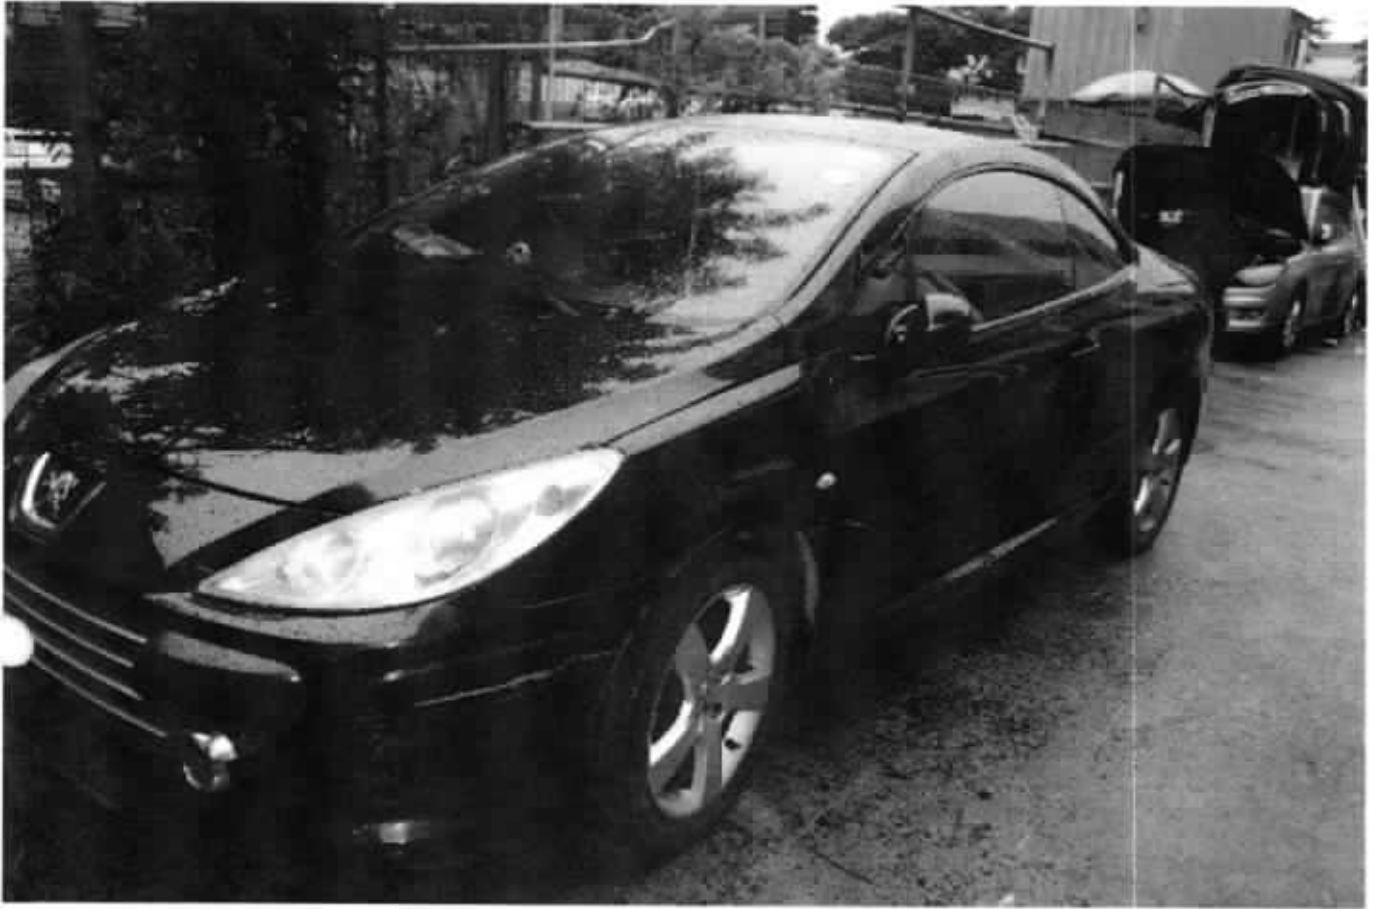
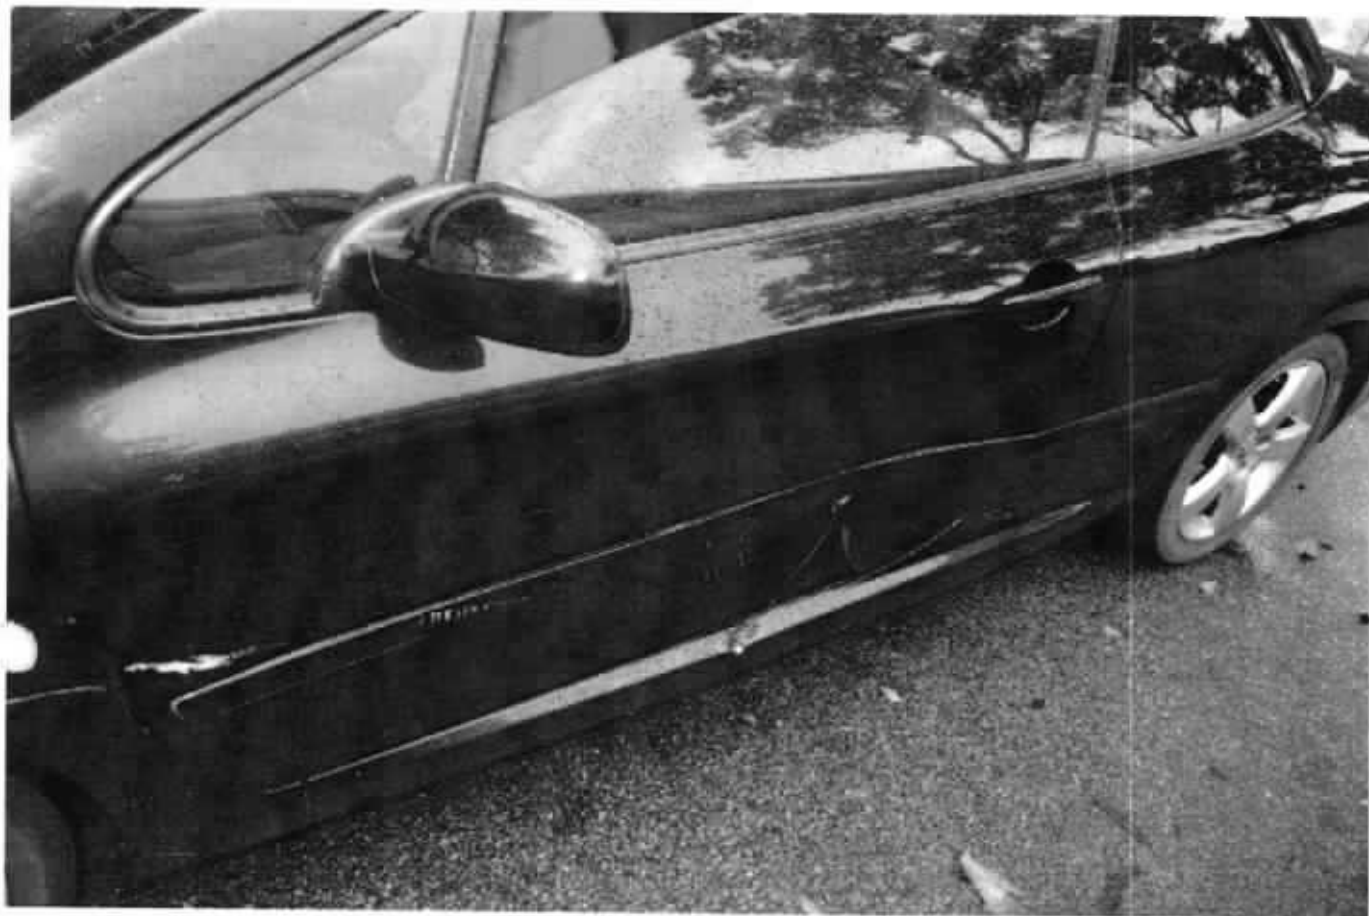
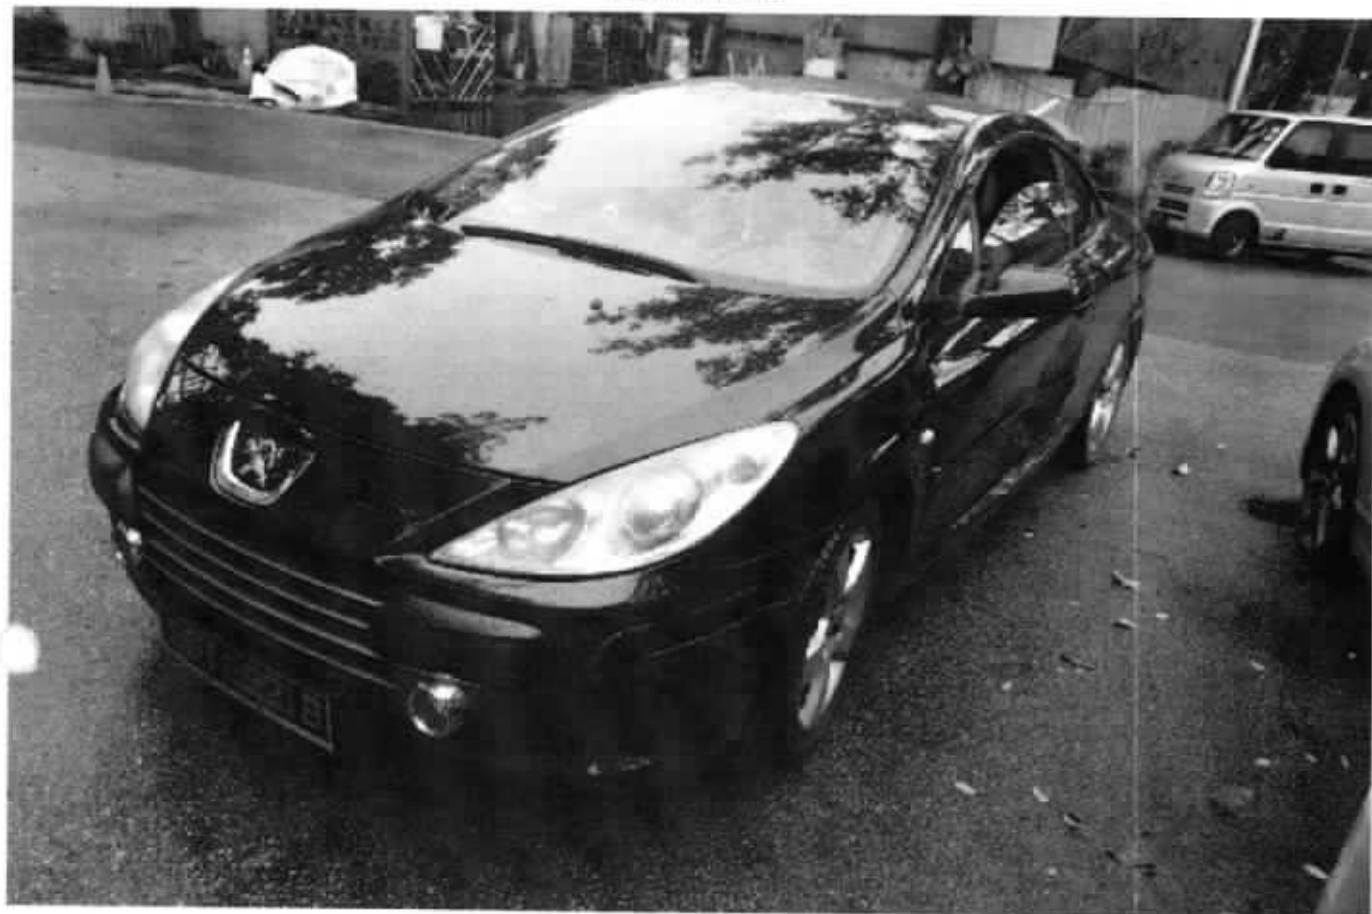
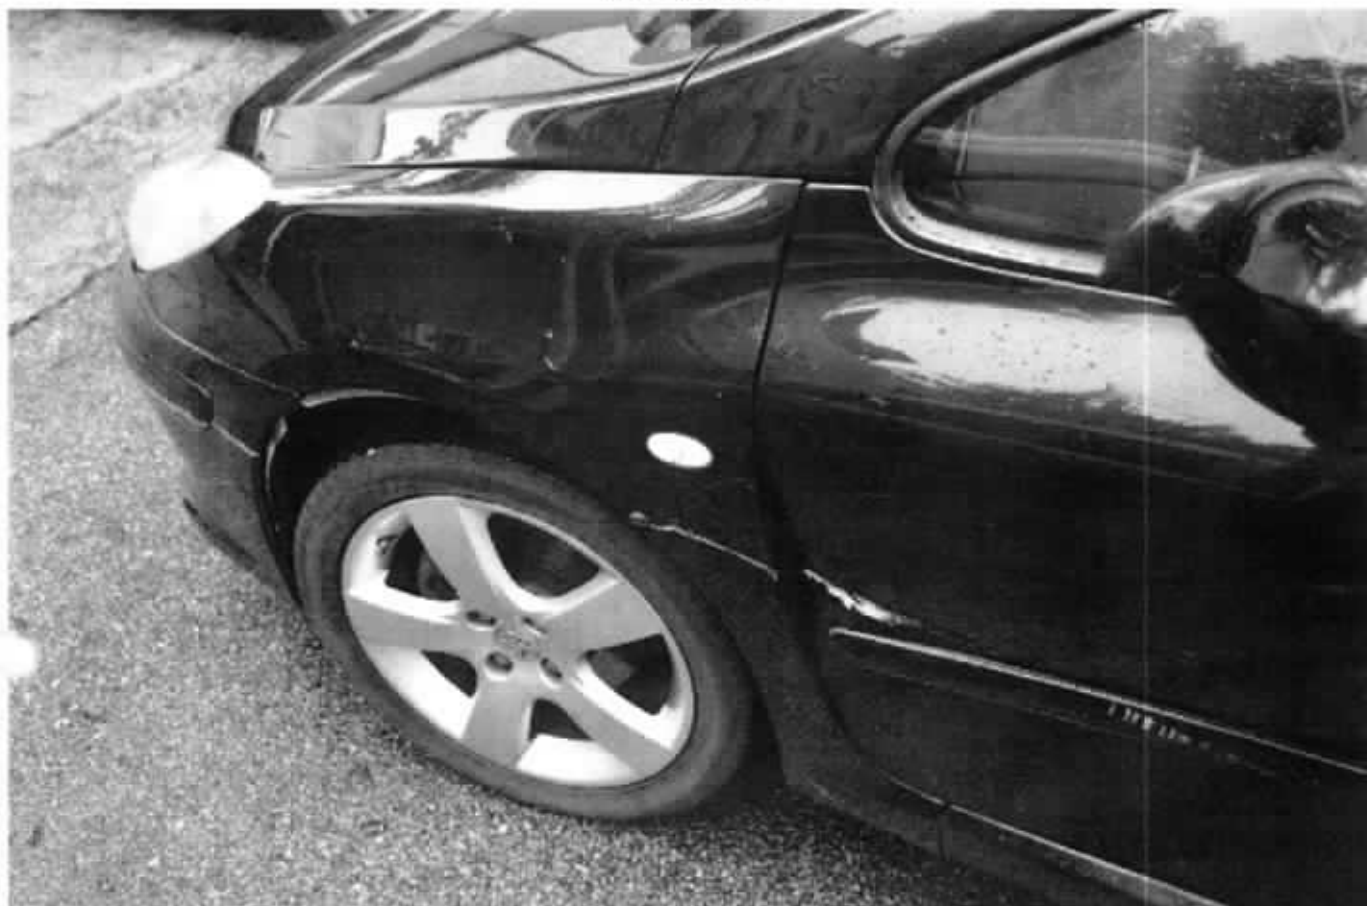
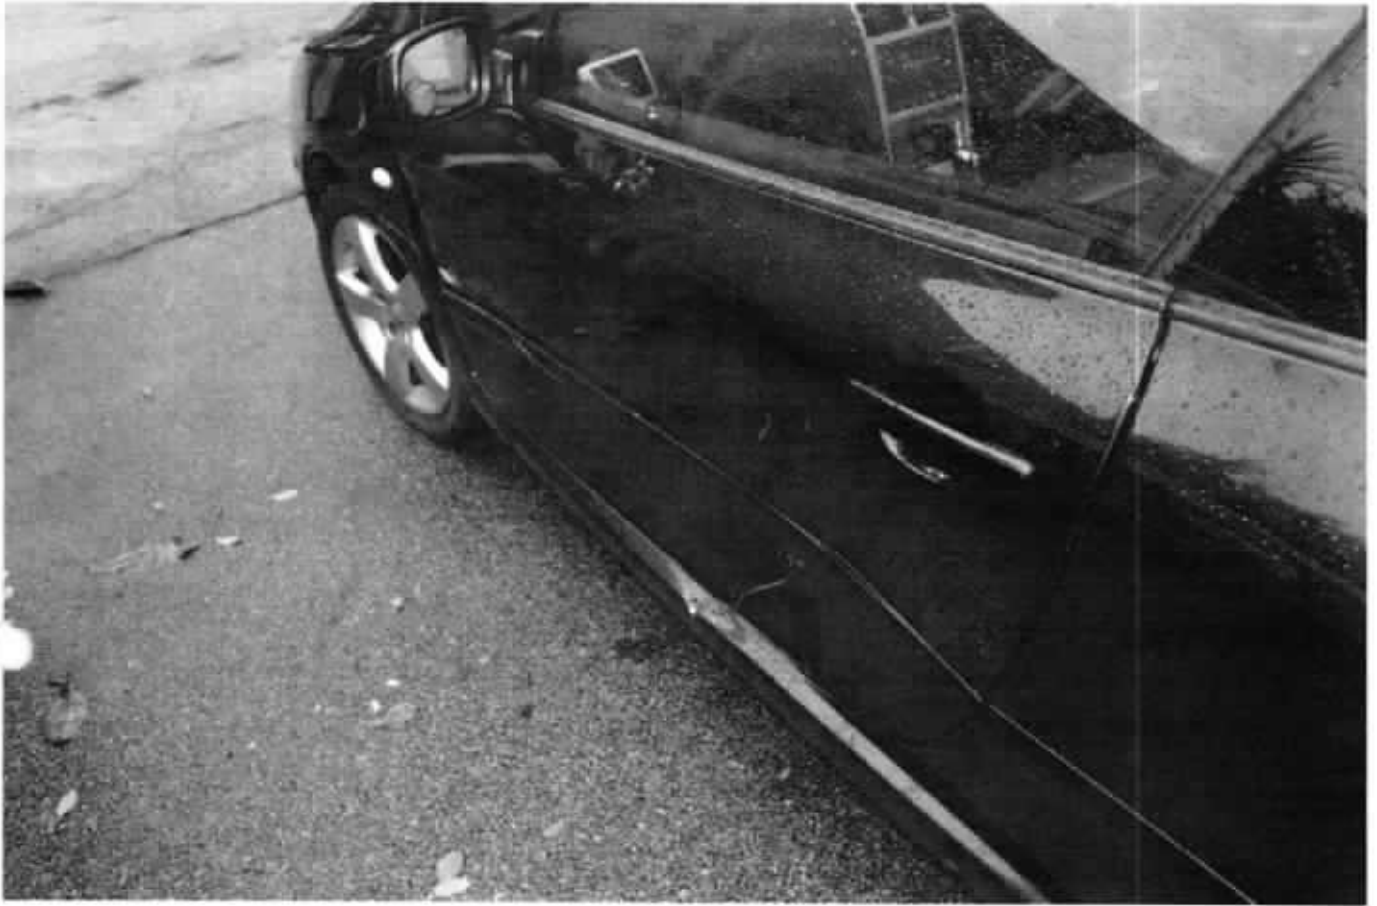
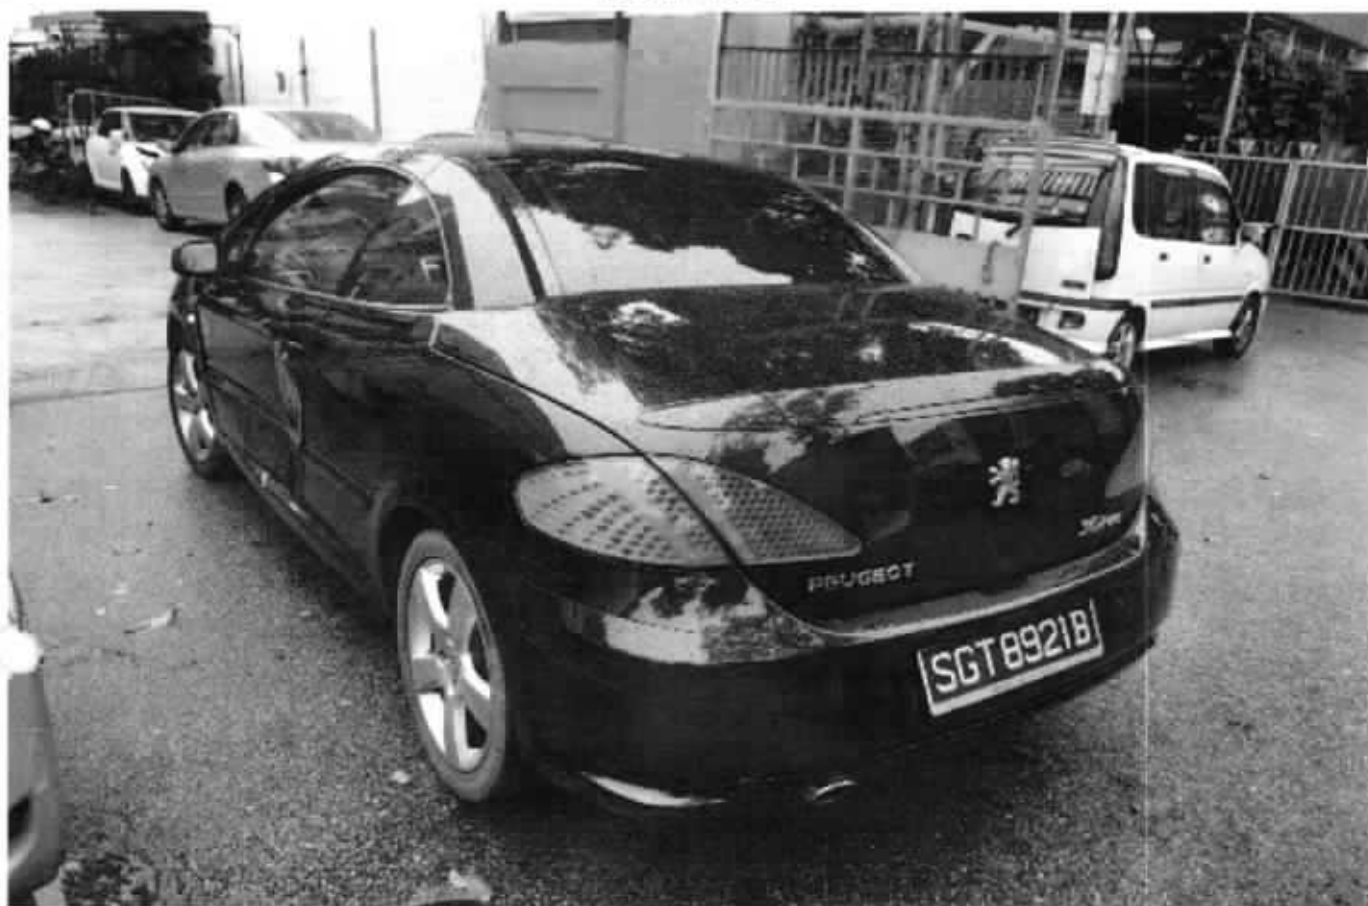
Front bumper scraped/deformed, front fender scraped/bent, front door scraped/dented, LHS side skirt dented/deformed, etc. Please see para. 8 of this report for more details.

Accident Photo

Recommended cost of repairs = \$5,200.00 (lump sum)
Estimated no. of days for repairs = Five (5).
