## ASSIGNMENT (Office)

SJ1 1962X

**ACCIDENT INVOLVING SJJ1962X & GY1634A ALONG ROBINSON ROAD JUNCTION MCCALLUM STREET ON  
22.05.2019**

## VEHICLE DAMAGE INSPECTION REPORT

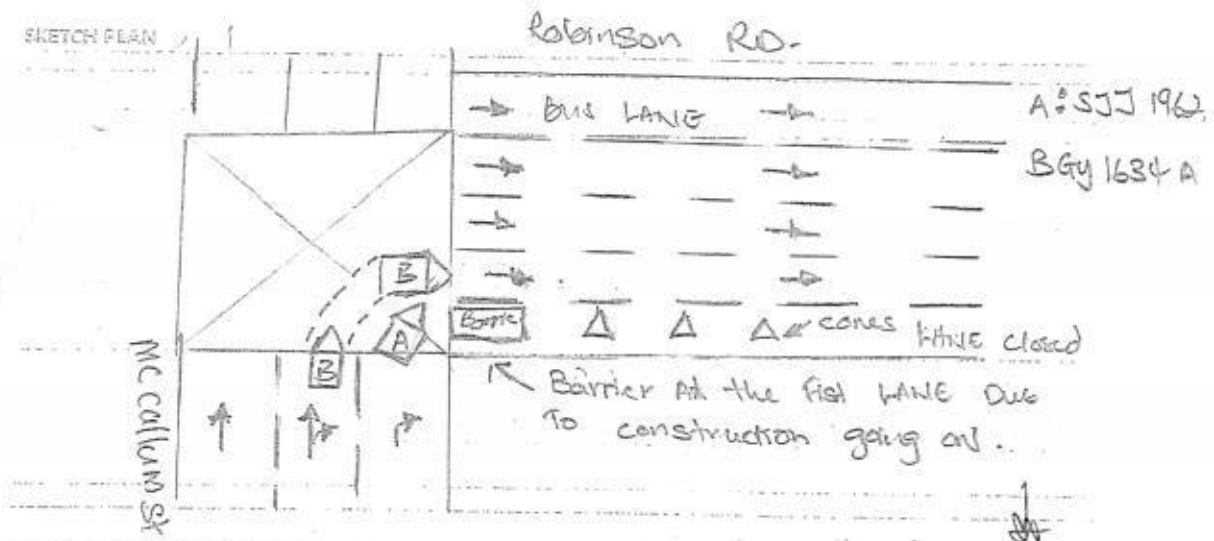
Sketch Plan #2 Pg. 1

This morning around 9.05am I was turning into Macullen Street on extra right lane. My intention is to turn into Robinson Road. the weather at that time was clear.

Vehicle Nissan 350 was on my left, last minutes signal to turn right which I am turning right as well.

Due to some road work on the ~~the~~ first lane and there was a barrage blockage as well I have to turn ~~from~~ second lane to be safer. I am approaching cautiously at the low speed before turning.

The vehicle Nissan 250, last minutes signal and ~~turn~~ turn abruptly straight into second lane which hit my car front part and causes damages. Both parties were not injured at that point of time.

On the Robinson Road there was Five lane and ~~the~~ lane one was partially closed due to construction the turning driver did not check right before turning.
