INSURANCE

ESTIMATE REPAIR BILL FOR HYUNDAI I30 WAGON REGN NO: SHD 1573 R

ACCIDENT INVOLVING SHD1573R AND SHD3594S ALONG BEDOK RESERVOIR ROAD ON 22.05.2019

VEHICLE DAMAGE INSPECTION REPORT

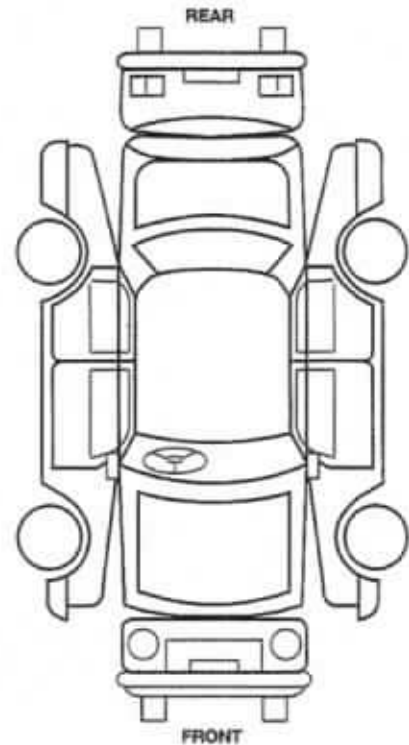
INDICATE AREA OF DAMAGE HERE:

BODY MARKINGS

1 - Light Dent
2 - Serious Dent
3 - Light Scratch
4 - Serious Scratch

5 - Damaged
6 - Chip
7 - Crack
8 - Peeling
