Vehicle No.: SDS 7116 G Vehicle Make & Model: MERCEDES BENZ S300L

PRE-REPAIR INSPECTION REQUEST – SDS7116G vs SLB9805H (OI) on D.O.A.: 23/05/2019

VEHICLE DAMAGE INSPECTION REPORT

Date of Assignment: 24/05/2019
Date Inspected: 24/05/2019 Inspected At: Team Autopro Pte Ltd
8 KAKI BUKIT AVENUE 4 #01-07
PREMIER @ KAKI BUKIT
SINGAPORE 415875
Estimated Period of Repair: 4.0 days

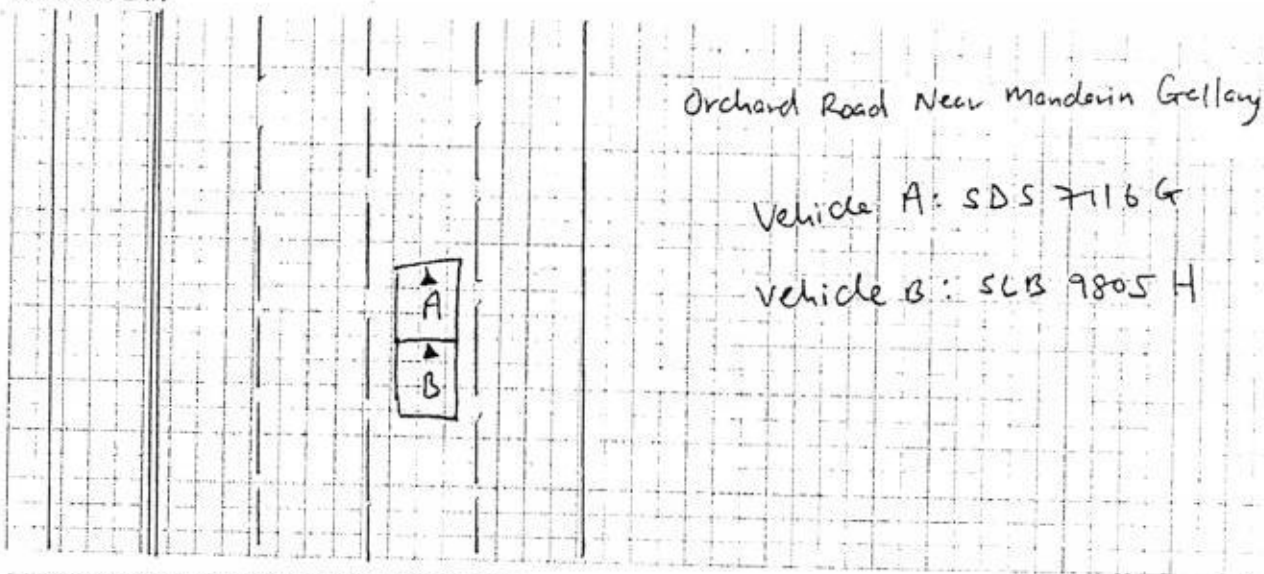
SKETCH PLAN

On the 23rd day of May 2019 at about 8.16am, I was driving SDS 7116 G along the second lane from the right along Orchard Road next to Mandarin Gallery Hotel and came to a stop at the traffic. The car in front stopped, I came to a stop too. Then motor car SLB 9805 H driven by a woman collided into my car and propelled my car forward. My wife who was a passenger was injured.

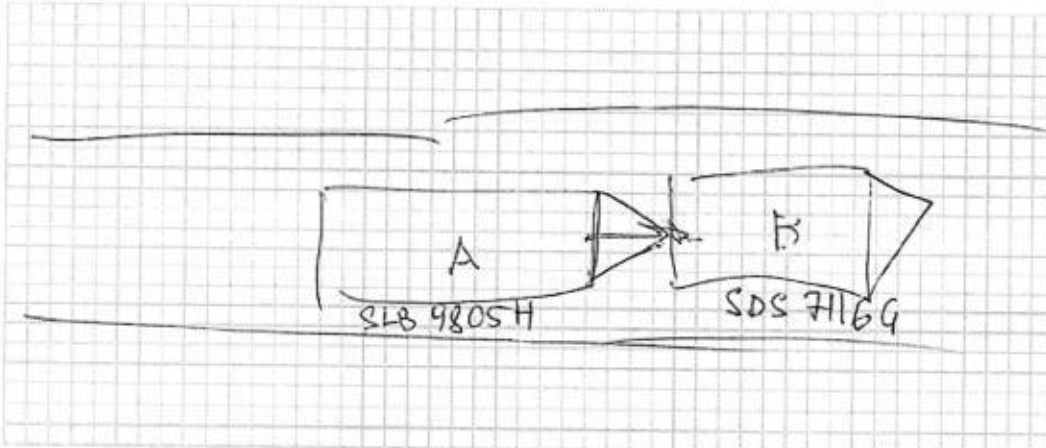
SKETCH PLAN

My Vehicle No (A): SLB 9805H
