Vehicle No.: SLJ1329B
Vehicle to be Exported: No
Intended Deregistration Date: 23 May 2019
Vehicle Make: MAZDA
Vehicle Model: MAZDA2 5-DOOR HATCHBACK 1.5L SP6EAT
Primary Colour: Pink
Manufacturing Year: 2016
Engine No.: P520362209
Chassis No.: JM6DJ2HAA01100889
Maximum Power Output: 85.0 kW (113 bhp)
Open Market Value: \$18,726.00
Original Registration Date: 29 Nov 2016
First Registration Date: 29 Nov 2016
Transfer Count: 0
Actual ARF Paid: \$8,726.00

ESTIMATED COST OF REPAIR FOR MAZDA 2 5-DOOR HATCHBACK 1.5L(2016) SLJ1329B

VEHICLE DAMAGE INSPECTION REPORT

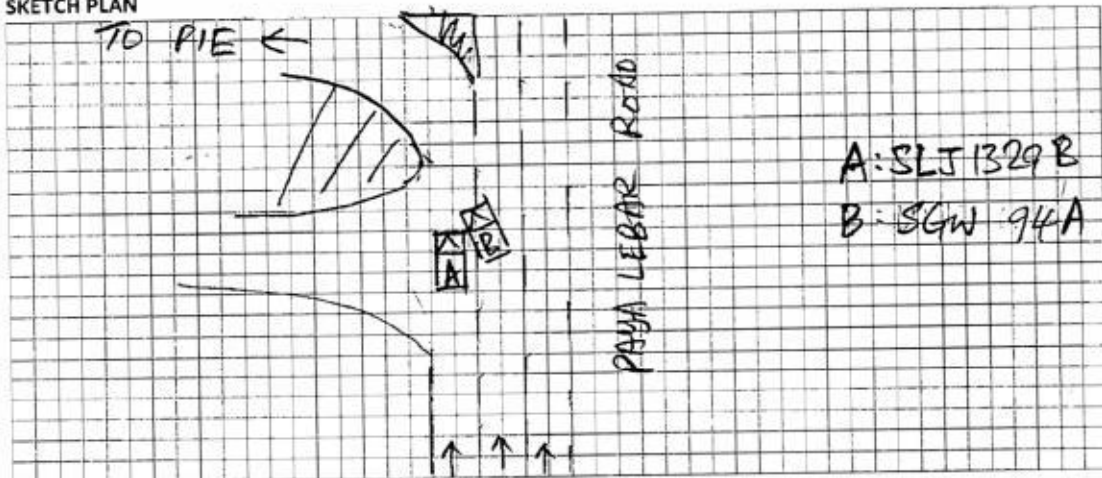
SKETCH PLAN

I WAS DRIVING ALONG PAYA LEBAR ROAD WHEN VEHICLE B CUT INTO MY LANE SUDDENLY AND THERE IS NO WAY I COULD STOP AND WE COLLIDED.
