ESTIMATE REPAIR BILL FOR KIA OPTIMA REGN NO: SHC 6002 U

ACCIDENT INVOLVING SHC6002U AND SH9254H ALONG CHANGI AIRPORT – T1/T3 TAOI QUEUE ON 27.05.2019

VEHICLE DAMAGE INSPECTION REPORT

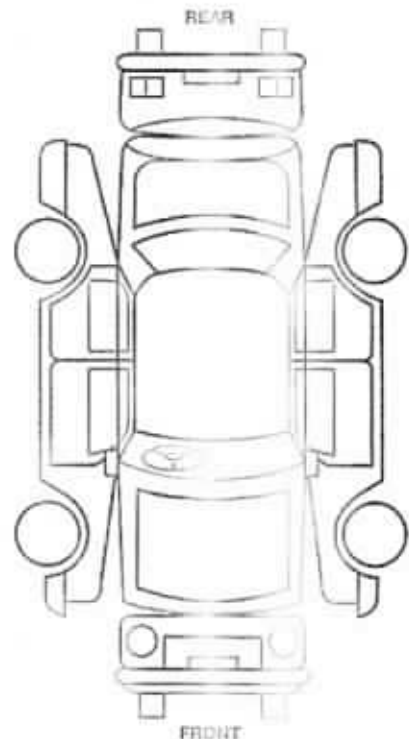
INDICATE AREA OF DAMAGE HERE:

| 1 - Light Dent | 5 - Damaged |
| 2 - Serious Dent | 6 - X |
| 3 - Light Scratch | 7 - X |
| 4 - Serious Scratch | 8 - X |
