ASSIGNMENT (Office)

SLK 8376M

VEHICLE DAMAGE INSPECTION REPORT

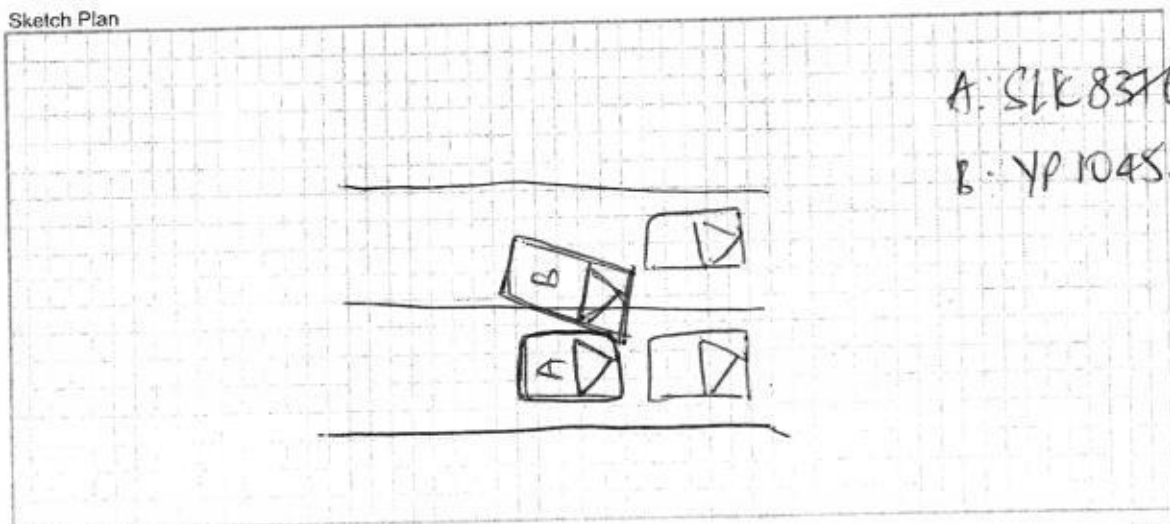
Sketch Plan

- Stationary behind a queue of car due to traffic light condition.
- Front car moved and while I was about to move off, vehicle B (YP10453) suddenly changed lane and collided into my car.

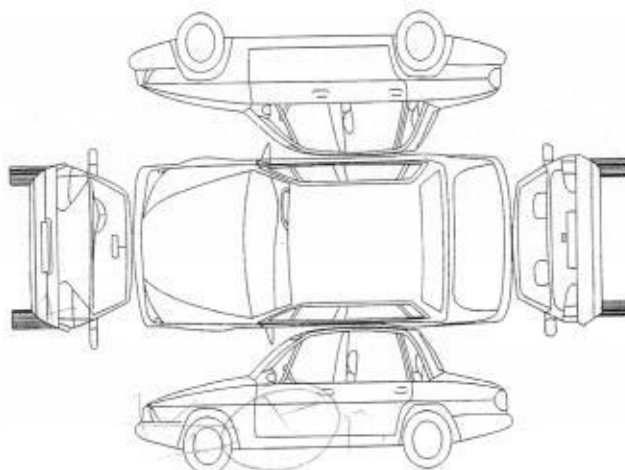
Place X on damaged area for scratch and Y for dent
