## VEHICLE DAMAGE INSPECTION REPORT

Our File No: CS/CT119009523/UQD3N2

Handling Insurer:	China Taiping Insurance (Singapore) Pte. Ltd.	Policy No:	DMCVSN18058318000	
Claimant Vehicle No :	YP6706C	Insured Vehicle No :	GBA8327B	
Date of Loss:	20/09/2018	Nature of Claim:	TP	Claim No: SNM19D202388C02

Reg No:	YP6706C	Engine No:	4JJ13A4636
Make & Model:	ISUZU NPR85UH5A, 3.0 D (M)	Chassis No:	JAANPR85HH7100644
Reg. Date:	05/07/2017 (Man. Year: 2017)	Odometer:	69657 km
Colour:	White		
Engine Capacity:	2999 cc		
Market Value/New Car Price:	N/A		
Sum Insured (S\$):	Market Value/New Car Price

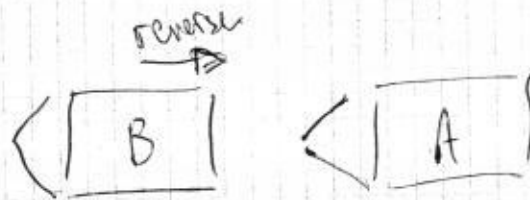
# SKETCH PLAN

A: YP6706C

B: GBA 8327B

I was driving YP6706C delivery shipment at 10 TUAS SOUTH AVE 8 On 20 September 2018 14.40 hrs. once I stop and want going down changing Pass from Security. Suddenly Van Station in front of me doing reversed and directly hit my truck front head. I was step horn and trying to warning van reversing But the van driver still continue doing reversed hit my truck.
