**Preliminary Advice**

| Vehicle No | : SLS6807H | Accident Date | : 23/05/2019 |
| Make | : SUBARU FORESTER | Policy No. | : 1700052708-01 |

## VEHICLE DAMAGE INSPECTION REPORT

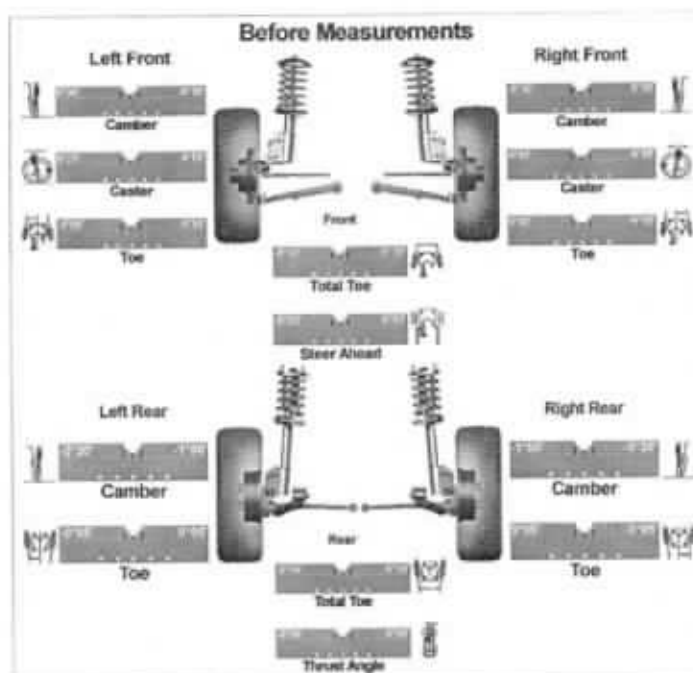
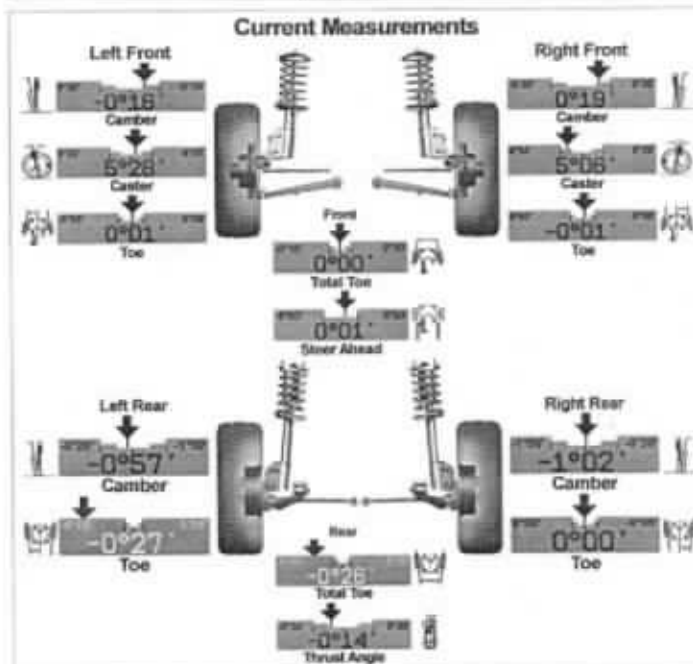
**Subaru : Forester : 2016-18 (SJ)**  
**4-Wheel Total Alignment**

Work Order: R001339  
 Name 2: WANG ZHAOYUN  
 Company: BLK 289D BUKIT BATOK STREET 25  
 License: SLS6807H  
 Year: 17  
 Technician: KUGAN  
 Odometer: 13697  
 Date: 11.6.19 9:53

**\*Note** - To conduct all wheel alignment before repair.

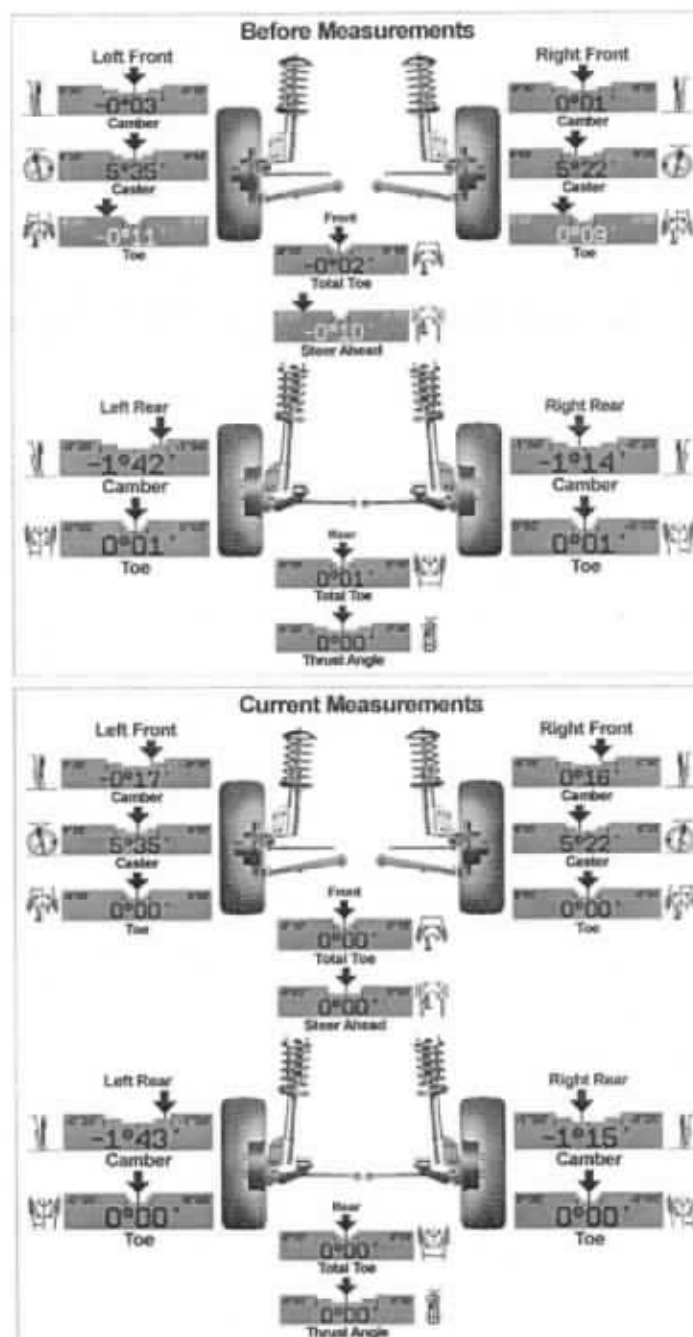
**Subaru : Forester : 2016-18 (SJ)**  
**4-Wheel Total Alignment**

Work Order: R001345  
 Name 2: WANG ZHAOYUN  
 Company: BLK 289D BUKIT BATOK STREET 25  
 License: SLS6807H  
 Year: 17  
 Technician: KUGAN  
 Odometer: 13697  
 Date: 11.6.19 17:10
