BMW 430i convertible 1998

FINAL REPAIR BILL FOR VEHICLE NO SLK37U

THE VEHICLE SUSTAINED DAMAGES AT THE REAR AND FRONT PORTION. DAMAGES SEE DETAILS.
--

ADJUSTMENT ON REPAIR COST FOR VEHICLE NO. SLK 37U

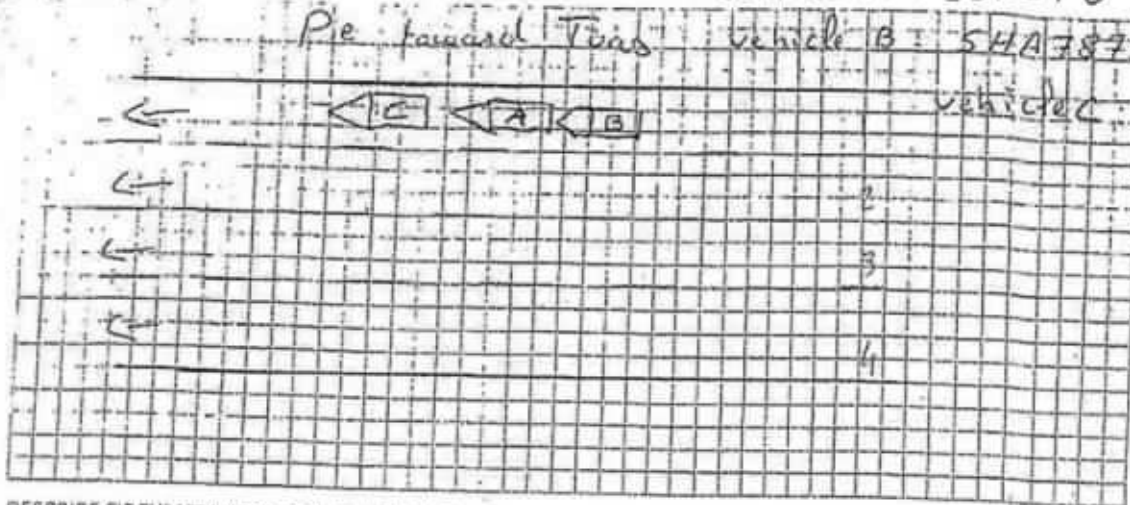
I was driving on lane 1 on PIE towards Tvas
 The traffic slow down I decelerate until I stop behind the Vehicle C
 (SLG4762D) Few seconds later Vehicle B (SHA7875X)
 Violently hit the rear of my vehicle and push it into collision
 with the vehicle C in front of me. I want to highlight that
 I never hit the Vehicle C until the Vehicle B collide into me
 Both front and back of my car are damaged I and my
 girlfriend suffer from injury and were given each
 two days of MC

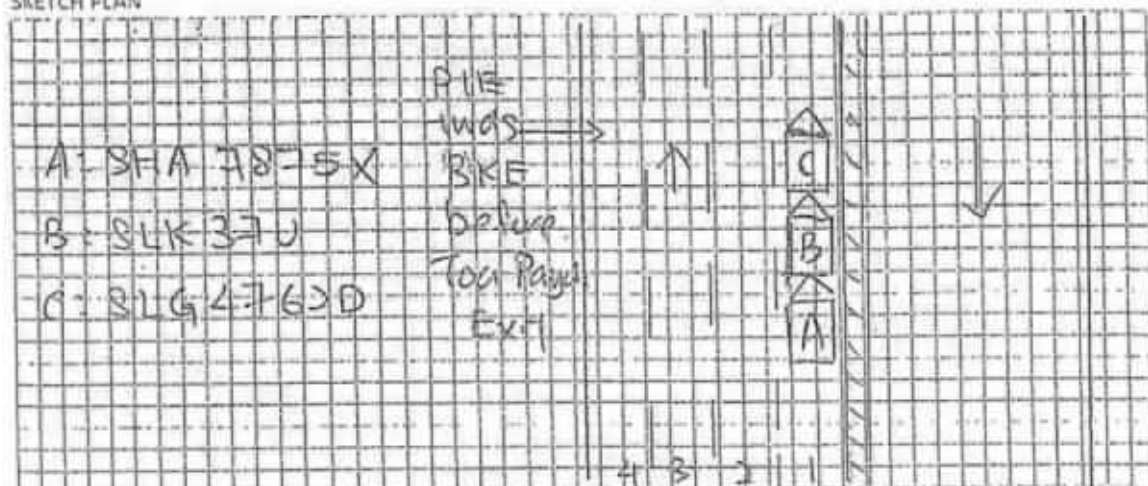
SKETCH PLAN

On 31/1/19 at about 15:30 hrs, I Veh A driving on above said location with a female passenger. Shortly traffic in front braked to stopped in sudden. I immediately applied brake upon noticed it but it was too late. As a result, my taxi front portion collided onto rear portion of Veh B. Subsequently Veh B surged forward hit onto Veh C. After that, my passenger said her knee suffered pain but she refuses to get any medical assistance. No police no ambulance came to scene.

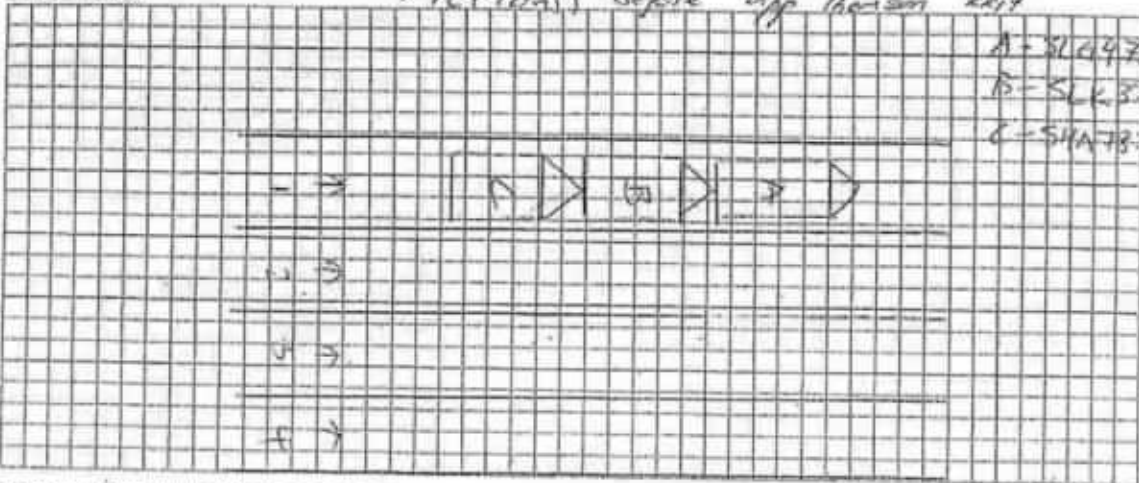
SKETCH PLAN

I Vehicle A was travelling along PIE(TUAS) before Upp Thomson Exit. ~~During~~ Due to traffic my Vehicle A have come to a complete stop. Suddenly Vehicle B have collided on to my rear partition. I shock and not realise it a 3 car chain collision with Vehicle C involved behind Vehicle B.
