To Inspect Vehicle No: SLZ 4017Y

The U/C / Chassis frame / Body Structure affected due to collision.

4. Description of Damages

ADJUSTMENT ON REPAIR COST FOR VEHICLE NO. SLZ 4017Y

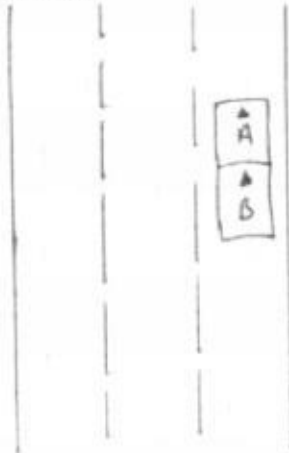
SKETCH PLAN

On the stated date and time, the vehicle in front of me stopped.

I followed suit. Suddenly Vehicle B hit onto my Vehicle rear portion.
