**Preliminary Advice**

Insured Vehicle No	: SLP5671D	Accident Date	: 02/06/2019
TP Vehicle No	: SHC8024T	Assignment Date	: 04/06/2019
Make	: MERCEDES-BENZ E220	Est. Duration of Repair	: 7.00
Date of Inspection	: 04/06/2019		
Inspection At	: COMFORTDELGRO ENGINEERING PTE LTD (LOYANG) 59 LOYANG DRIVE SINGAPORE 508969

**Point of Impact / General Description of Damages**

## VEHICLE DAMAGE INSPECTION REPORT

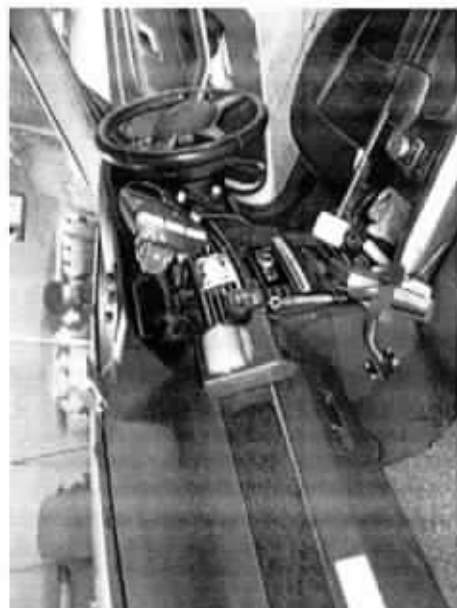
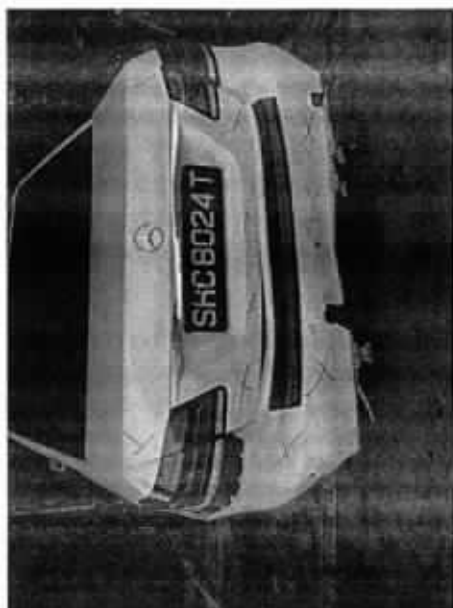
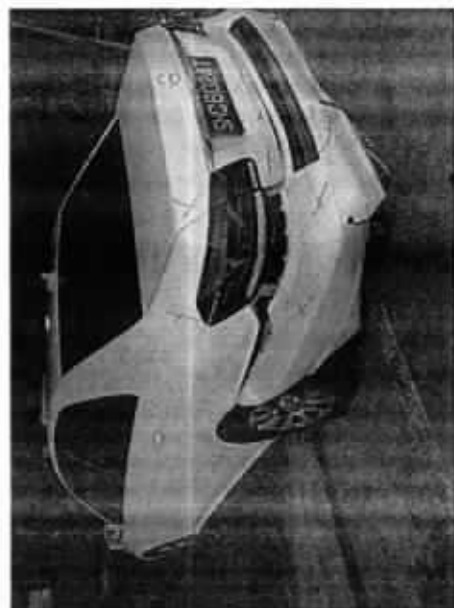
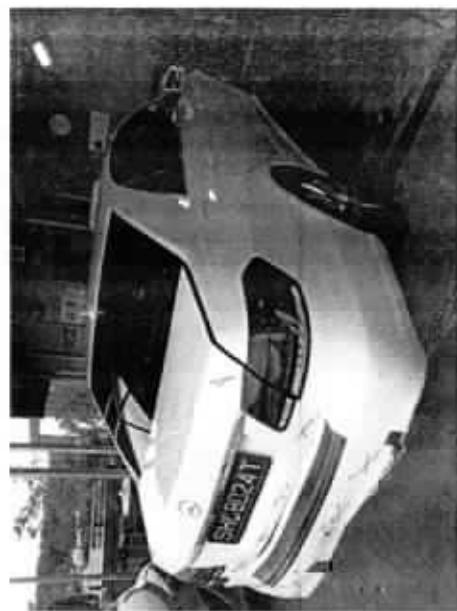
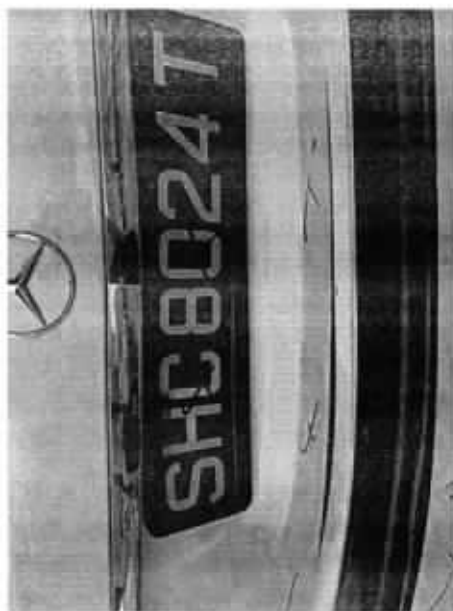
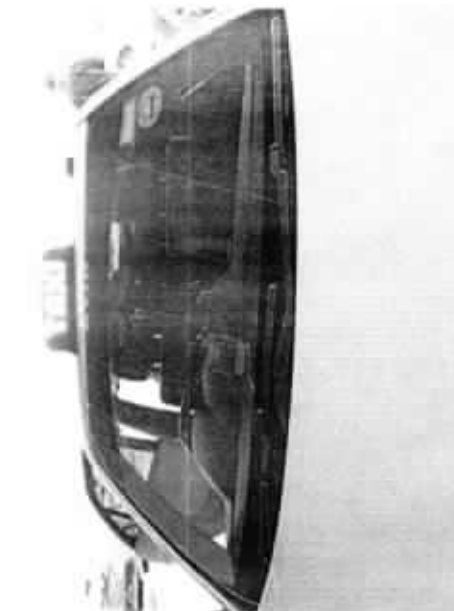
The U/C / Chassis frame / Body Structure affected due to collision.

The vehicle sustained impact / damages rear portion and parts claimed are consistent to the accident.
