SLR6713A - OD CLAIM - AIG INSURED - ARRANGE SURVEY - 04/06/2019...

**Preliminary Advice**

## VEHICLE DAMAGE INSPECTION REPORT

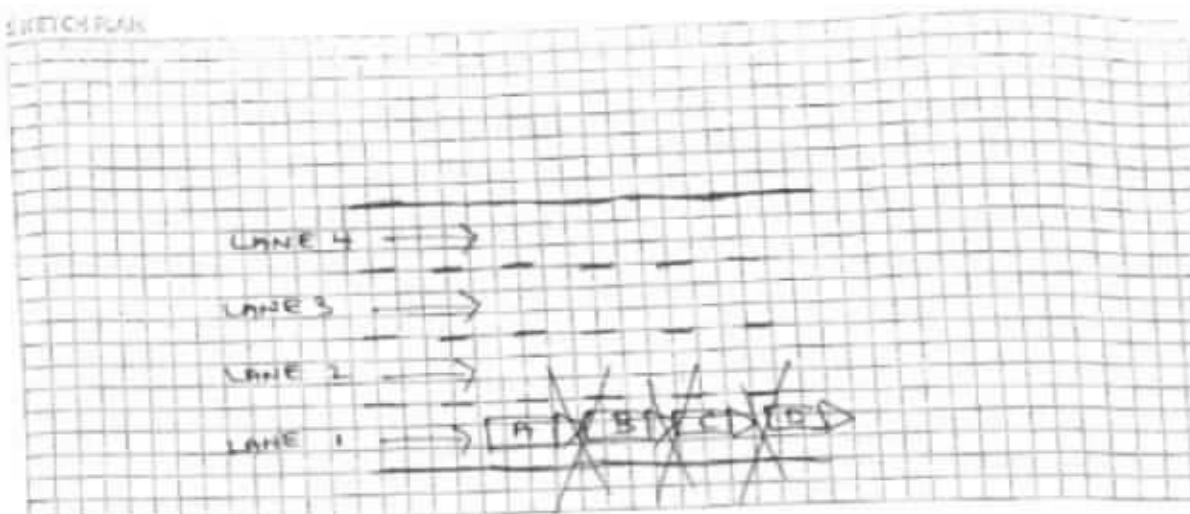
# Accident Sketch Plan

## DESCRIBE CIRCUMSTANCES OF THE ACCIDENT

On 21/01/19 at about 6:50pm, I was driving on TPE toward PB, heading towards KPE, Bumpas Road, on the 1st lane (most right lane). The traffic was heavy during the point in time. I saw the car in front of me started braking as such I hit the brakes as well. As the car could not stop in time, I collided into the rear of the car in front of me (SLP 52265). I then realised that it was a chain collision and I was the 1st car. None of the drivers were injured video footage is with the Traffic Police. I will submit it once I have gotten the SD card back.
