To Inspect Vehicle No: SKX 8139A

Make: CHEVROLET SONIC

**Preliminary Advice**

## VEHICLE DAMAGE INSPECTION REPORT

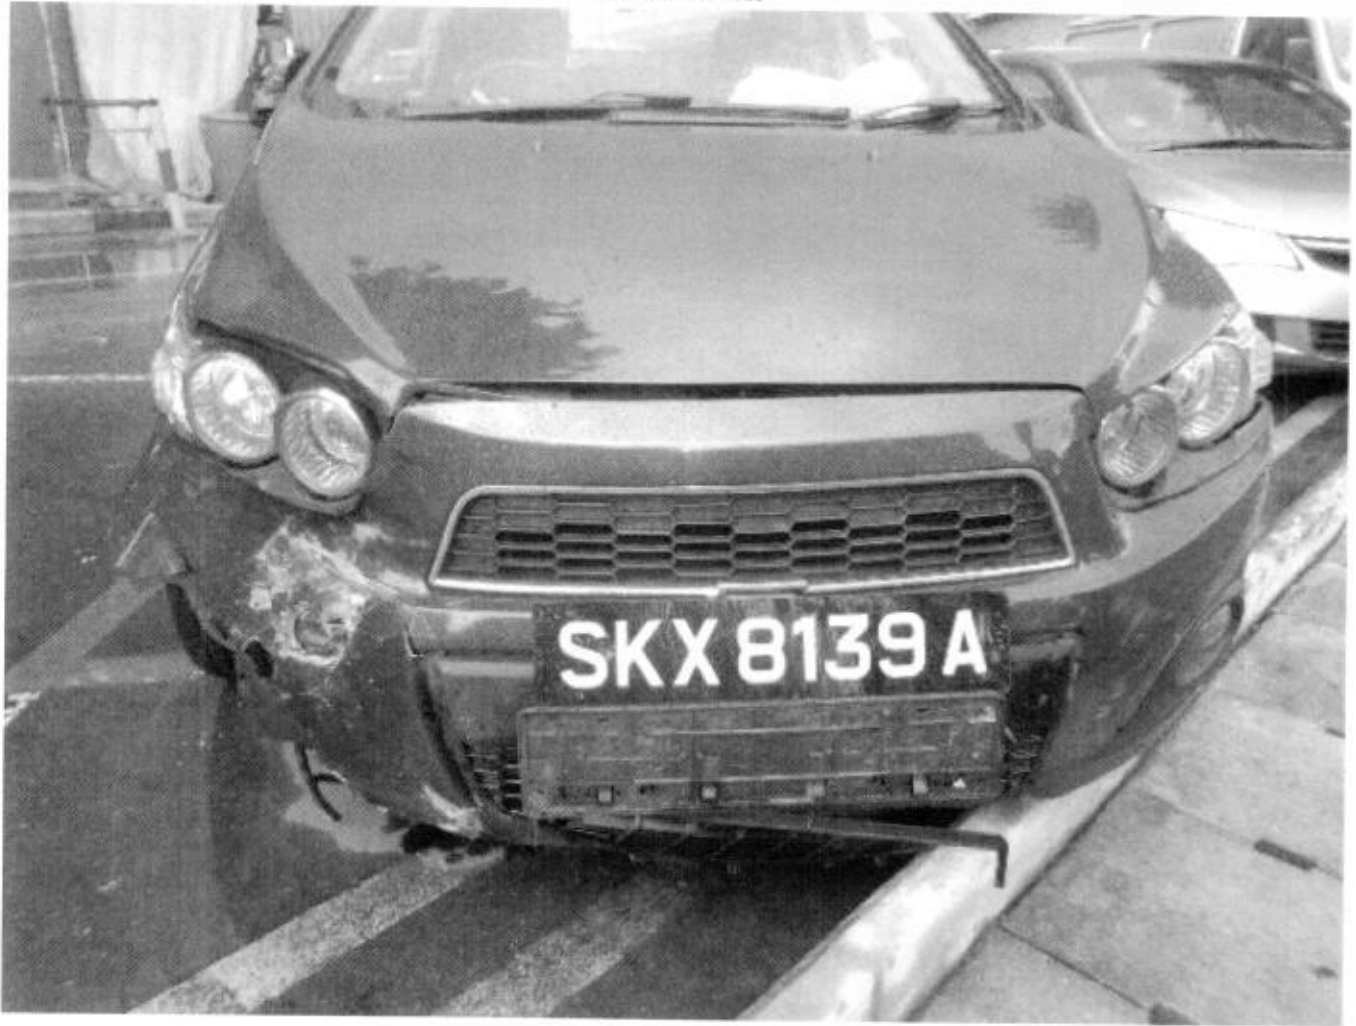
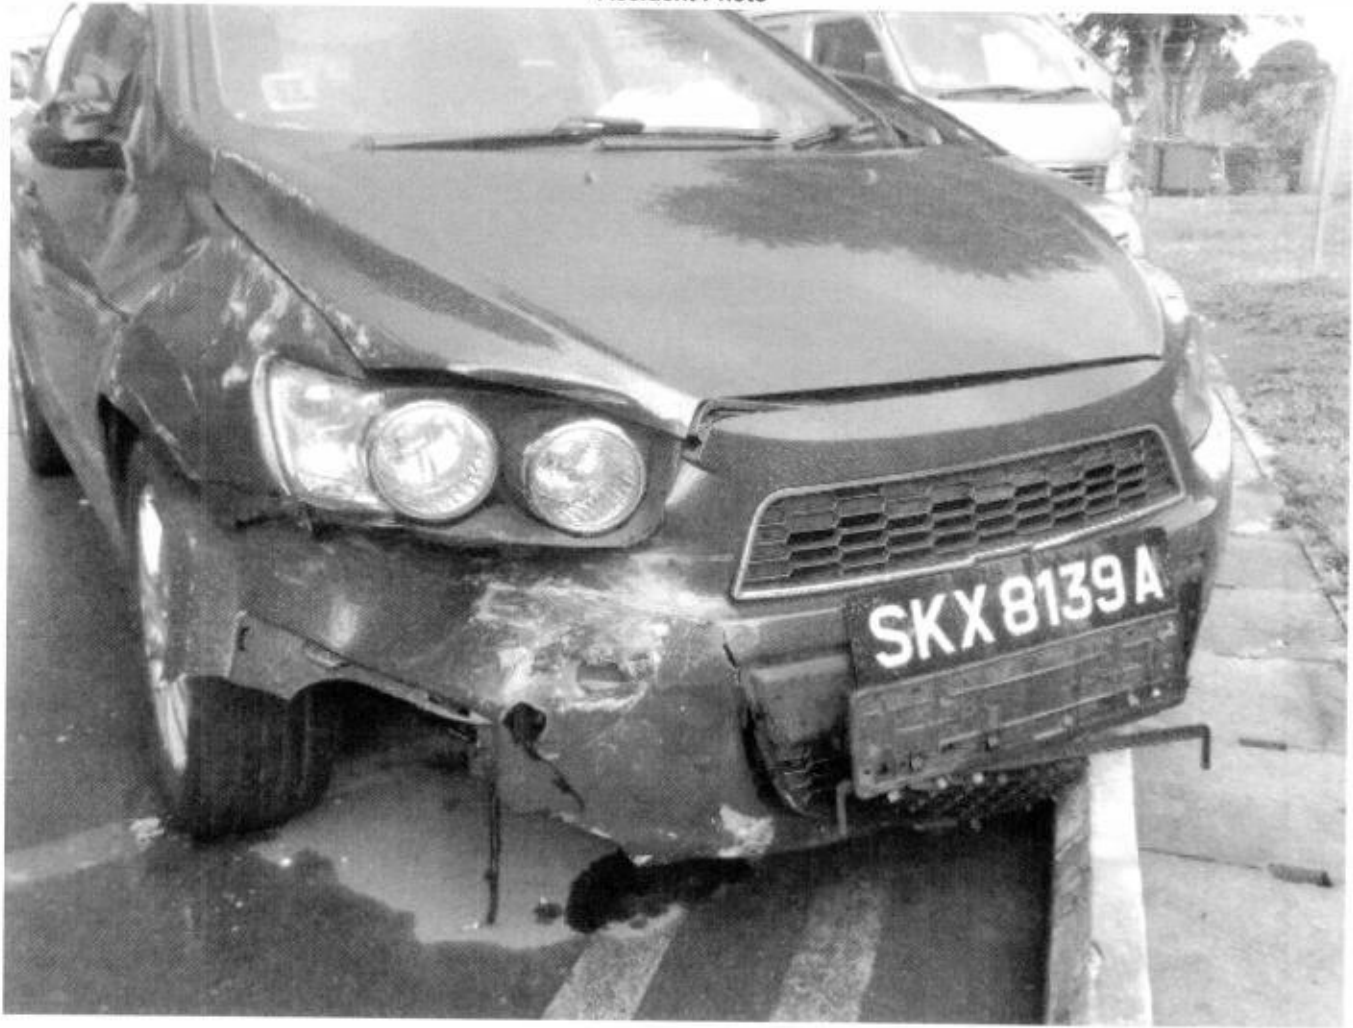
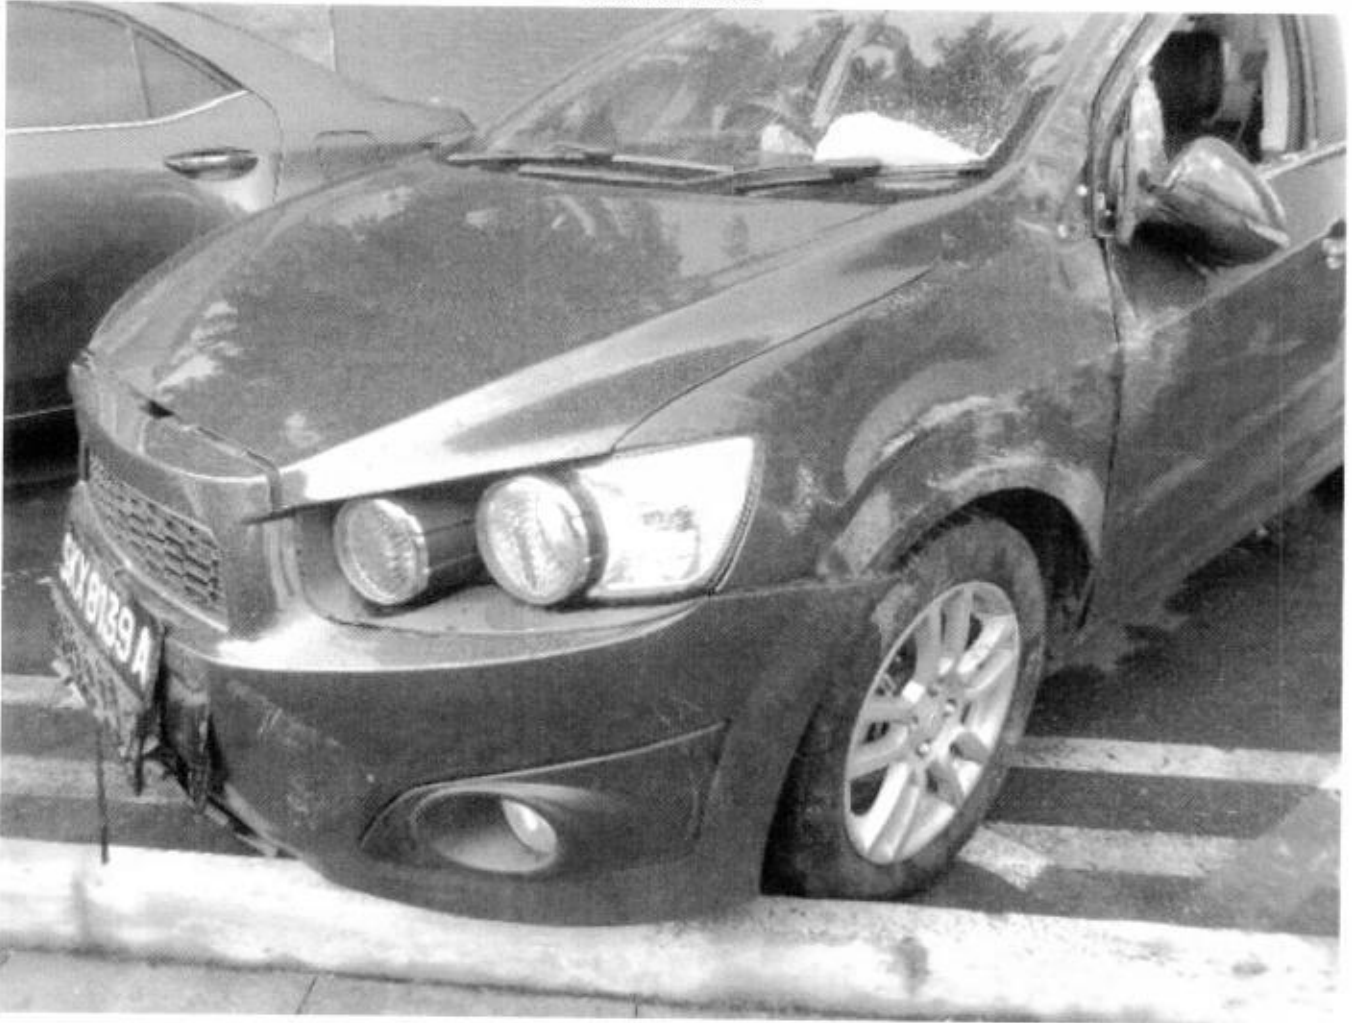
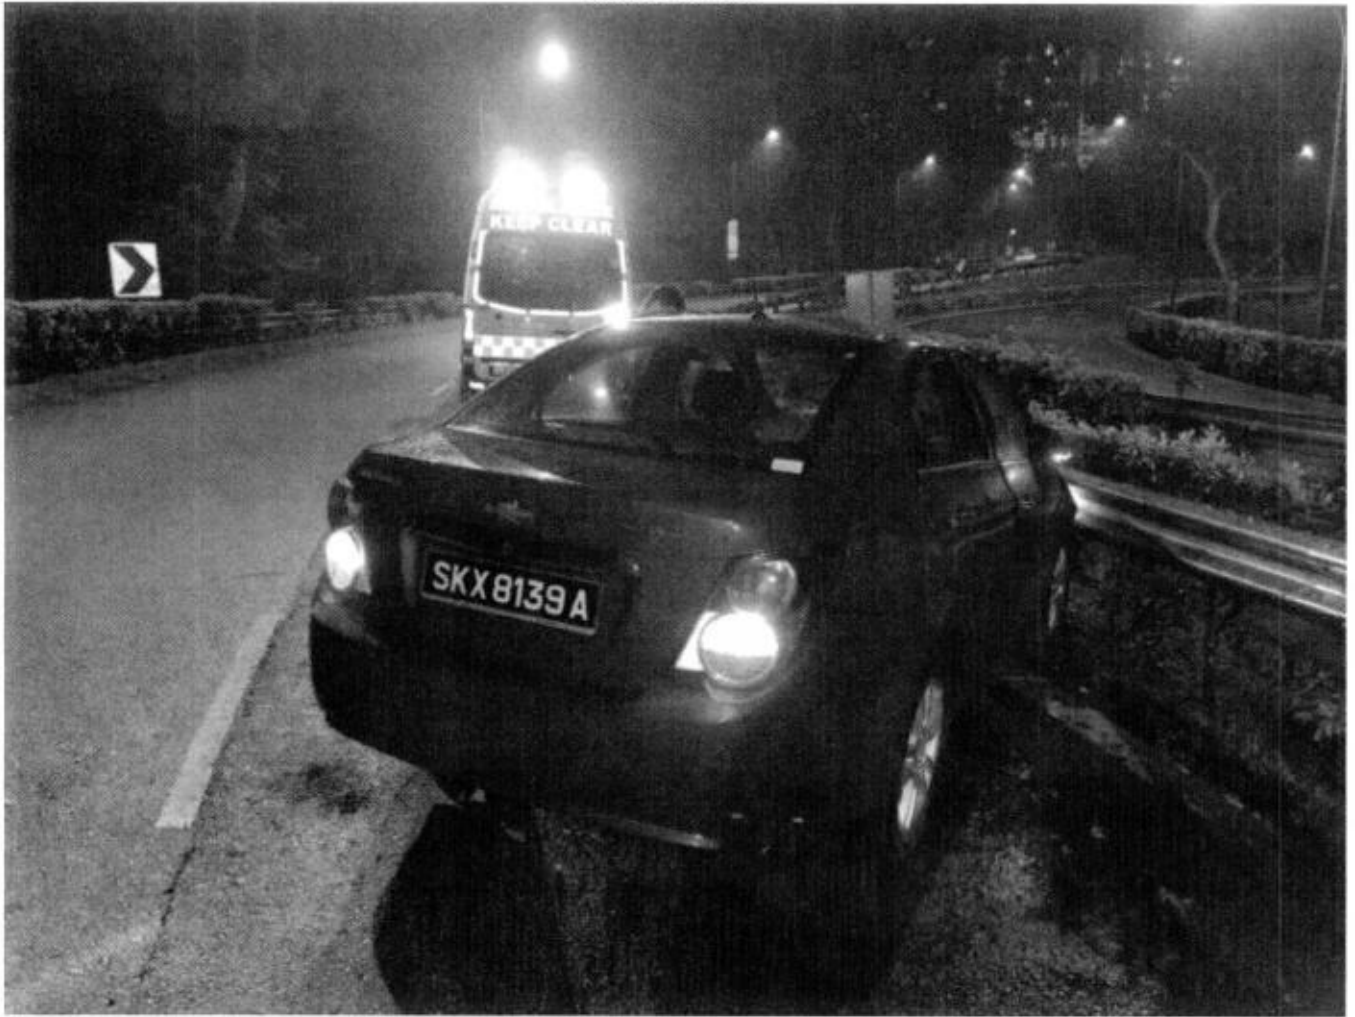
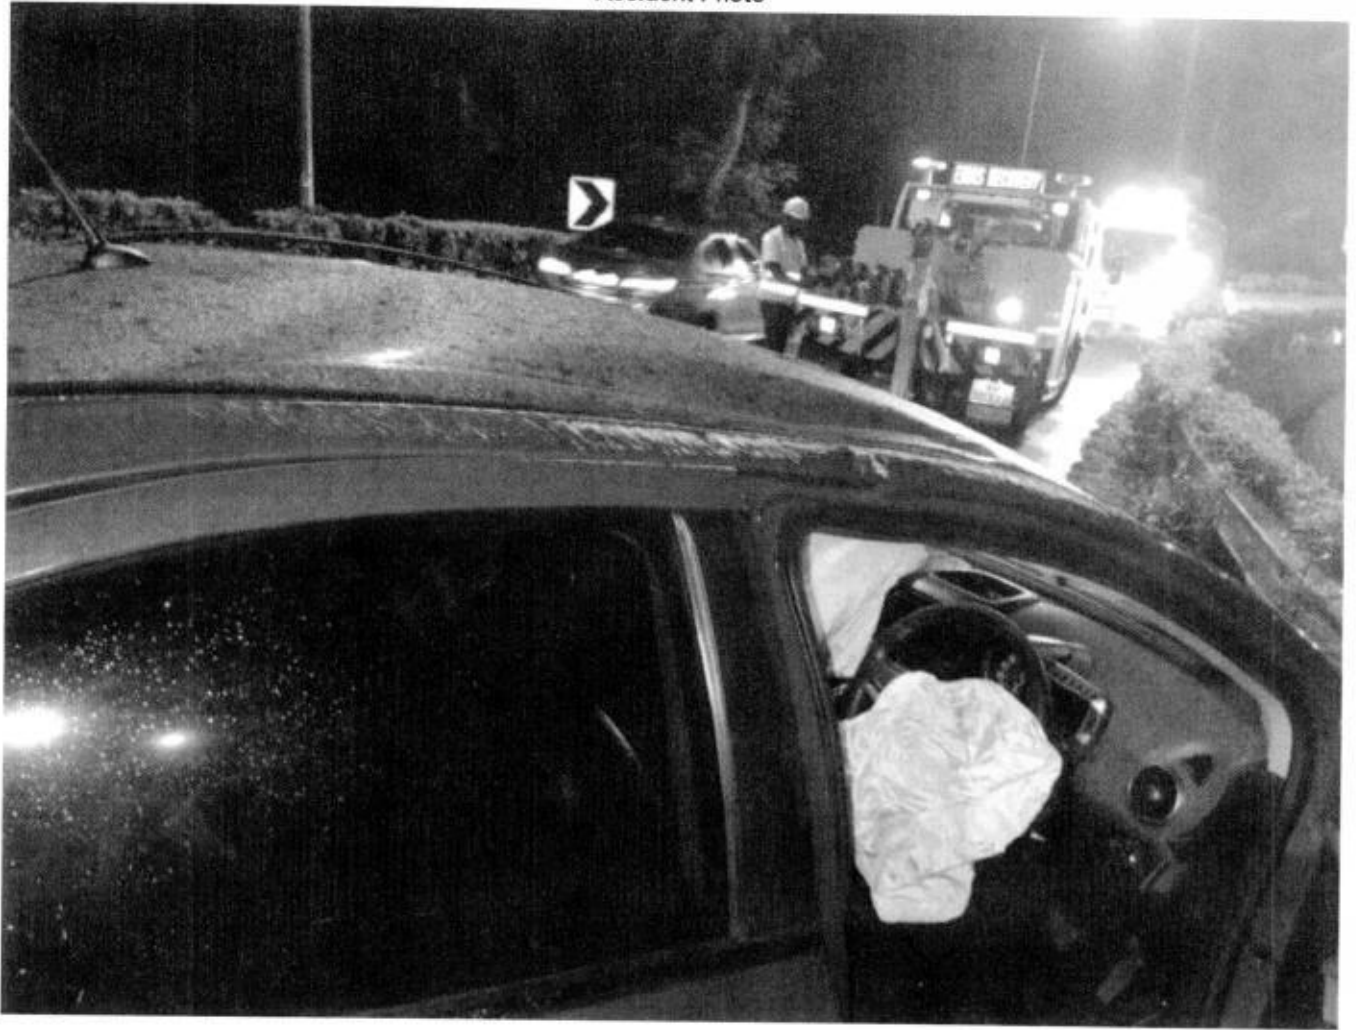
Accident Photo

The U/C / Chassis frame / Body Structure affected due to collision.

The vehicle sustained impact / damages front portion, o/s and n/s body. The body structure affected due to collision and parts claimed are consistent to the accident.

In view of the above, the vehicle is uneconomical to be repaired, you are advised to invite tender for the wreck.
