### 1. Policy Particulars :- THIRD PARTY CLAIM

### 4. Description of Damages

THE VEHICLE SUSTAINED DAMAGES AT THE FRONT PORTION.  
DAMAGES SEE DETAILS.

## ADJUSTMENT ON REPAIR COST FOR VEHICLE NO. SGT 5804B

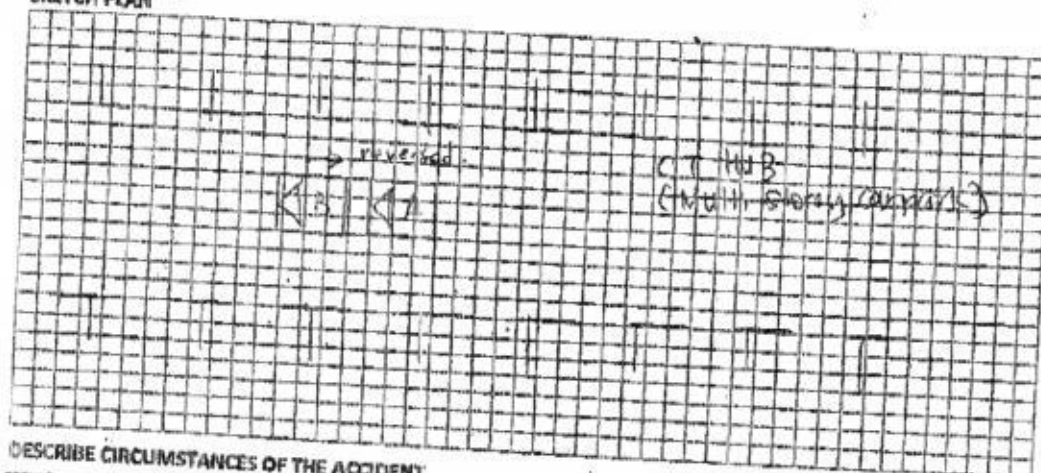
## SKETCH PLAN

On 01/06/19 at about 8:30am, I was waiting to exit the carpark. Car B which was in front of me made a reversed and hit the front portion of my car (A).
