CS/INC19010014/ETd302

RE: ESTIMATE COST OF REPAIR TO SHD2480T TOYOTA CAMRY HYBRID 2.5G CVT

DAMAGE ASSESSMENT REPORT

ADJUSTMENT ON REPAIR COST FOR VEHICLE NO. SHD 2480T

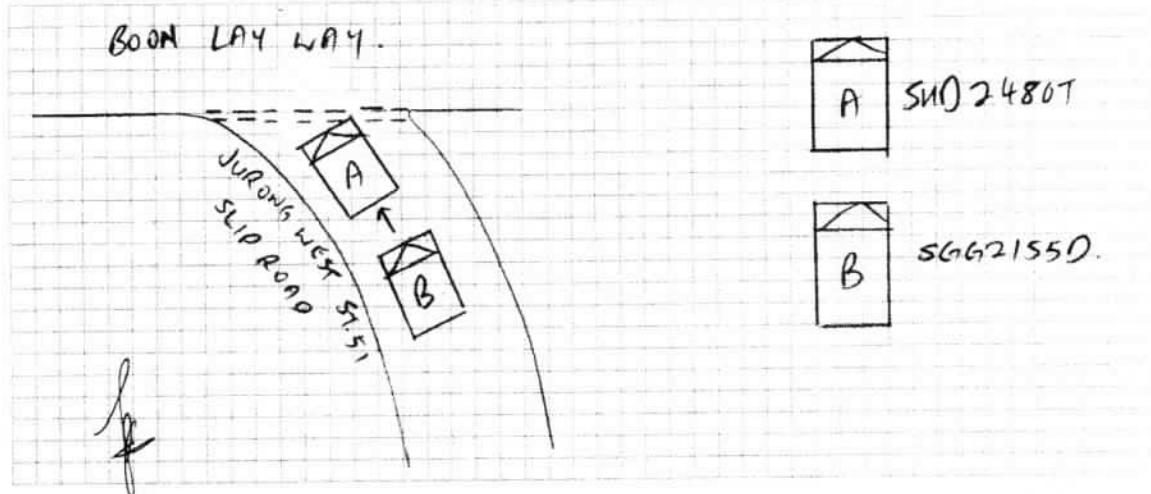
SKETCH PLAN

On 03.06.2019 @ 0755 hrs, my taxi SHD2480T stopped at the slip road of Jurong West Street 51, checking the oncoming vehicles along Boon Lay Way. While stationary, one car SGG2155D rear ended my taxi.
