REF: CS3/116/1900069/ACD3SM

SKL 2317E

SKL2317E (JD Motorsports)

VEHICLE DAMAGE INSPECTION REPORT

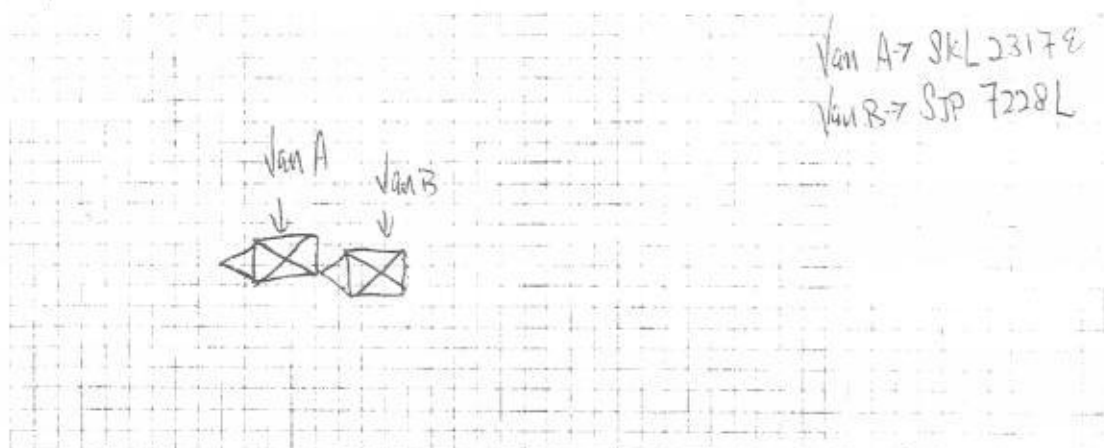
SKETCH PLAN

I was driving along woodlands checkpoint, suddenly I felt a huge impact from the rear, I alighted from my vehicle and realise veh B had hit onto the rear of my vehicle.
