VEHICLE DAMAGE INSPECTION REPORT

Our File No: CS/CT119010115/T1TD3E2

Claimant Vehicle No: SLP3607D Insured Vehicle No: SJZ4895C

Date of Loss: 04/06/2019 Nature of Claim: TP Claim No: SNM19D202504C02

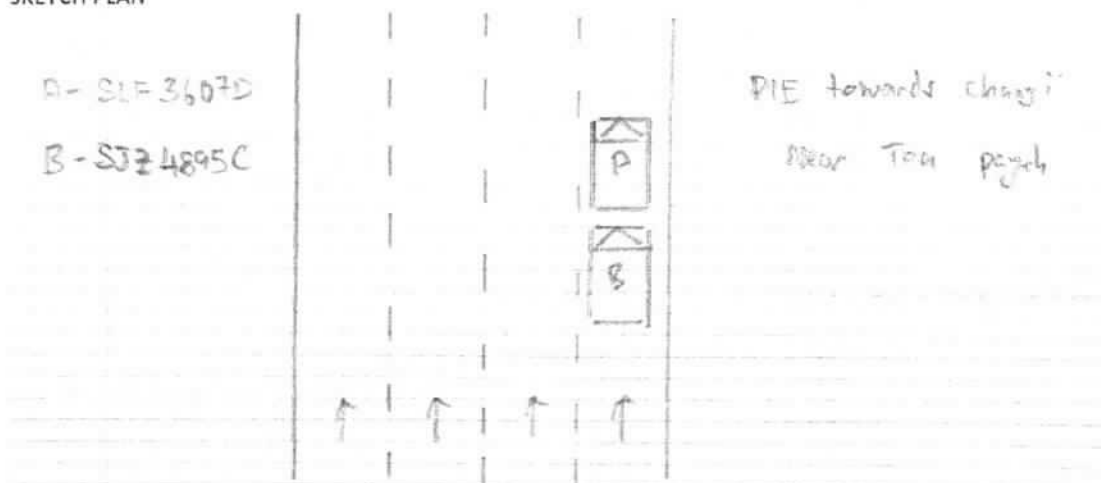
SKETCH PLAN

On the 04/06/19 at about 1330hrs, I was travelling straight along the first lane of PIE towards changi near tea porch. As the traffic was slow at the point of time. Suddenly vehicle in front of me jammed brake and i followed thru and manage to stop in time but after a few seconds, i felt an impact from my rear. After the accident, i alised to check and realised vehicle B (SJZ 4895C) had hit into my rear portion.
