AUTOMOBILE ASSESSMENT REPORT

Assessment of Vehicle No : SGH 7495J

At the time of inspection observed that this vehicle had sustained damages to the RHS MIDDLE portion

VEHICLE DAMAGE INSPECTION REPORT

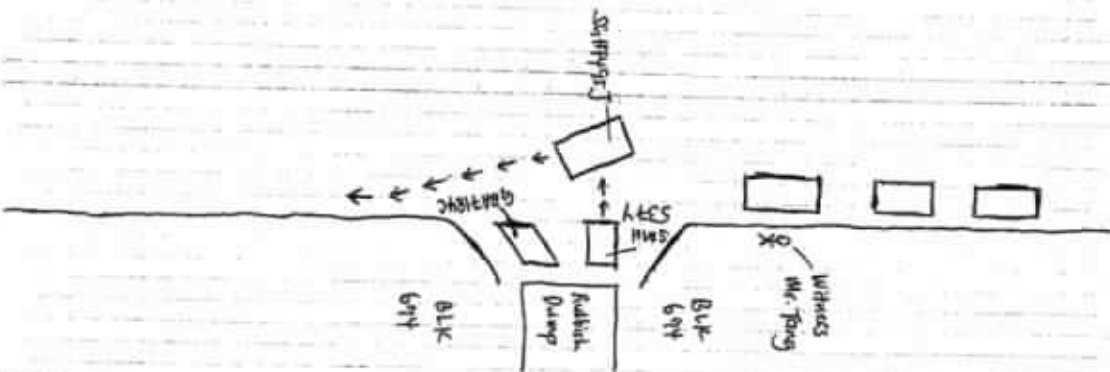
SKETCH PLAN

The incident happened on 23 March 2019 at roughly around 6:30 pm, at BLK 694 JURONG WEST CENTRAL 1, rubbish dump area.
Vehicle TOYOTA PRIUS SMH 537 Y reversed onto my vehicle Toyota WISH S6H7495 J while I was reversing to temporarily park my vehicle along the rubbish dump area. The owner of the vehicle was stationary at the rubbish dump area and reversed out onto my vehicle without checking his rear mirror fully. My intention of parking my vehicle temporarily along the rubbish dump area was to offload heavy marketing icons.
There was a witness named Mr. Tang, contact number 96897147, whom happened to witness the whole incident.
Owner of Toyota Prius : LIAN SOON CHYE
NRIC : S9303953 C

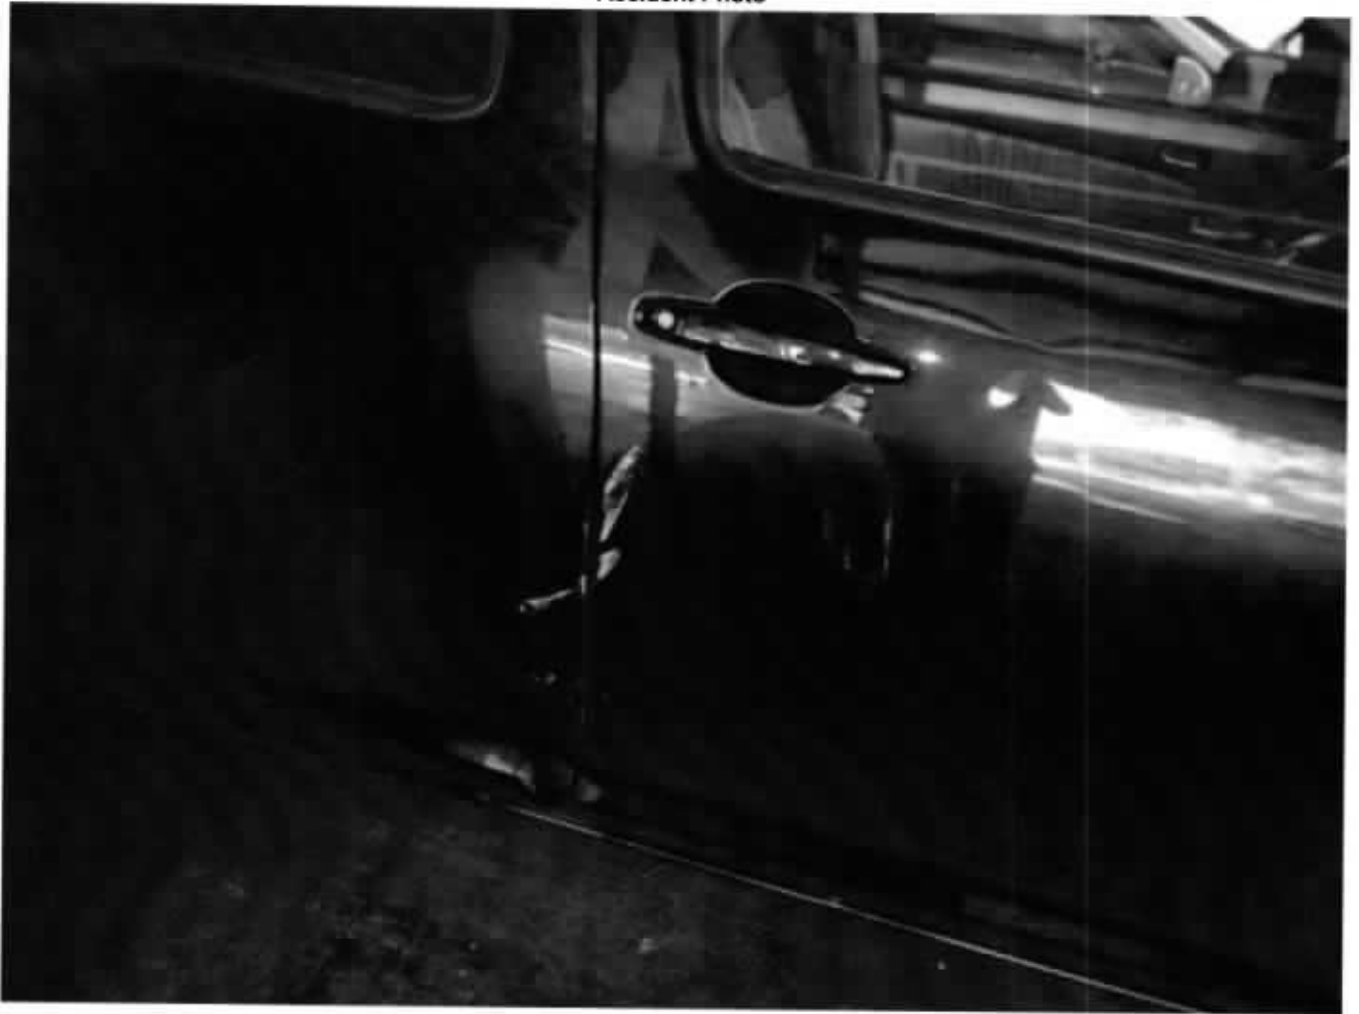
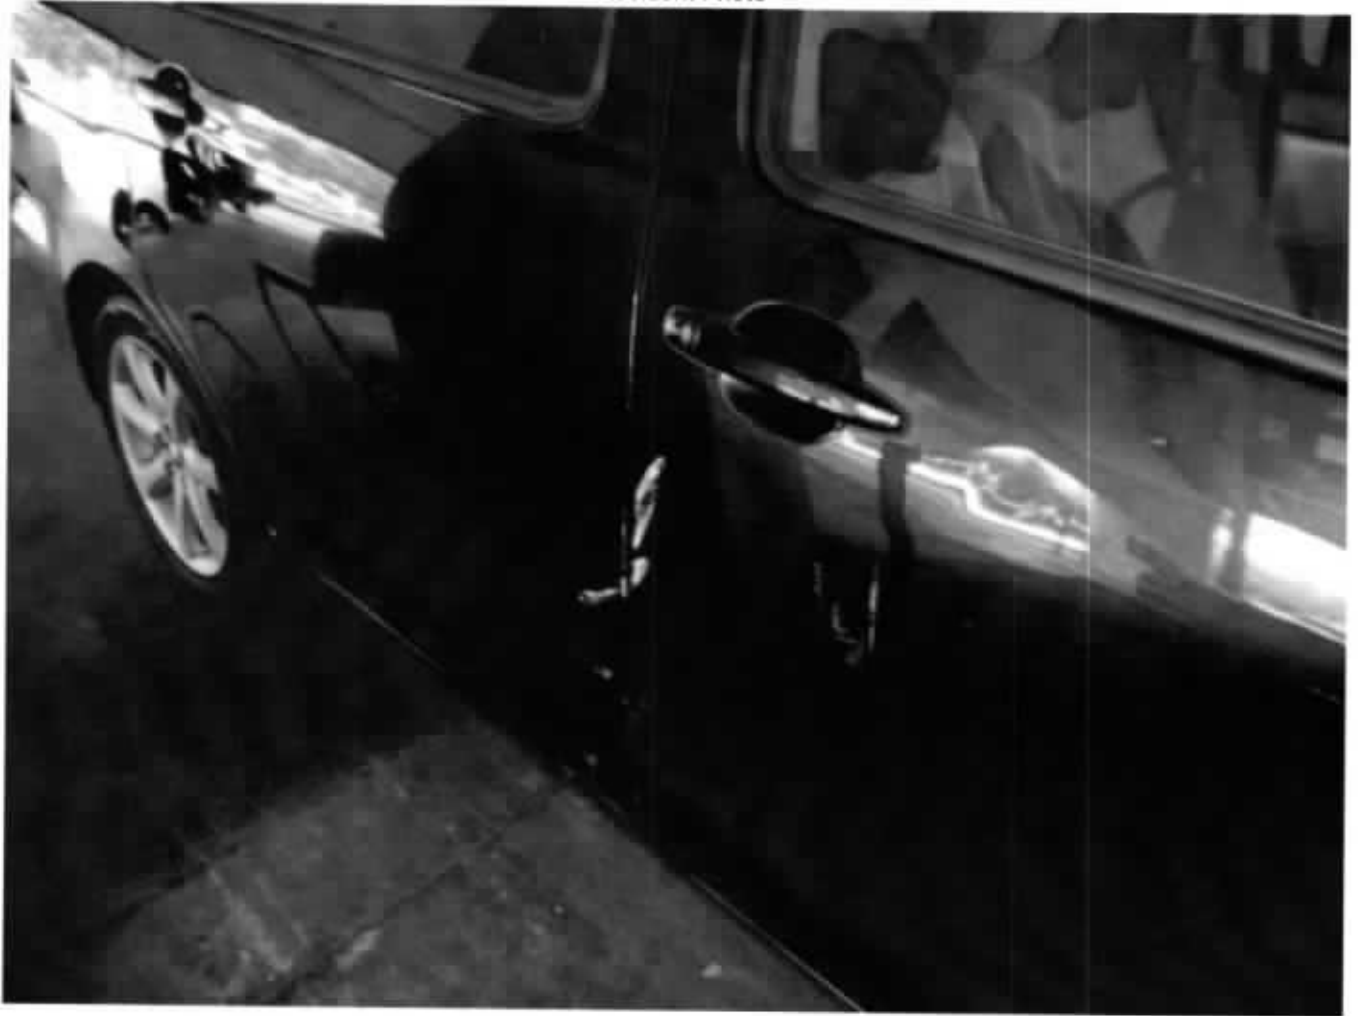
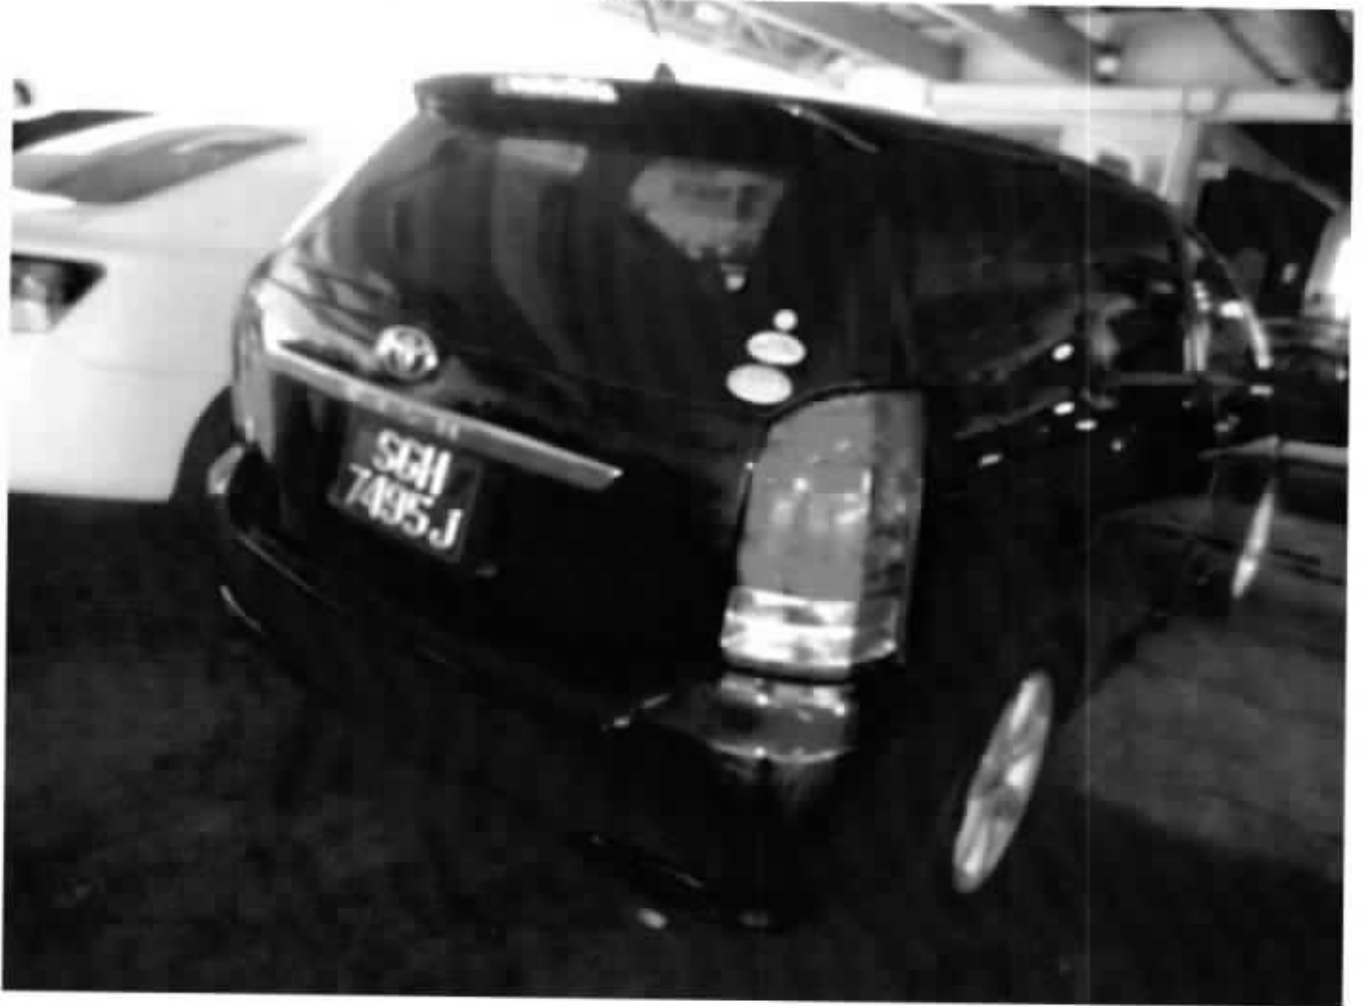
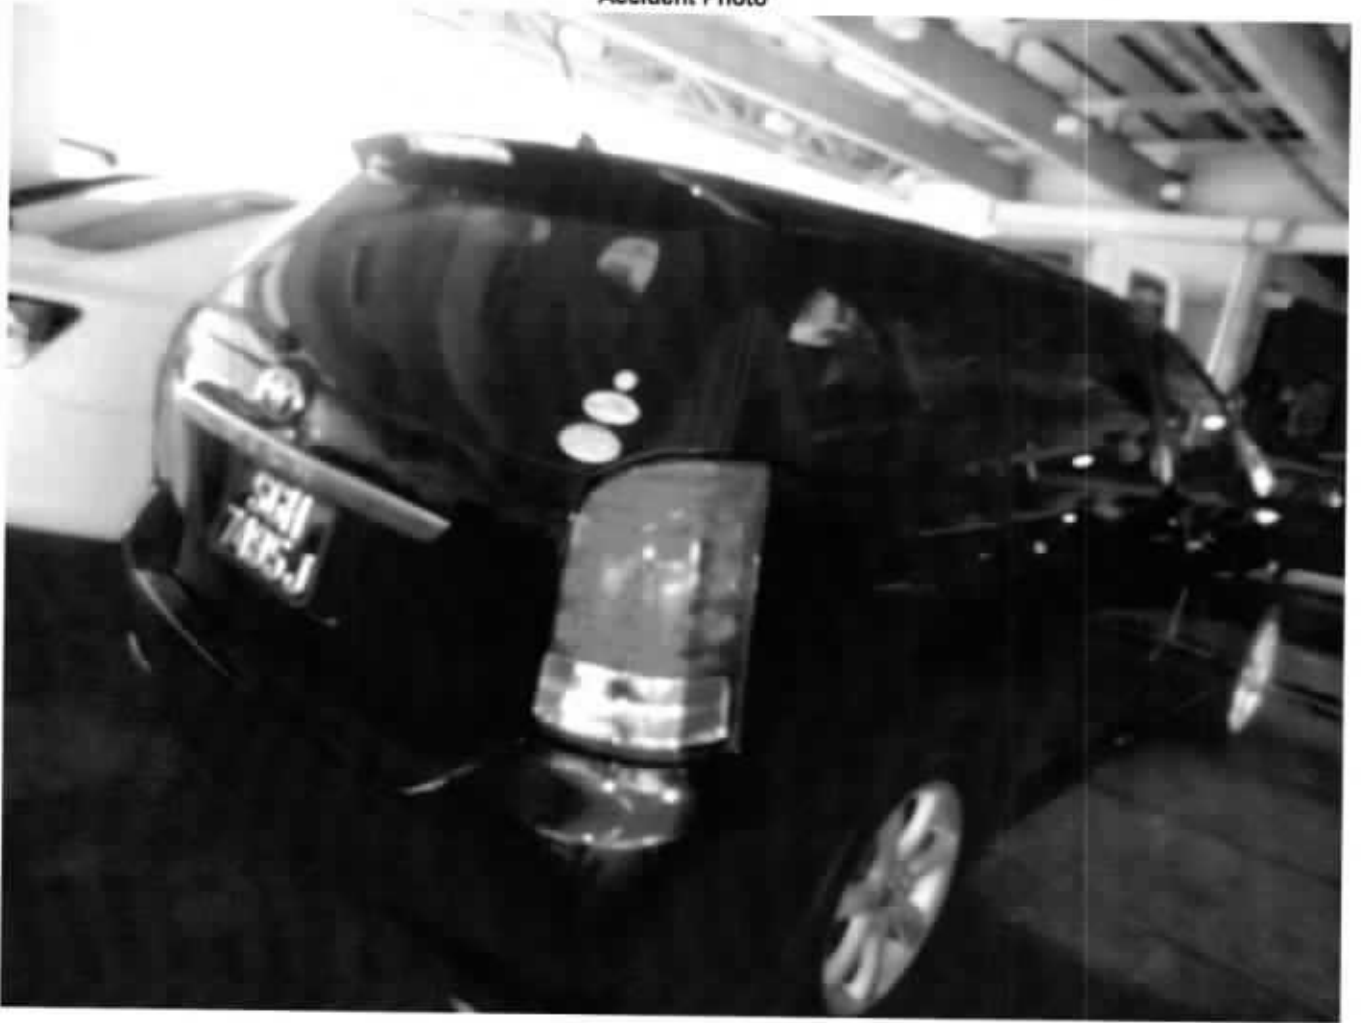
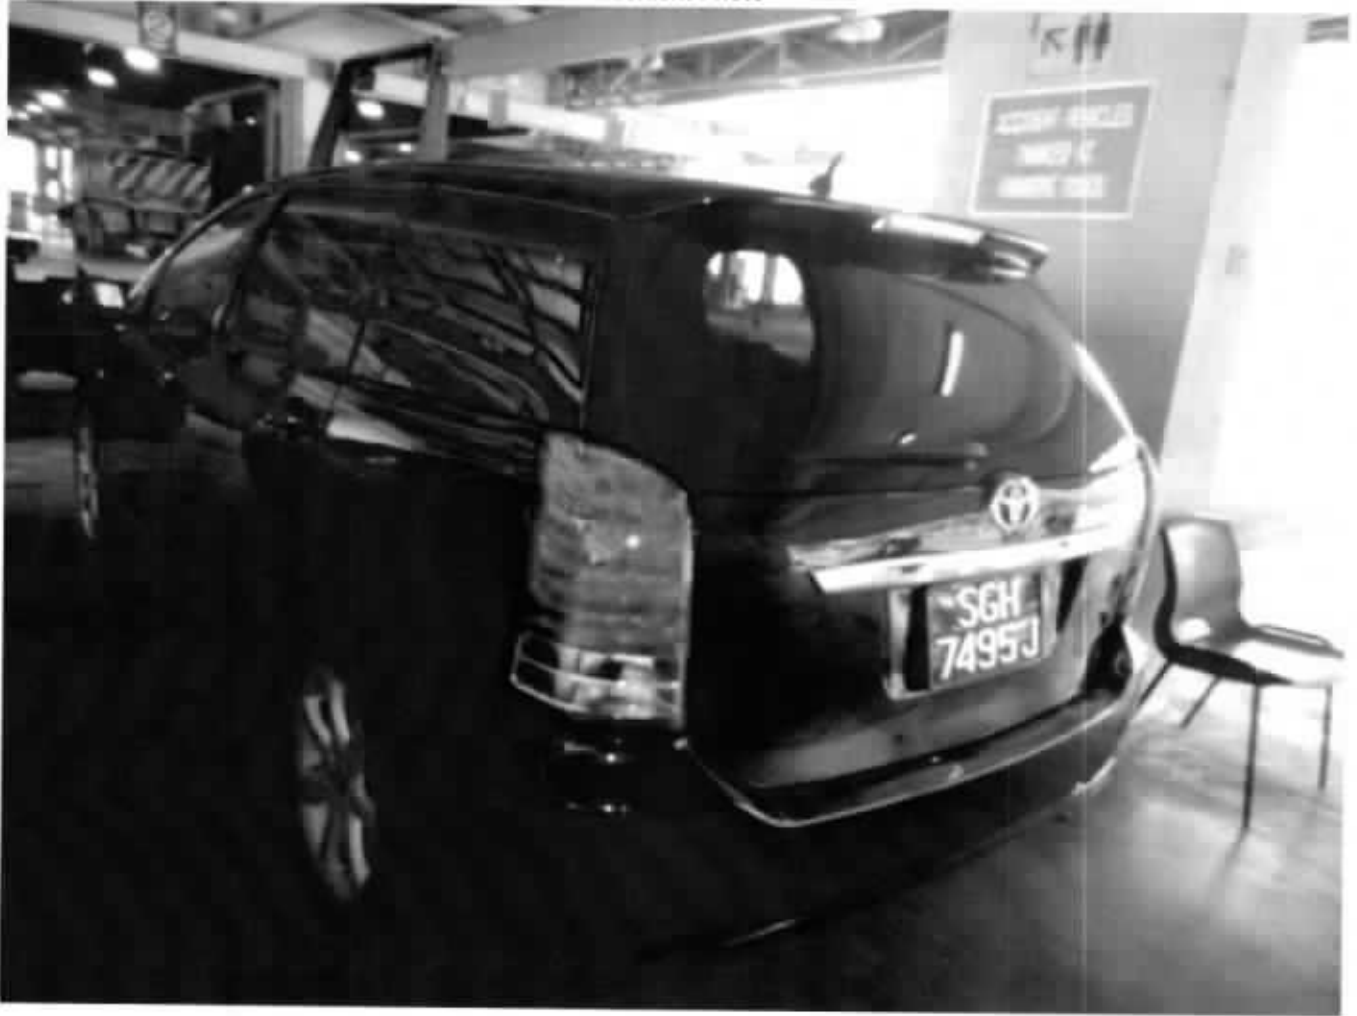
Accident Photo

Type Of Accident	SIDE SWIPE
Weather Conditions	CLEAR
Road Surface	DRY

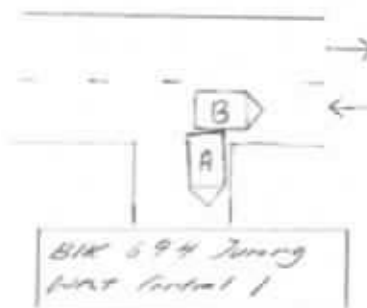
Sketch Plan

Veh A - SGH 5374

Veh B - SGH 7495J

On 23/02/19 @ 18:25hrs, my vehicle A (SGH 5374) was at BIK 694 Jorong West Central 1, Rubbuckh Chute alighting my passenger. After alighting my passenger, I did check my blind spot and my rear mirror and everything is clear then I made a move out and sudden vehicle B (SGH 7495J) making a move without checking had hit onto the rear left side portion of my vehicle A.
