ASSESSMENT FOR REPAIRS :  
VEHICLE NUMBER : SJ57699U  
VEHICLE MODEL : VOLKS WAGEN

### DAMAGE ASSESSMENT REPORT

**ADJUSTMENT ON REPAIR COST FOR VEHICLE NO. SJS 7699U**

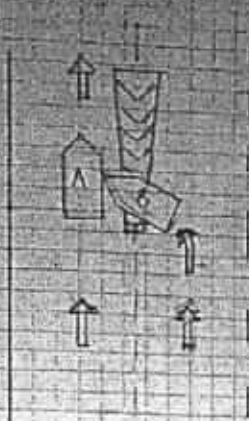
KFE EXITING TO TPE (SENGKANG)

KFE EXITING TO CHANGI AIRPORT

A - SJT 7699J

B - SJW 4931Y

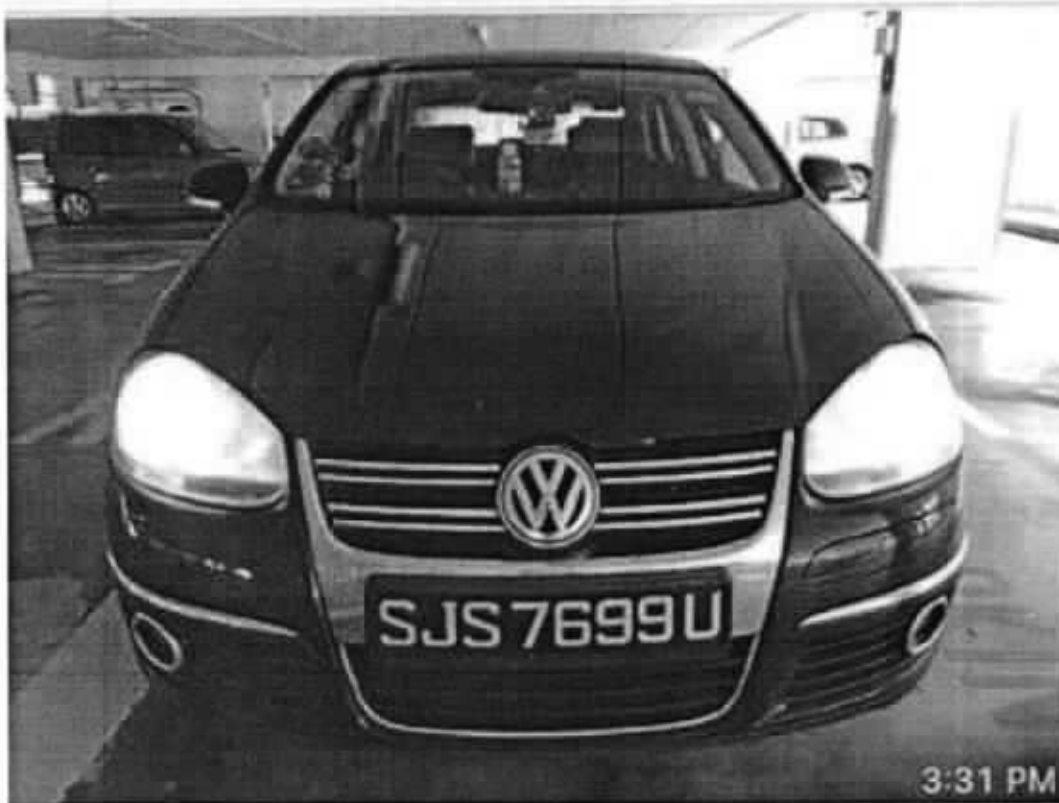
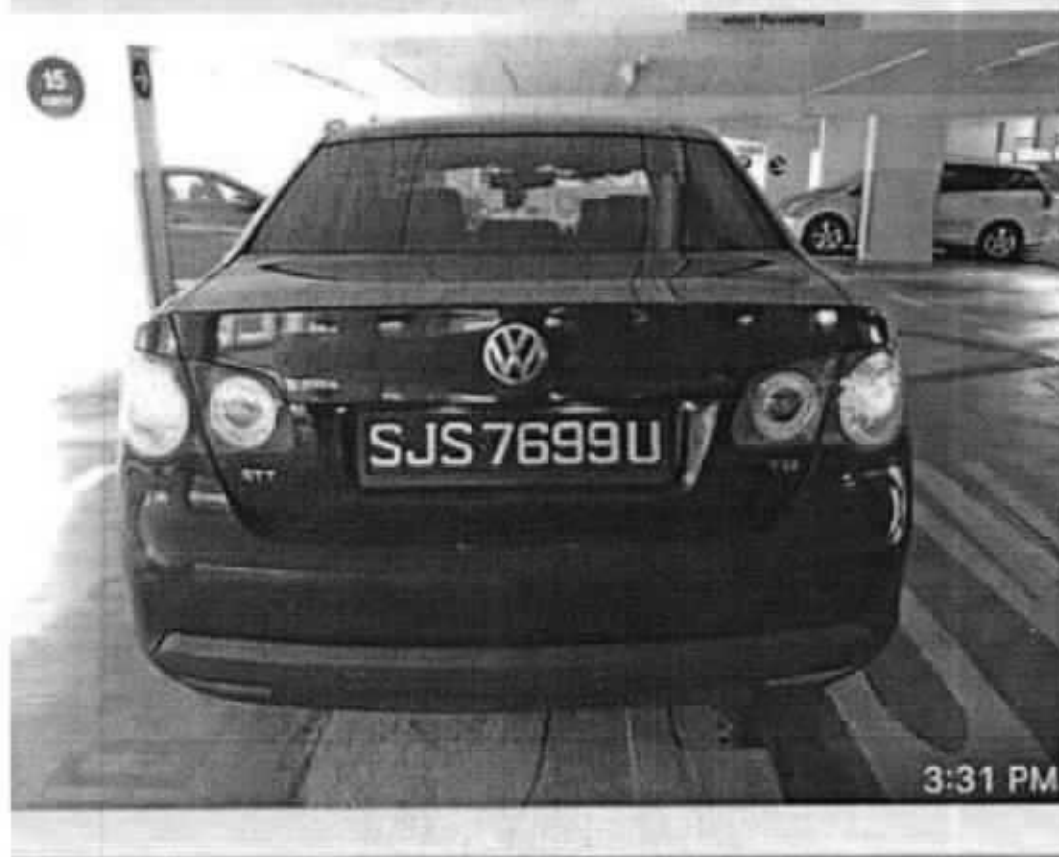
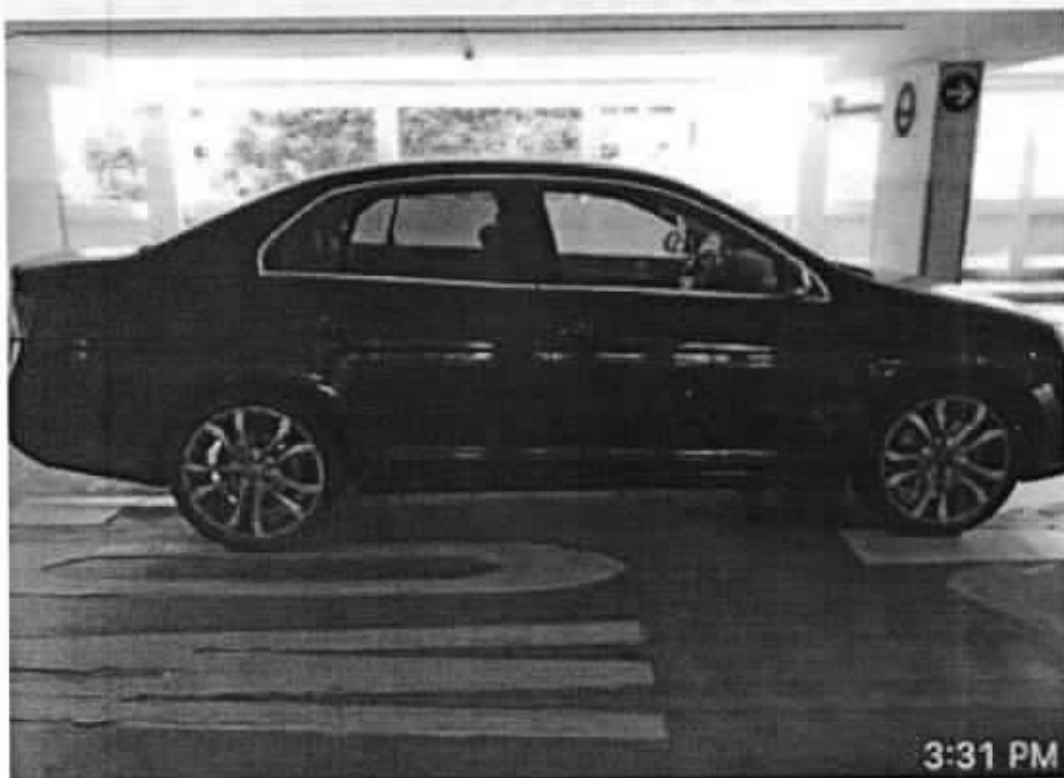
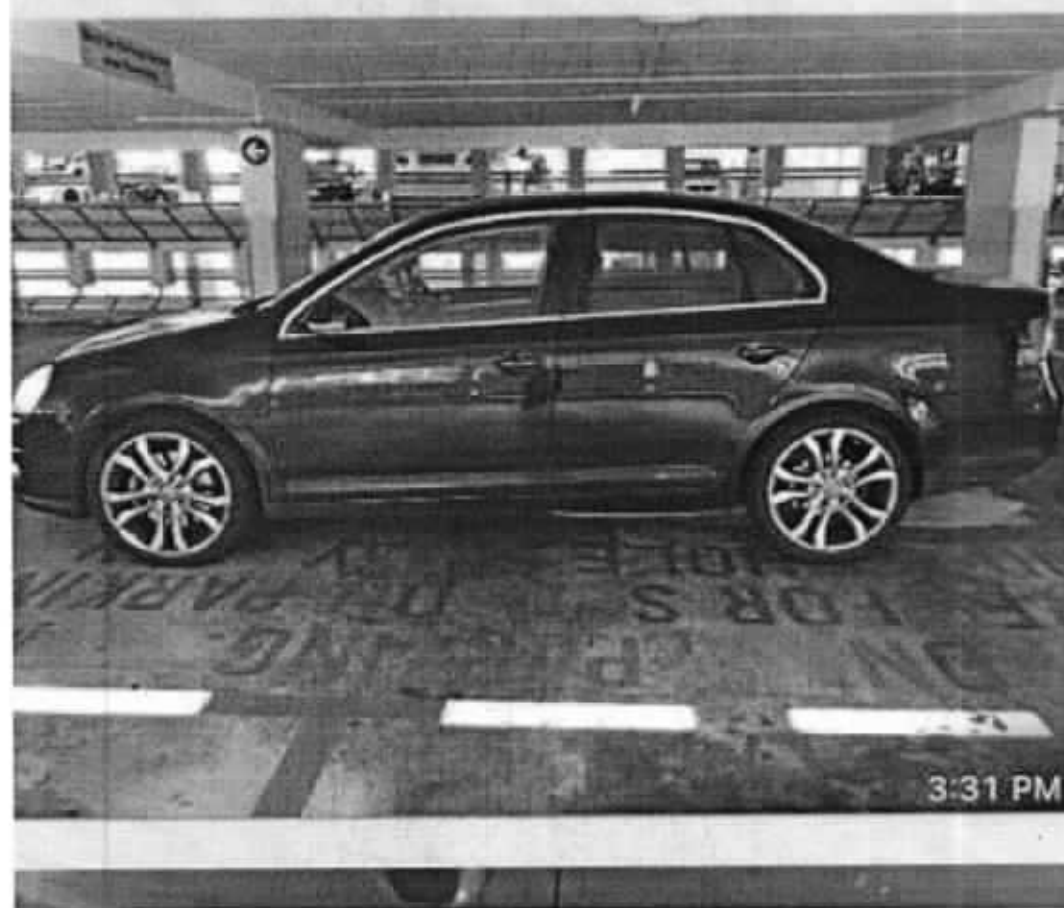
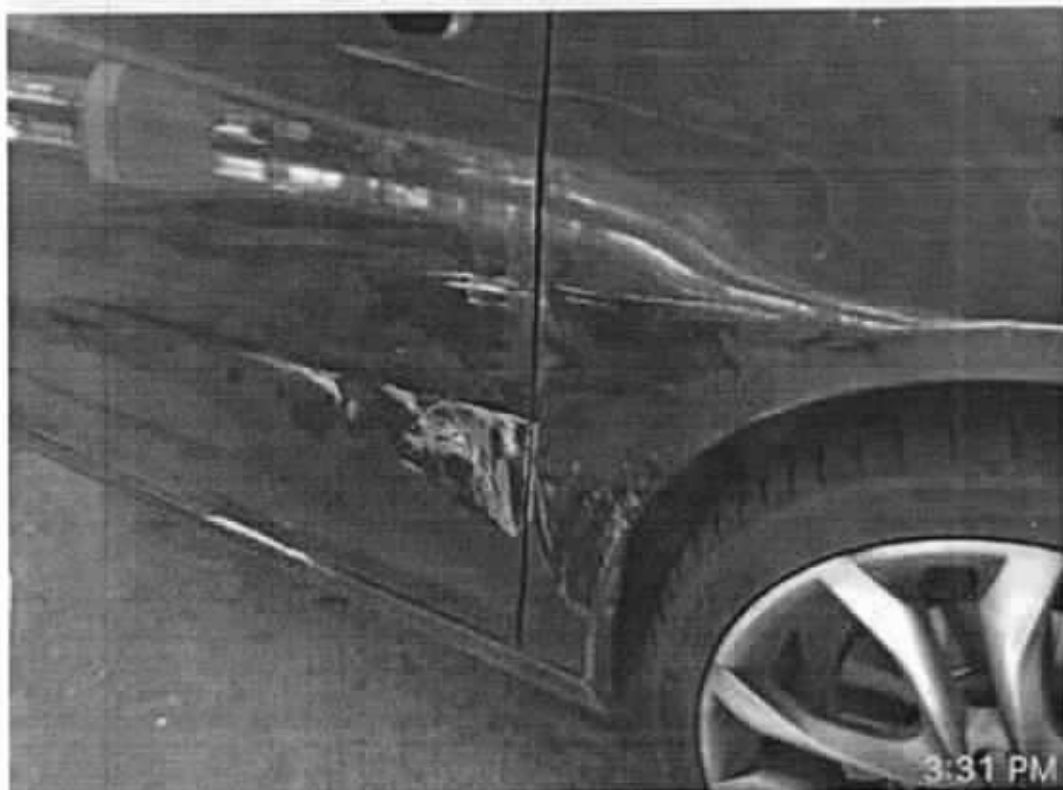
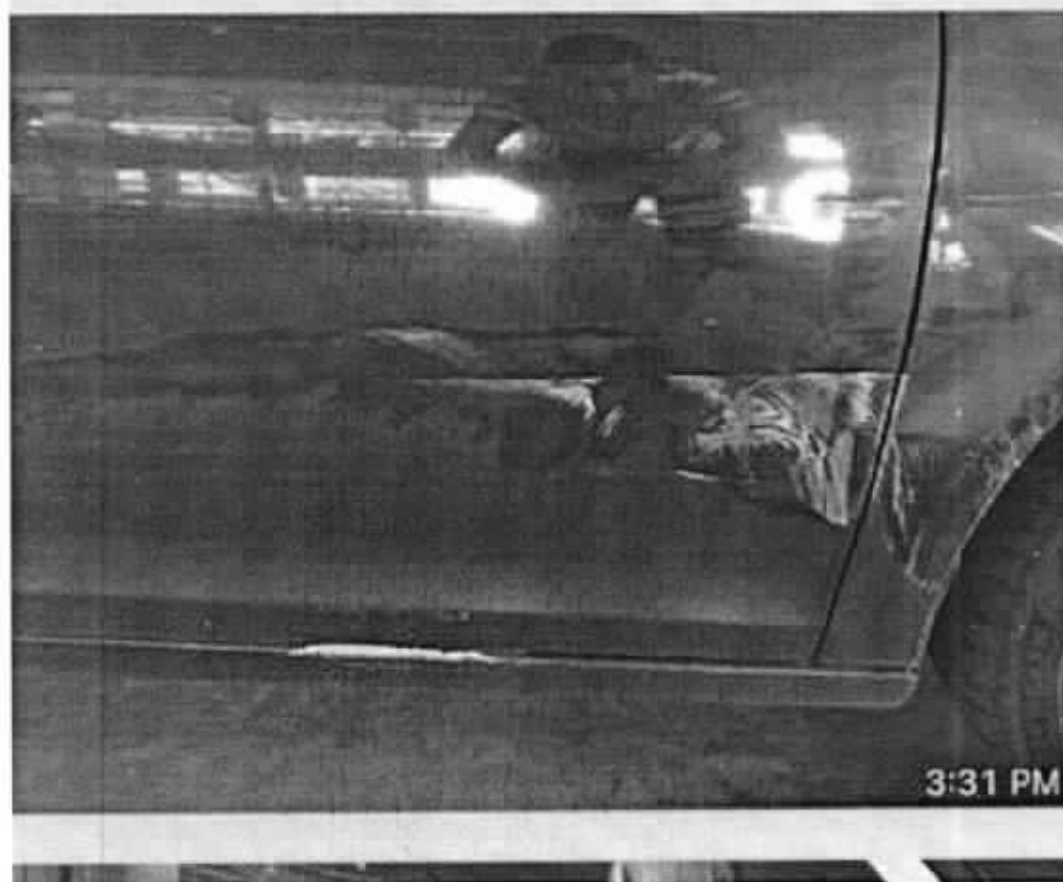
Accident Photo

THE VEHICLE SUSTAINED DAMAGES AT THE O/S BODY.  
DAMAGES SEE DETAILS.

| Qty | Description of Parts | Condition | Estimate By Workshop (\$) | Our Adjusted (\$) |
|---|---|---|---|---|
| | REPAIR AND FIX / REPLACE ACCIDENT DAMAGED PARTS. INCLUSIVE OF THE REPAIR OF DRIVER'S DOOR (RIGHT). | | 1,600.00 | 400.00 |
| | <b>RECOMMENDED COST OF LUMP SUM REPAIRS (TO ITS PRE-ACCIDENT CONDITION) (CONFIRMED)</b> | | | <b>1,550.00</b> |
