PRE-REPAIR INSPECTION REQUEST – SLB4566E vs SJQ878B (OI) on D.O.A.: 07/06/2019

SLB4566E Honda Vezel

VEHICLE DAMAGE INSPECTION REPORT

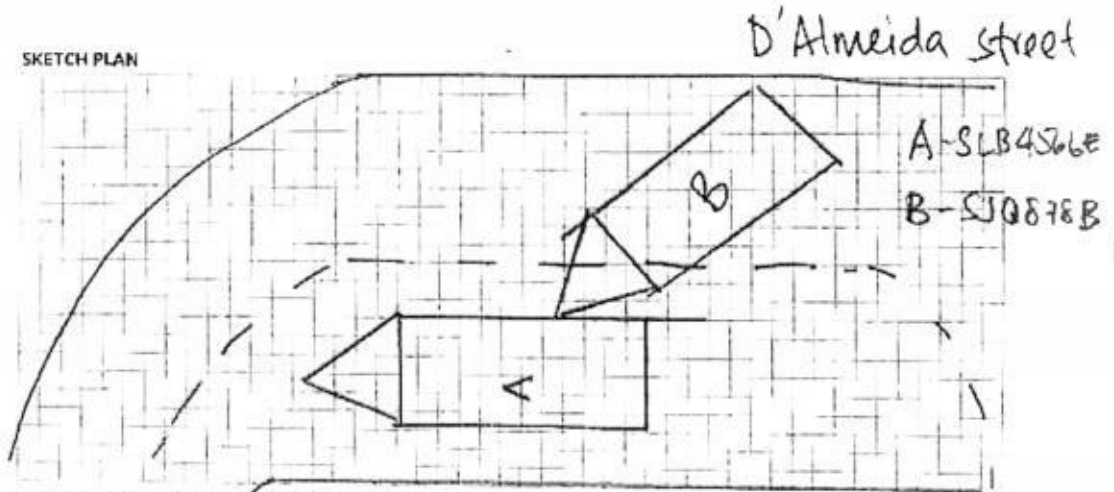
Sketch Plan #2

I have just turned into D'Almeida Street at 7:43am on 7/6/2019 and
 changing to the left lane. At a sudden I felt an impact from behind and
 hit my head on my steering wheel. I immediately stopped the car and
 looked back to find SJ0878B from the right lane had attempted to run on
 red and because the driver was not looking nor indicated to change lanes,
 they had rammed into the back right side of my car.
 I had then stopped the car to exchange particulars with the driver. She had
 then willingly agreed to pay out of pocket for my damages and requested
 that the accident is ~~not~~ her fault. After some discussions, she has
 informed that she will claim against her insurance, hence the report is
 made on 7/6/2019 after a call with Alan Lee on 10/6/2019 at 13:55pm.
