VEHICLE NO: SHD 3445P

MODEL : HYUNDAI i40

4.		Descripti			
	THE VEHICLE SU	STAINED DAMAGES AT THE RE	AR POR	TION.	
	DAMAGES SEE D	ETAILS.			
5.		Genera	I Inform	ation	
	Accident Date	16/06/2019	Inspe	ction Date	17/06/2019
	Survey held at	COMFORTDELGRO ENGINEER	RING PT	E LTD	
		59 LOYANG DRIVE SINGAPORE 508969			
5a.		R	emarks		
		ON WAS CONDUCTED ON A"WITCE TO YOUR INSTRUCTIONS, W			
5b.		Estimate	Days o	f Repair	
	ESTIMATED NOR	MAL PERIOD FOR REPAIR:		4 Working Days

### ADJUSTMENT ON REPAIR COST FOR VEHICLE NO. SHD 3445P

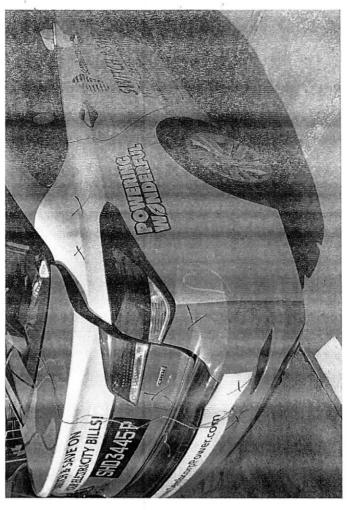
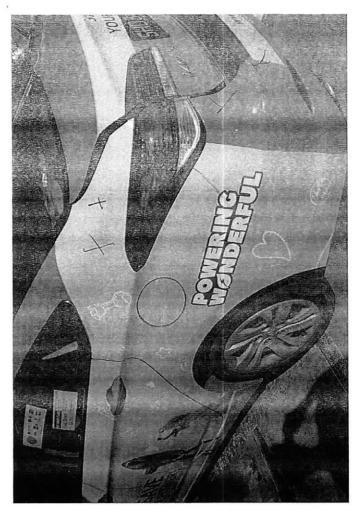
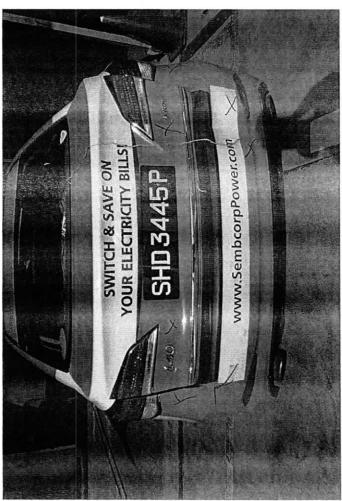
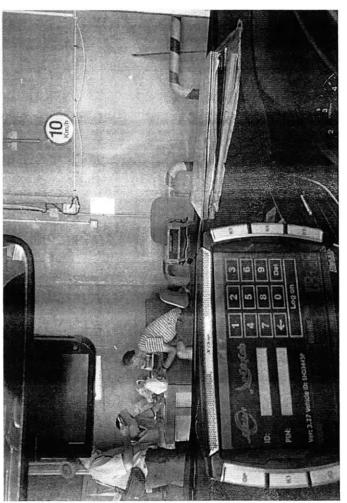
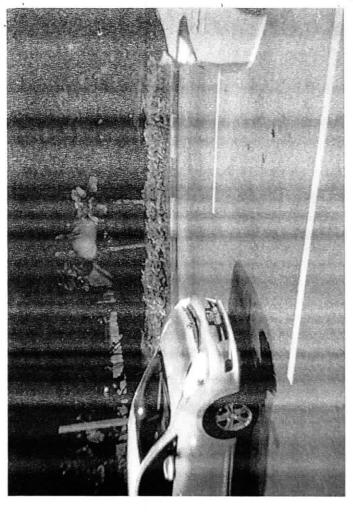
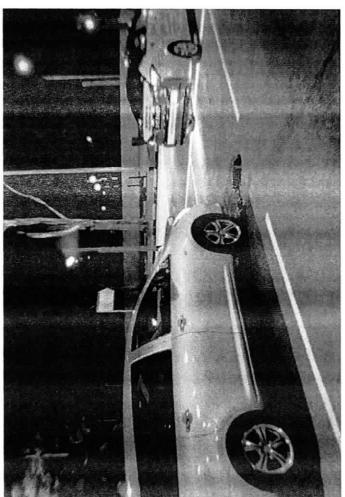
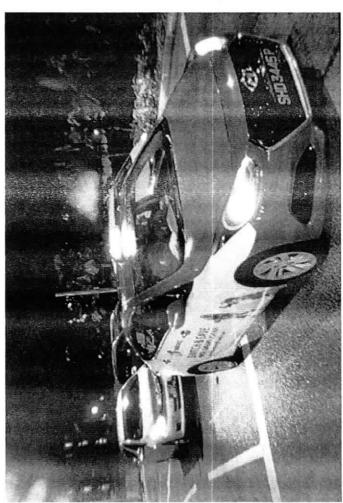
Qty	Description of Parts	Condition	Estimate By Workshop (\$)	Our Adjusted (\$)
	REPLACEMENT OF PARTS			
1	BOOT LID	BUCKLED	2,174.90	2,174.90
1	BOOT LID LOCK UPPER	JAMMED	102.60	102.60
1	BOOT LID LOCK LOWER	TO REPAIR SEE LABOUR	31.70	-
1	BOOT LID 'H' EMBLEM	NECESSARY	28.70	28.70
1	BOOT LID CRDI PLATE	NECESSARY	27.90	27.90
1	BOOTLID MOULDING	SERVICEABLE	85.00	-
1	BOOTLID 140 EMBLEM	SERVICEABLE	27.90	-
1	BOOTLID LOWER GARNISH	TO REPAIR SEE LABOUR	227.90	-
1	REAR BUMPER	CRACKED	553.00	553.00
1	REAR BUMPER REINFORCEMENT	BENT	428.40	428.40
2	REAR BUMPER REINFORCEMENT BRACKET (LH/RH) @\$80.30	BENT	160.60	160.60
10	REAR BUMPER CLIP	NECESSARY	22.00	22.00
2	REAR BUMPER BRACKET @\$35.60	CRACKED	71.20	71.20
1	REAR BUMPER SPONGE	CRACKED	103.50	103.50
1	REAR BUMPER UNDER COVER	CRACKED	228.00	228.00
1	REAR BUMPER REFLECTOR LAMP, RH	SERVICEABLE	30.60	-
1	REAR PANEL	DEFORMED	526.70	526.70
1	REAR PANEL GARNISH	SERVICEABLE	57.70	-

1	REAR PANEL LOWER PANEL	TO REPAIR SEE LABOUR	89.40	-
2	REAR FENDER (LH/RH) @\$2171.40	TO REPAIR SEE LABOUR	4,342.80	-
1	REAR WINDSCREEN MOULDING	NOT NECESSARY	28.30	-
	LESS 20% DISCOUNT		-1,869.76	-885.50
			7,479.04	3,542.00
	SPECIAL NETT ITEMS			
1	BOOT LID COMFORT LOGO & TEL NO. STICKER (SN)	NECESSARY	30.00	30.00
	REAR BUMPER REVERSE SENSOR (SN)	SHORTED	135.70	135.70
1	REAR BUMPER RUBBER MAT (SN)	NECESSARY	50.00	50.00

RECOMMENDED COST OF LUMP SUM REPAIRS	4,400.00
(TO ITS PRE-ACCIDENT CONDITION) (CONFIRMED)
