PRE-REPAIR INSPECTION REPORTMSG INSURANCE (SINGAPORE) PTE LTD
16 RAFFLES QUAY #24-01 HONG LEONG BLDG
SINGAPORE 048581

Ref: CS3/MSG19010764/Ecd3s2

THE VEHICLE SUSTAINED DAMAGES AT THE FRONT N/S PORTION.	
---	--

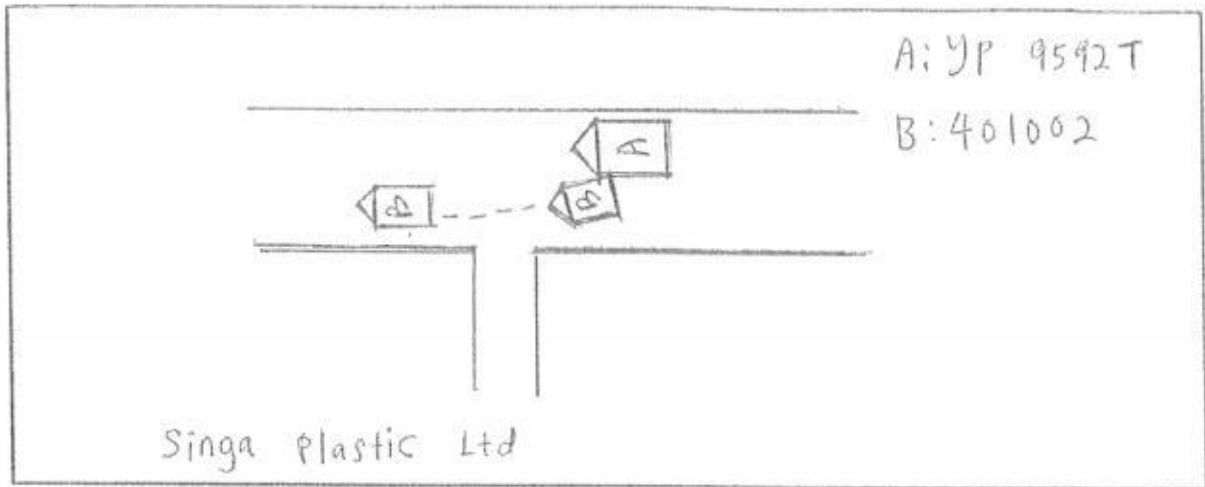
SKETCH PLAN

On 23.5.2019 at 3.50pm, I was stationary at 1 Fourth
Chin Bee Road at Singa Plastic Ltd inside the factory.
I was waiting inside my lorry to collect something
from the factory. There was a forklift in front of
me and suddenly he reversed and hit on my
front left door.
