VEHICLE DAMAGE INSPECTION REPORT

Our File No: CS/MSG19010788/K1QD3E2

Claimant Vehicle No : SHD1436D

Make & Model: HYUNDAI I30 GDH, 1.6 D TCI 5DR DCT (M)

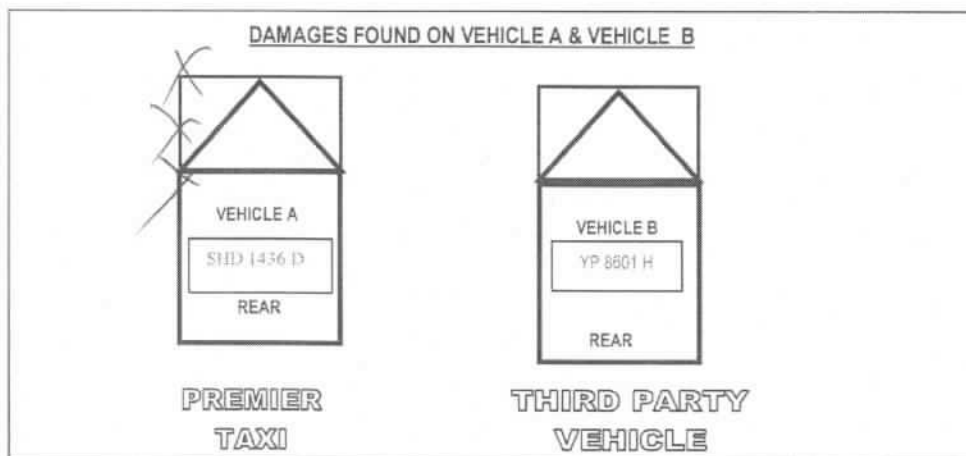
GIA/MS Sketch Plan Pg. 1

ON 14/06/2019 @ 1205HRS, I WAS DRIVING MY TAXI (SHD 1436 D) – TRAVELLING ALONG AIRPORT BOULEVARD INTO T3 LINK SOUTH, TOWARDS THE TAXI QUEUE OF CHANGI AIRPORT T1, IN THE RIGHT LANE.

WHILE I WAS MOVING AHEAD (BEFORE THE YELLOW BOX JUNCTION), SUDDENLY VEHICLE B (YP 8601 H – LORRY) WHICH WAS INITIALLY IN THE LEFT LANE, FAILED TO KEEP FOR PROPER LOOK OUT & CLEARANCE – HAD ENCROACHED ONTO MY PATH ON LEFT ABRUPTLY.

AS SUCH, THE RIGHT PORTION OF VEHICLE B COLLIDED ONTO THE LEFT FRONT PORTION OF MY TAXI.

DUE TO THE IMPACT, MY TAXI HAD DAMAGES ON THE LEFT FRONT & THE LEFT WING MIRROR WAS TOTAL DAMAGED. I AM NOT AWARE OF DAMAGES TO VEHICLE B.

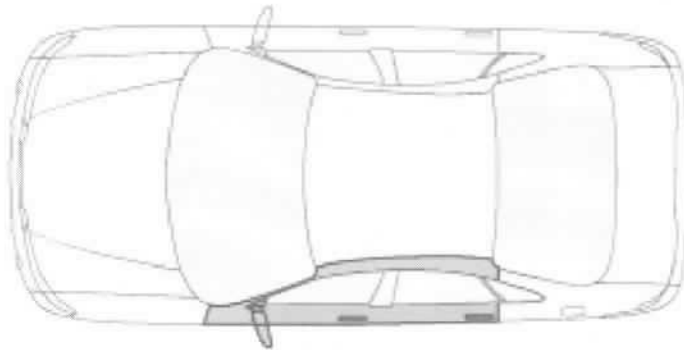
Damage Areas

The vehicle sustained impact / damages n/s front portion and parts claimed are consistent to the accident.

Code	Description	Time Base 10 WU/h	Price = 50.00 SGD/h	
			WU	Price SGD
87602R00	R + R LEFT MIRROR		2.0	10.00
0283	FRONT BUMPER REPAIR		10.0*	50.00
0741	L/F WING REPAIR		10.0*	50.00
2247	L/A-PILLAR REINF REPAIR		10.0*	50.00
Labour Cost		Hrs	WU	
Panel / Mechanical Labour		3.20	32.0	160.00
Total of Labour				160.00
