From: Motor Claim - III <motorclaim@iii.com.sg>
Sent: Tuesday, 25 June 2019 5:07 PM
To: Veron Chen (LKKAuto)
Cc: Lalitha Krishnan - III; SUR
Subject: RE: PRE-REPAIR INSPECTION FOR VEHICLE NO. YN1349T (Accident involving YN1349T and PC1047D on 03.06.2019)

**ACCIDENT INVOLVING YN 1349 T & SLT 1513 H & PC 1047 D ON 03 JUNE 2019 ALONG PRINSEP STREET IN FRONT OF SINGAPORE POOLS BUILDING AT ABOUT 1130 HOURS
(NOTICE TO INSURER TO CONDUCT PRE-REPAIR SURVEY WITHIN 2 WORKING DAYS PURSUANT TO PARAGRAPH 6.2 OF PRE-ACTION PROTOCOL FOR NIMA CASES)**

VEHICLE DAMAGE INSPECTION REPORT

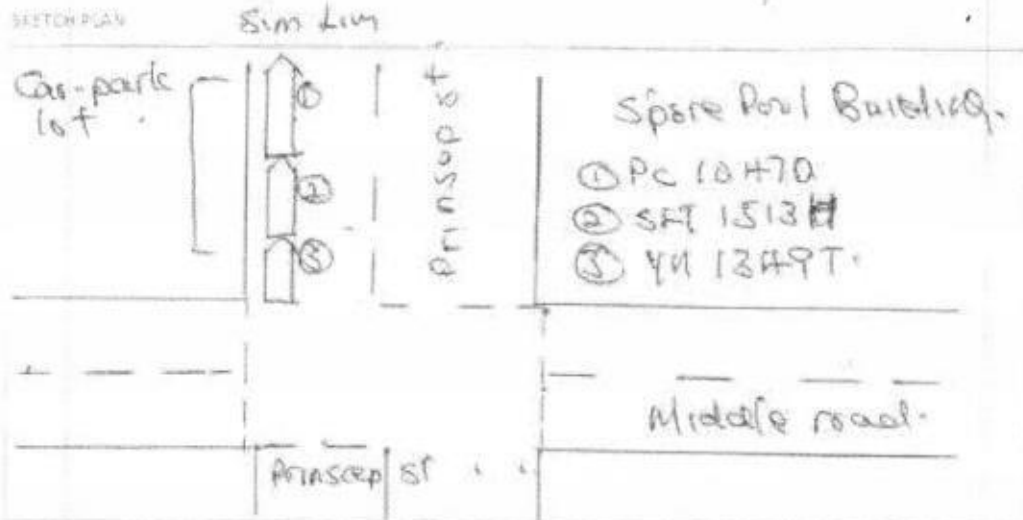
Accident Sketch Plan

On 3rd June 2019, at around 1130hrs, I did park my lorry (YN 1349T) along Prinsep St (to do delivery) in front of Singapore Pool building. In front of my lorry, there is a vehicle ① Toyota Prius (SFT 1513H) & ② Bus coach (PC 1047D).

After I alighted from my lorry, I heard a loud bang. Then I saw the Bus coach (PC 1047D) reverse into the car (SFT 1513H) which in turn hit my front bumper.
