PRELIMINARY ADVICE OF VEHICLE NO. SLN 5647K.

SINGAPORE ACCIDENT STATEMENT

THE VEHICLE SUSTAINED DAMAGES AT THE N/S FRONT PORTION. DAMAGES SEE DETAILS.

ADJUSTMENT ON REPAIR COST FOR VEHICLE NO. XE 2361J

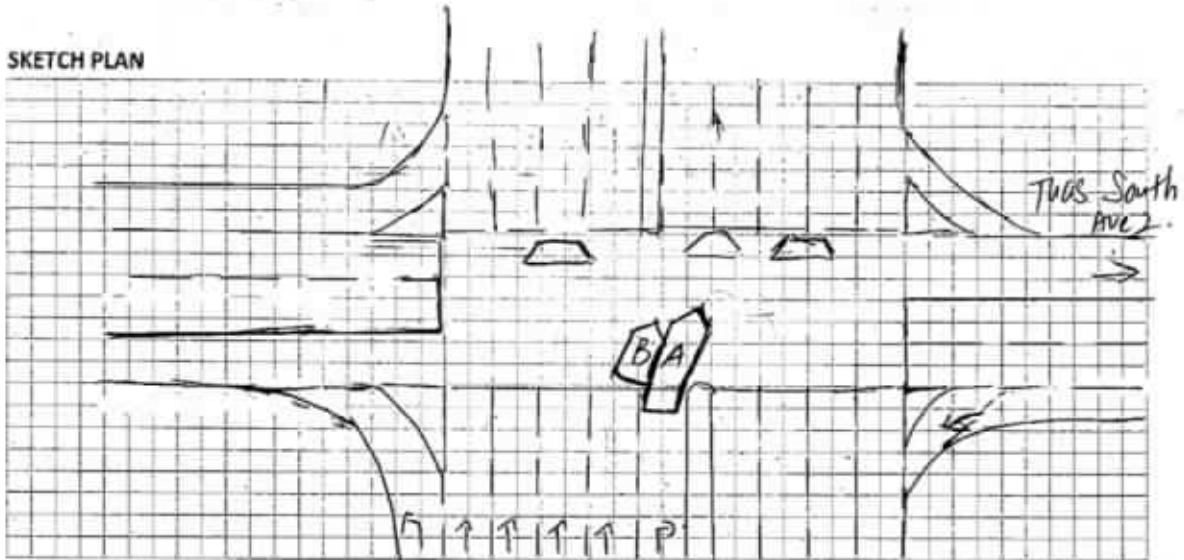
Sketch Plan #2 Pg. 1

On the above date and time, I was driving along Tuas Ave 2 in XE2361J by myself crossing towards Tuas Ave 1 via the traffic junction. I noticed the traffic junction was congested and moving slowly. While engaging in a turn towards Tuas Ave 1, a grey colour Honda Vezel marked SLG5363R that was moving by my left side bumped into the side bumper of my vehicle. This damaged the bumper. Thereafter, the driver of the vehicle got out at the side of the road and I got out as well, before we exchanged particulars. This report is for insurance claiming purposes. No injuries were sustained on both sides. The other driver's particulars are S8703826B, Lee Jing Heng, Justin.

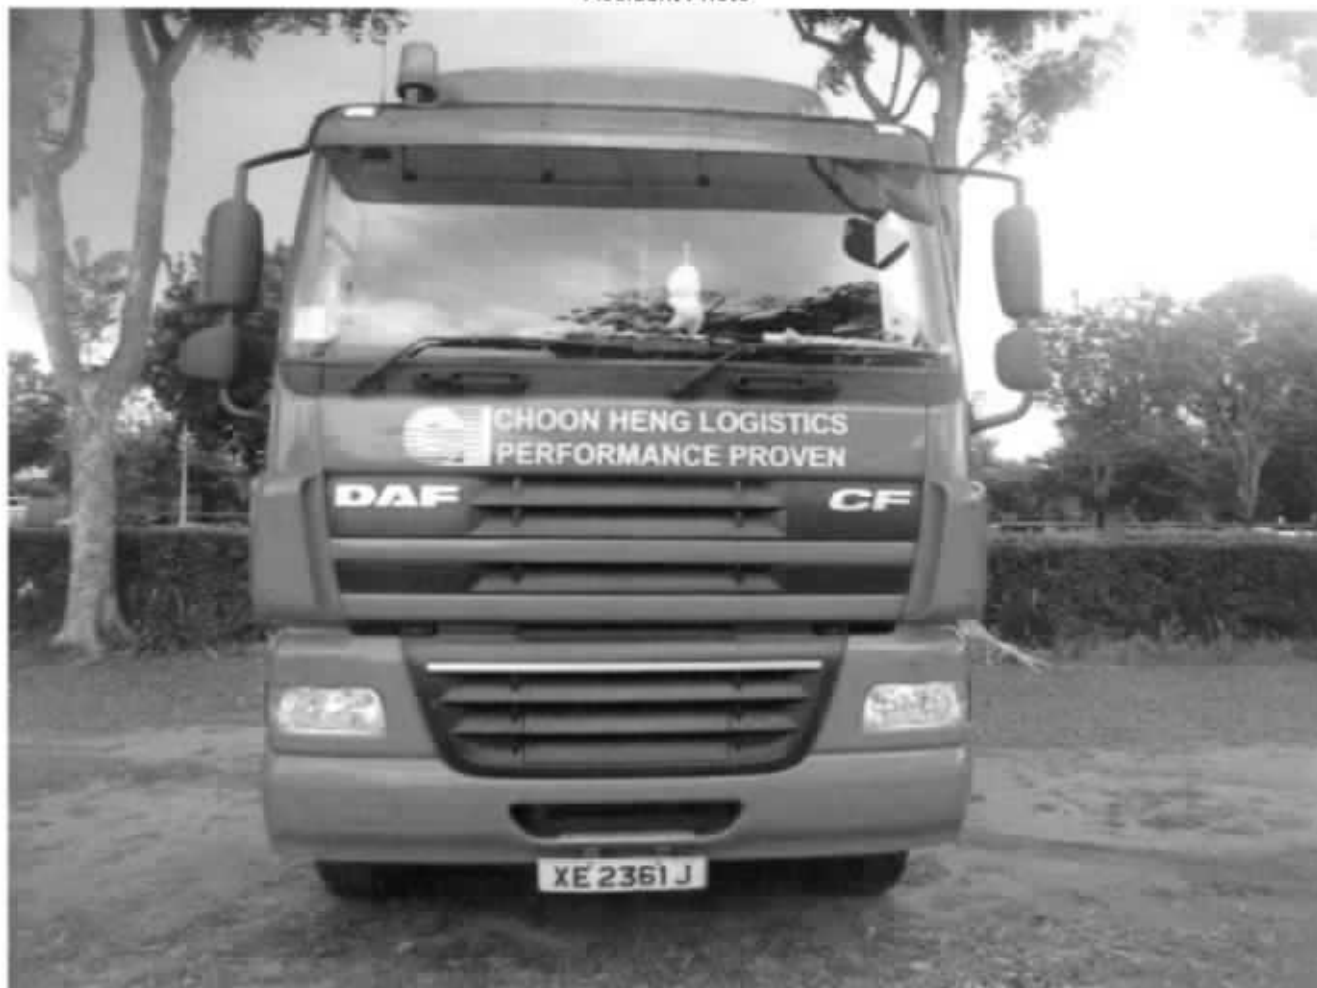
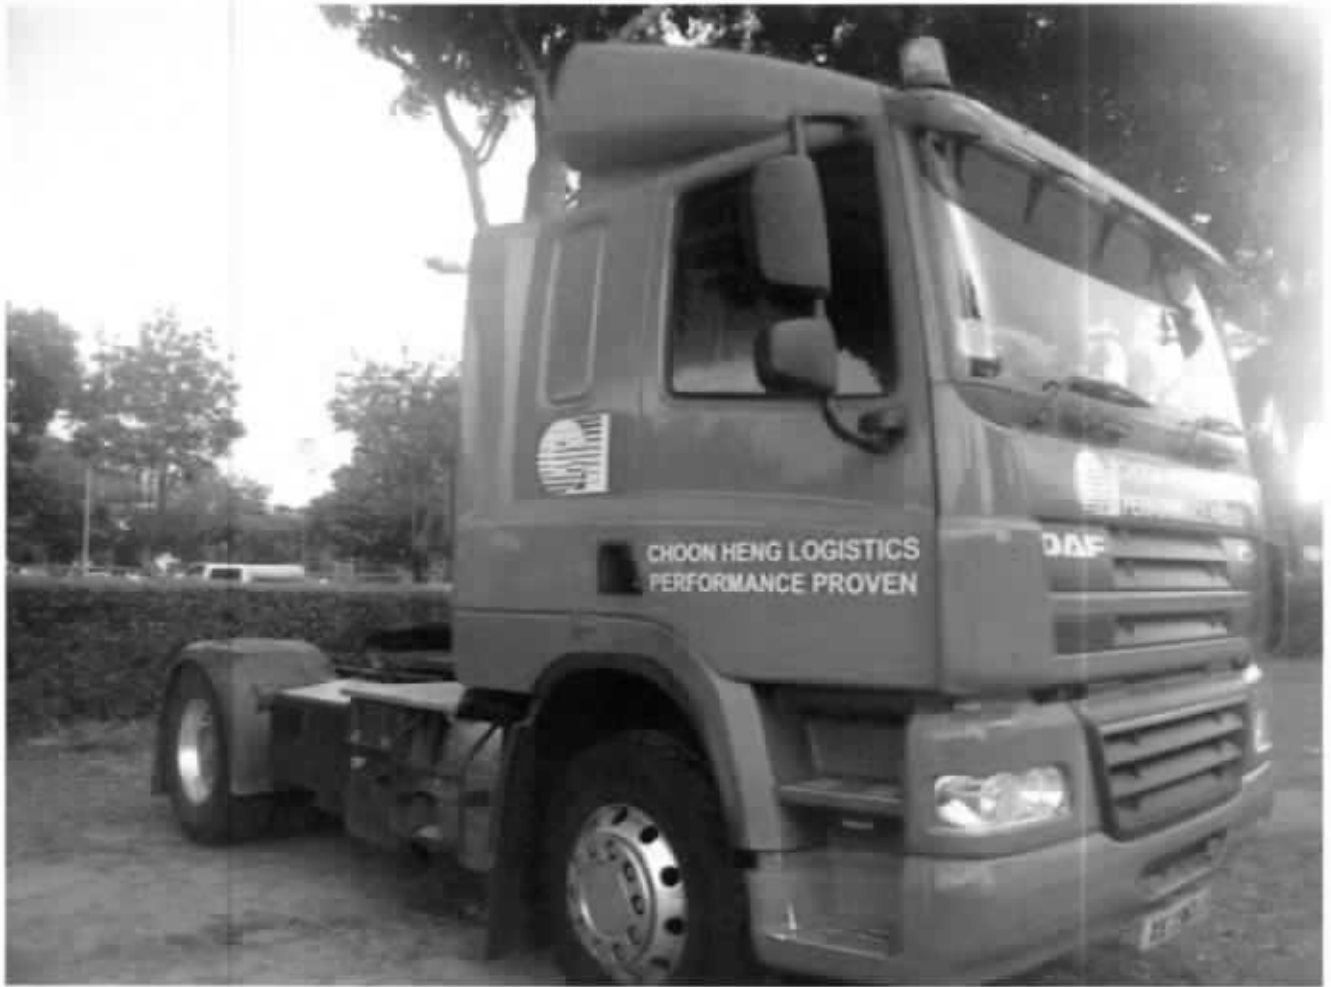
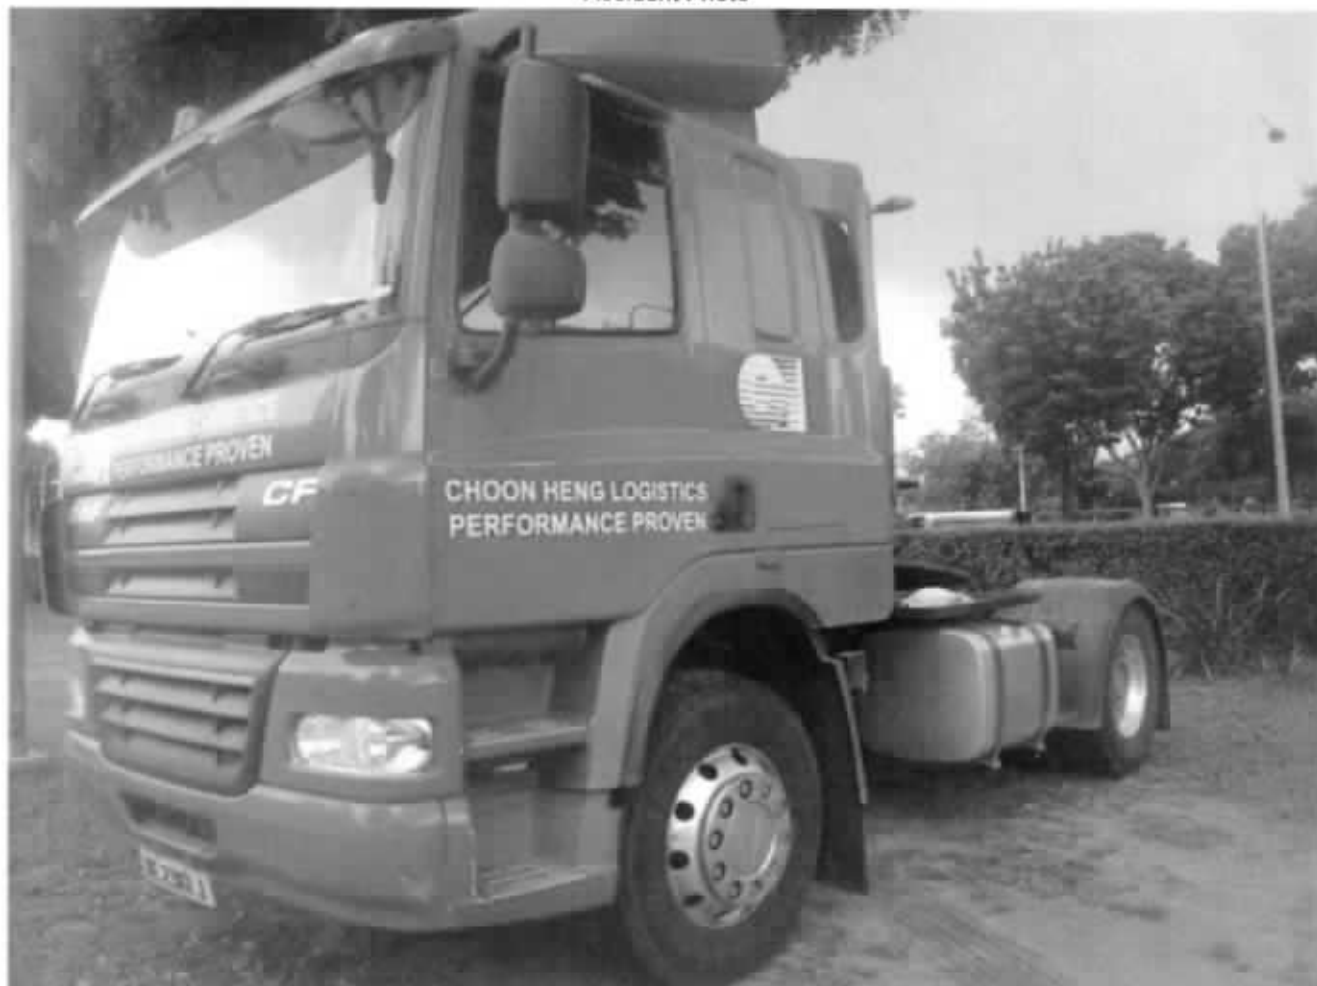
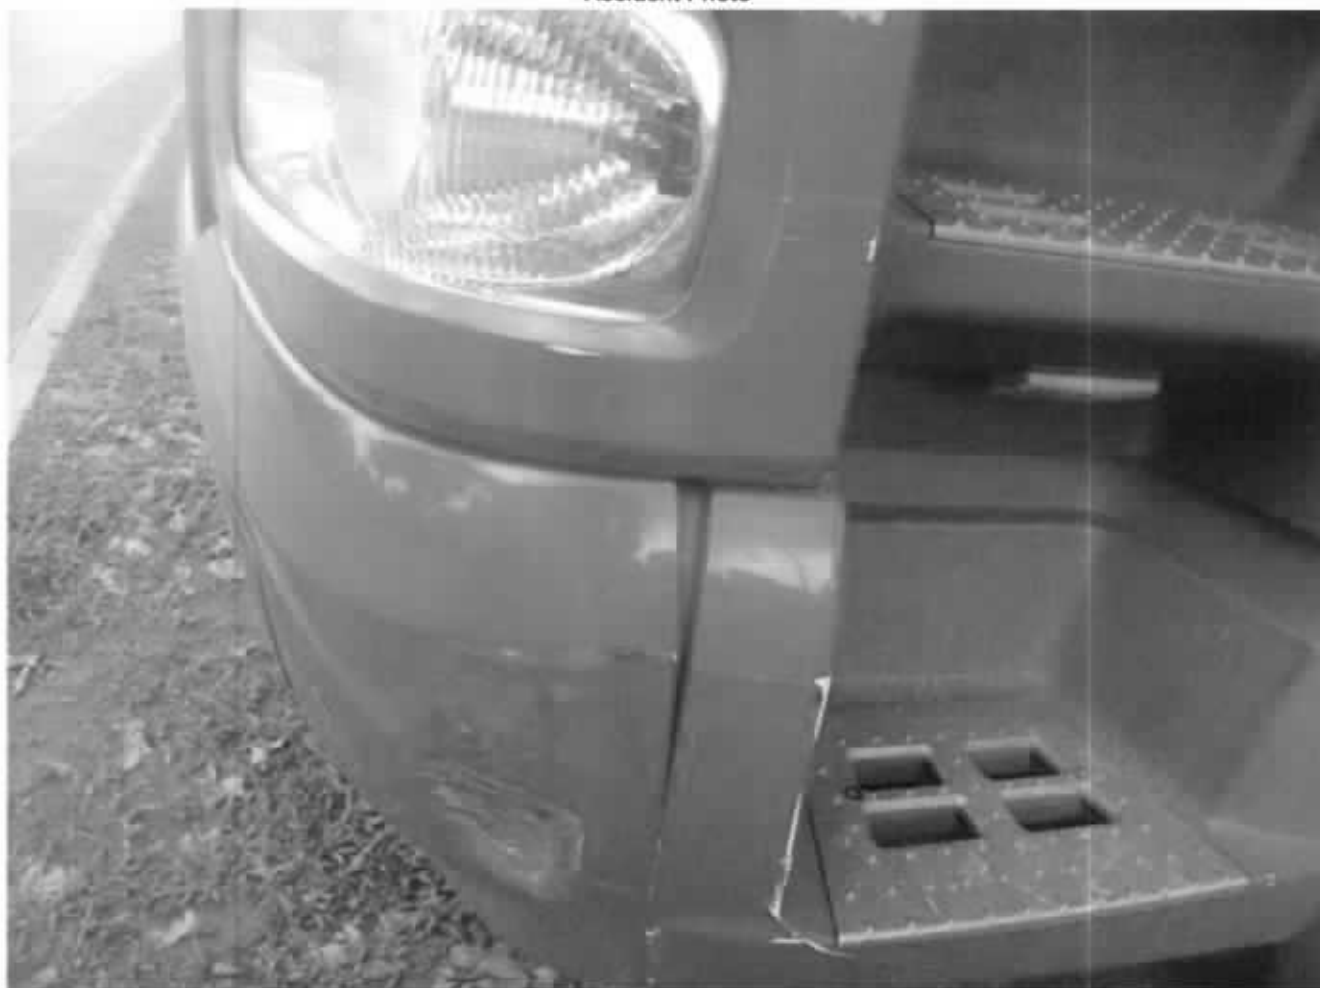
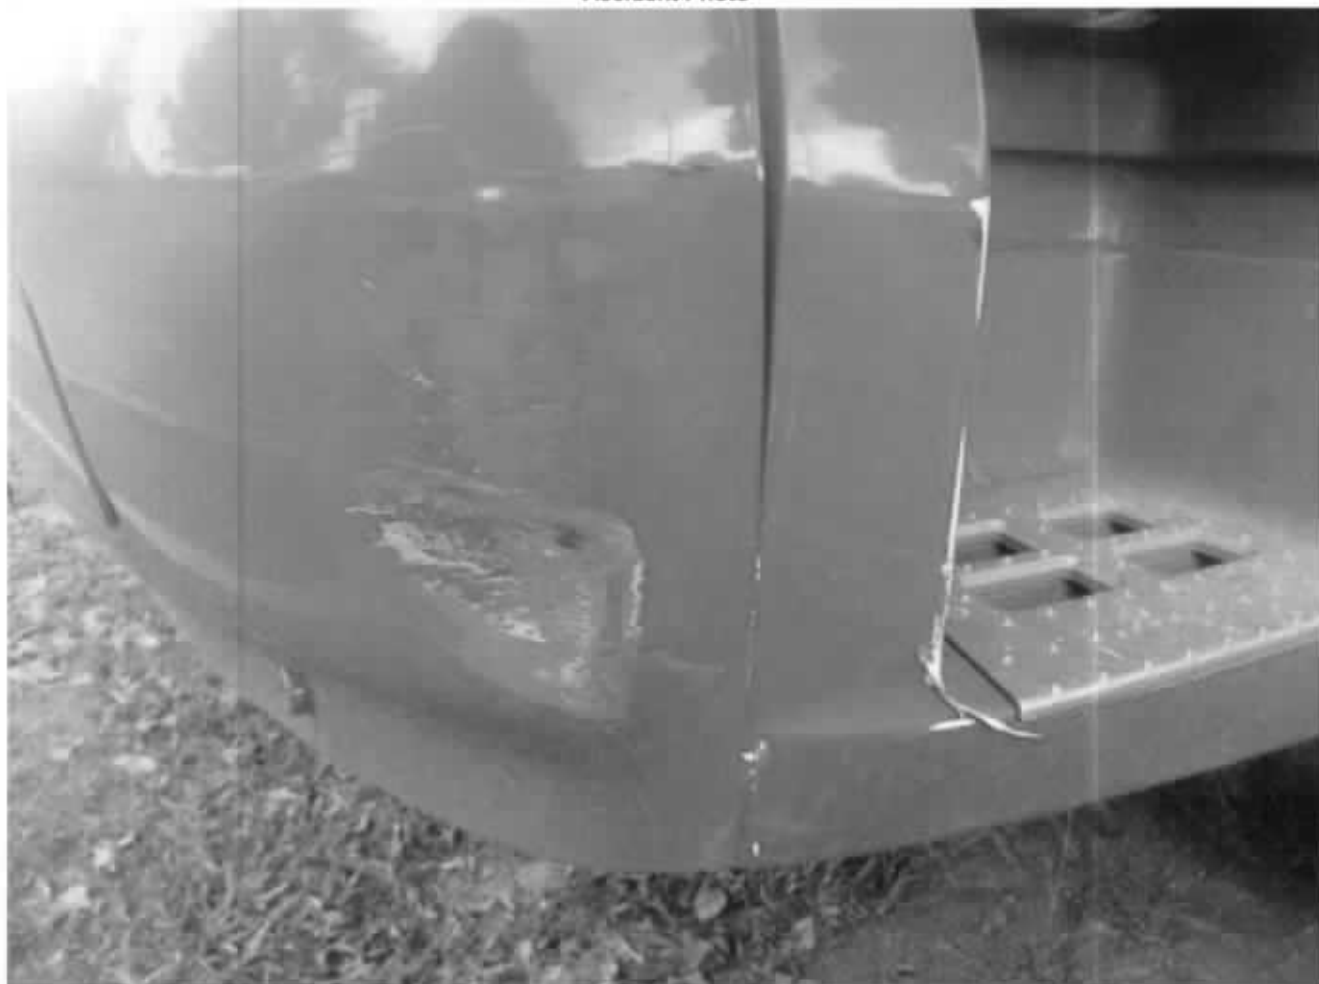
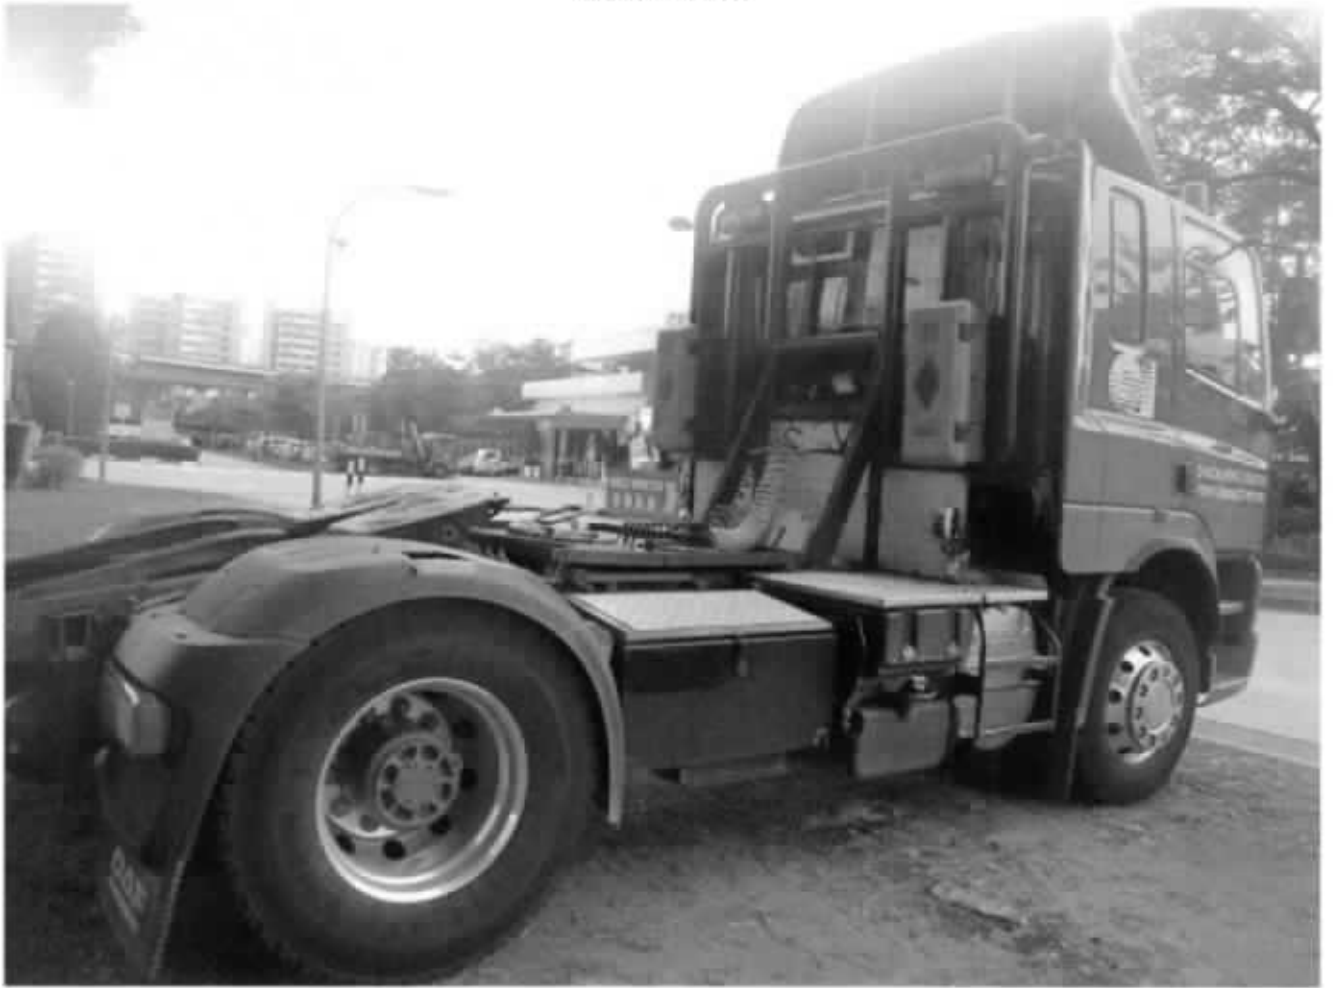
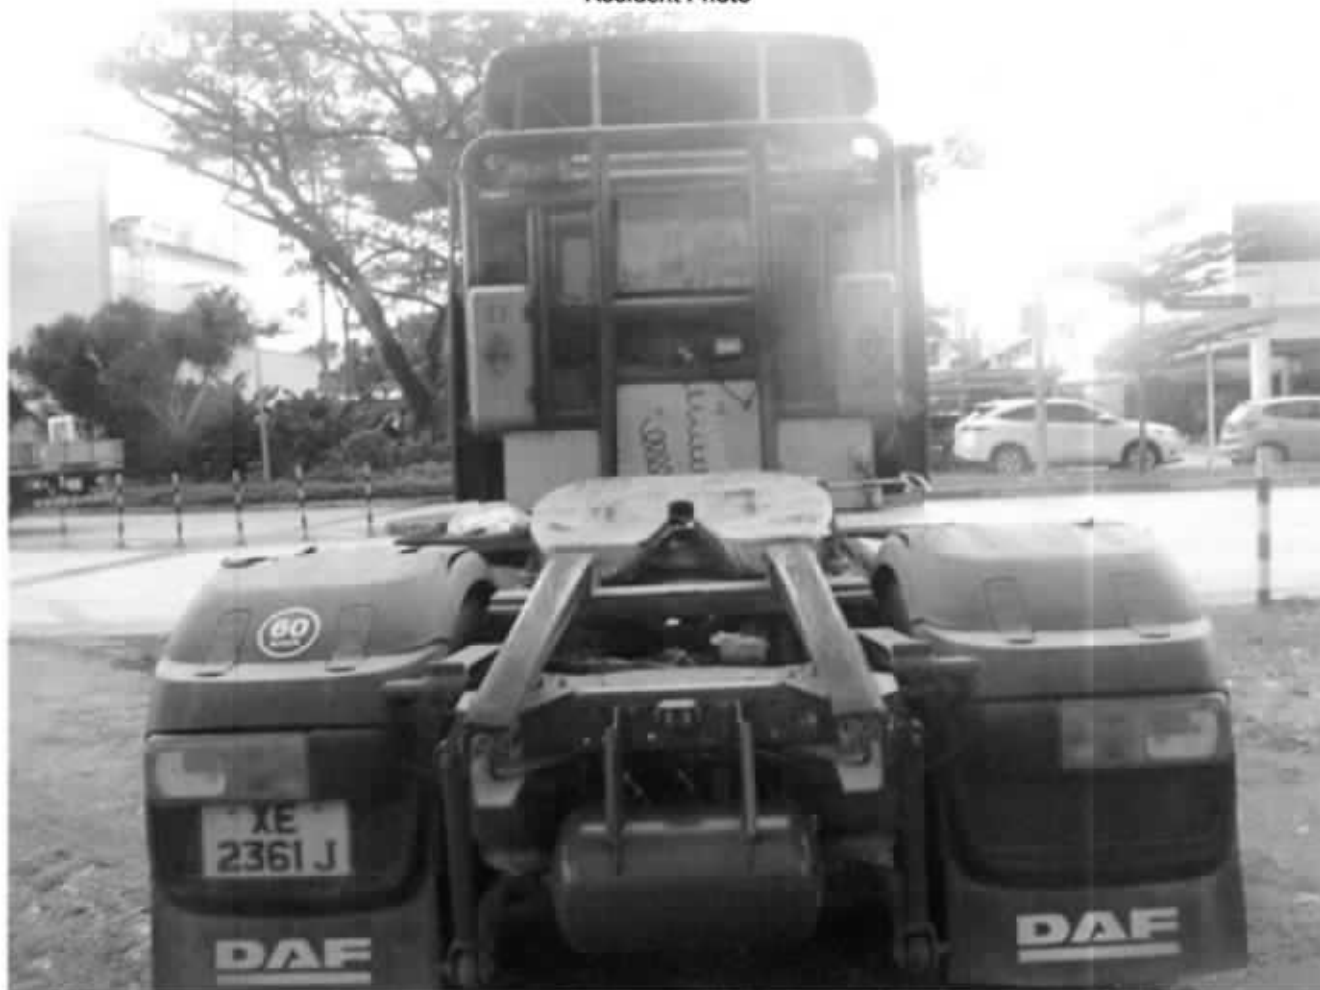
Accident Photo

The vehicle sustained damages at the n/s front portion.

Qty	Description of Parts	Condition	Estimate By Workshop (\$)	Our Adjusted (\$)
	<u>REPLACEMENT OF PARTS</u>			
1	STEP	CRACKED TO REPAIR SEE LABOUR	110.00	110.00
1	FRONT BUMPER ASSY WILL KNOCK AND USE BACK (NPA)		-	-
	LESS 10% DISCOUNT		-	-11.00
			110.00	99.00
	<u>LABOUR</u>			
	REMOVAL AND REPLACEMENT OF NEW STEP COVER. PENNEL BEATING AND SPRAY PAINTING. DISMANTLE AND FIX BACK FOR ALL ACCIDENT PARTS. INCLUSIVE OF THE REPAIR OF FRONT BUMPER ASSY WILL KNOCK AND USE BACK.		1,040.00	800.00
			1,040.00	800.00
	GRAND TOTAL		1,150.00	899.00
RECOMMENDED COST OF REPAIRS				899.00
