From: Lee Chen Sin <ChenSin.Lee@ethozgroup.com>
Sent: Thursday, 11 July 2019 11:02 AM
To: Rasul (LKKAuto)
Cc: SUR
Subject: RE: FINALIZATION REPORT OF SKX-8106-U HONDA VEZEL (OD)(FWD)

Preliminary Advice

Vehicle No	: SKX8106U	Accident Date	: 20/06/2019
Make	: HONDA VEZEL	Policy No.	: PNPV2016-00000666-02
Assignment Date	: 23/06/2019	Excess	: S\$500.00
Date of Inspection	: 24/06/2019	Est. Duration of Repair	: 6.00
Inspection At	: ETHOZ PROTECT PTE LTD (BUKIT BATOK) 30 BUKIT BATOK CRESCENT SINGAPORE 658075

VEHICLE DAMAGE INSPECTION REPORT

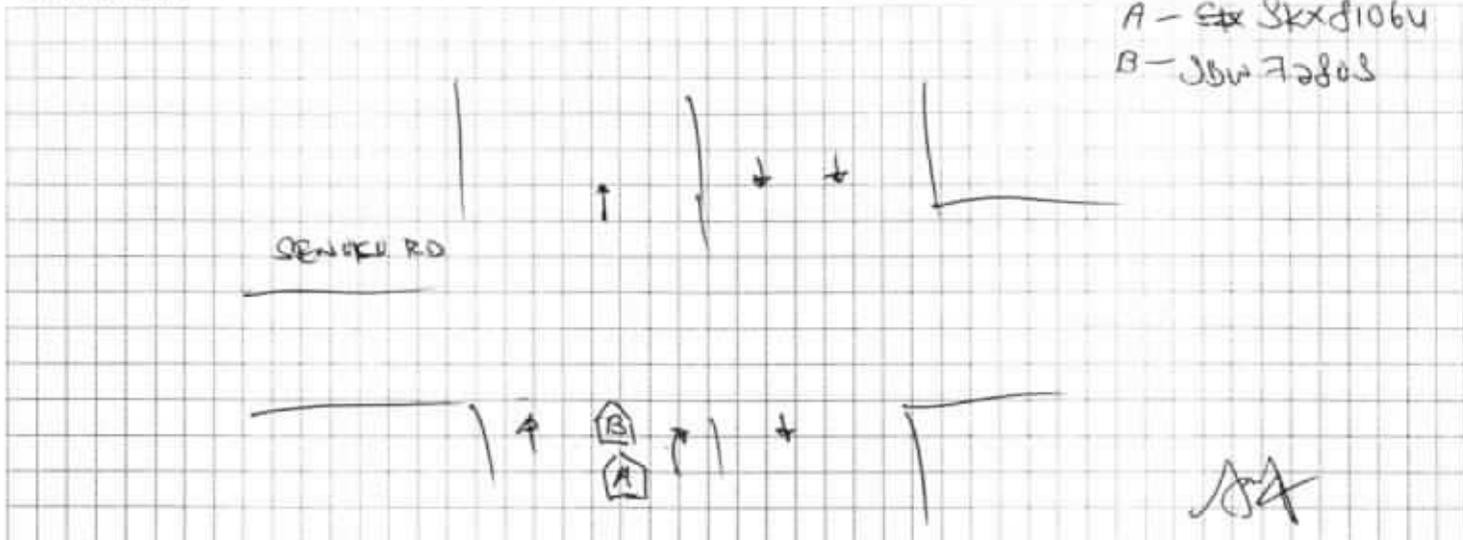
SKETCH PLAN

I WERE TRAVELING BEHIND THE CAR WHEN WE WERE REACHING THE JUNCTION. WE WERE TRAVELLING AT LESS THAN 60KM/H AND I WERE ABOUT 2 CAR DISTANT AWAY. WHEN WE WERE NEAR AT THE JUNCTION, HE MADE A HARD BRAKE WHEN THE GREEN LIGHT TURNED TO AMBER. BY THE TIME I REACTED AND BRAKED WITH MY CAR. I COULD PREVENT THE CAR FROM COLLIDING INTO HIS CAR.
