Vehicle No.:	SMF3812T
Vehicle to be Exported:	No
Intended Deregistration Date:	24 Jun 2019
Vehicle Make:	HONDA
Vehicle Model:	FREED HYBRID 1.5G AUTO
Primary Colour:	Silver
Manufacturing Year:	2018
Engine No.:	LEB5606972
Chassis No.:	GB71072497
Maximum Power Output:	101.0 kW (135 bhp)
Open Market Value:	\$25,123.00
Original Registration Date:	07 Nov 2018
First Registration Date:	07 Nov 2018
Transfer Count:	0
Actual ARF Paid:	\$17,173.00

***SMF3812T (MCT19060564)**
[SHB6661Y]
TP
LEE BENG HUAT
Jun 22 2019 10:00AM
[-]
Choo Motor Spray Painter

VEHICLE DAMAGE INSPECTION REPORT

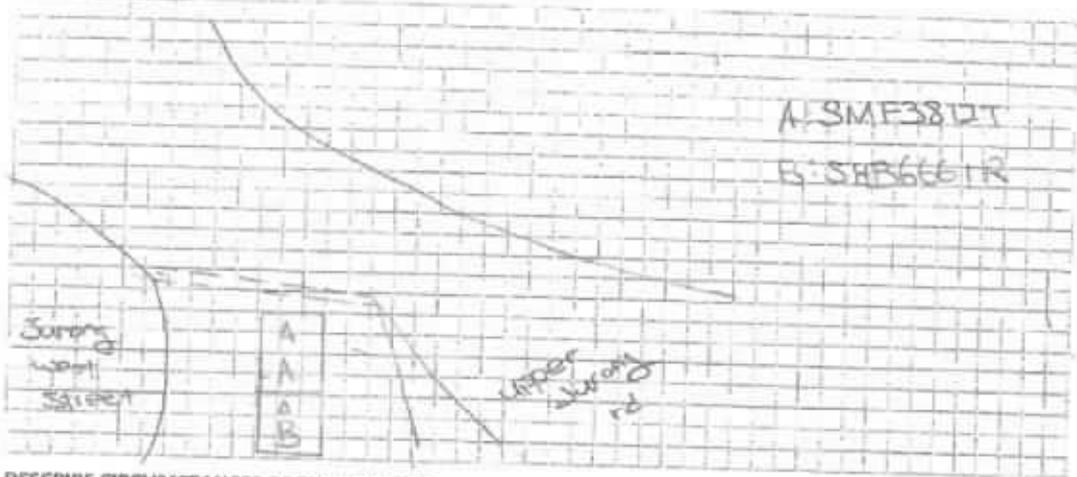
SKETCH PLAN

on 22/06/19 I was driving along Jurong West Street (slip road). I was stationary as I was checking for traffic. Suddenly vehicle B hit my rear.

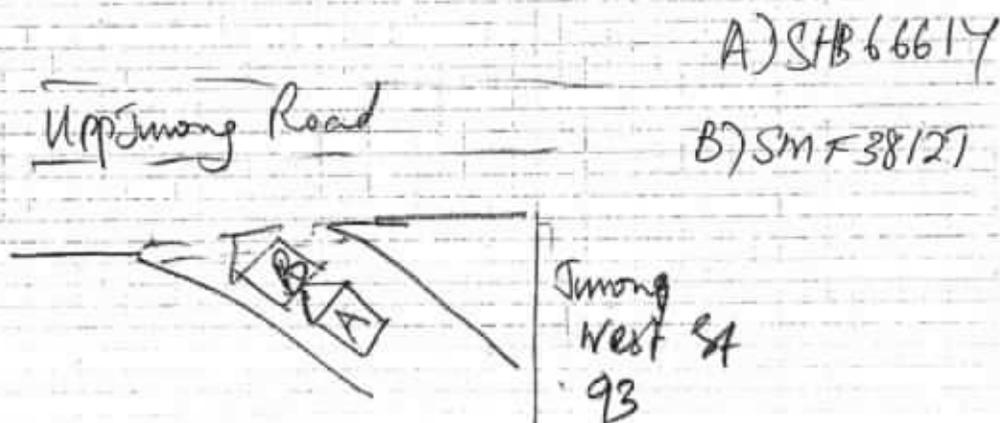
SKETCH PLAN

On 22/6/19 at about 1045hrs when I just moved my Veh A after waiting behind Veh B along the Slip Road. My vehicle collided into the rear of veh B when it stopped suddenly after moving forward.
