Accident Date : 01 December 2018
Inspection Date : 10 December 2018
Repairer Name : GP Motoring Pte Ltd
282 Macpherson Road,
Singapore 348607

GENERAL DESCRIPTION OF DAMAGE VEHICLE

ADJUSTMENT ON REPAIR COST FOR VEHICLE NO. FBE 8030K

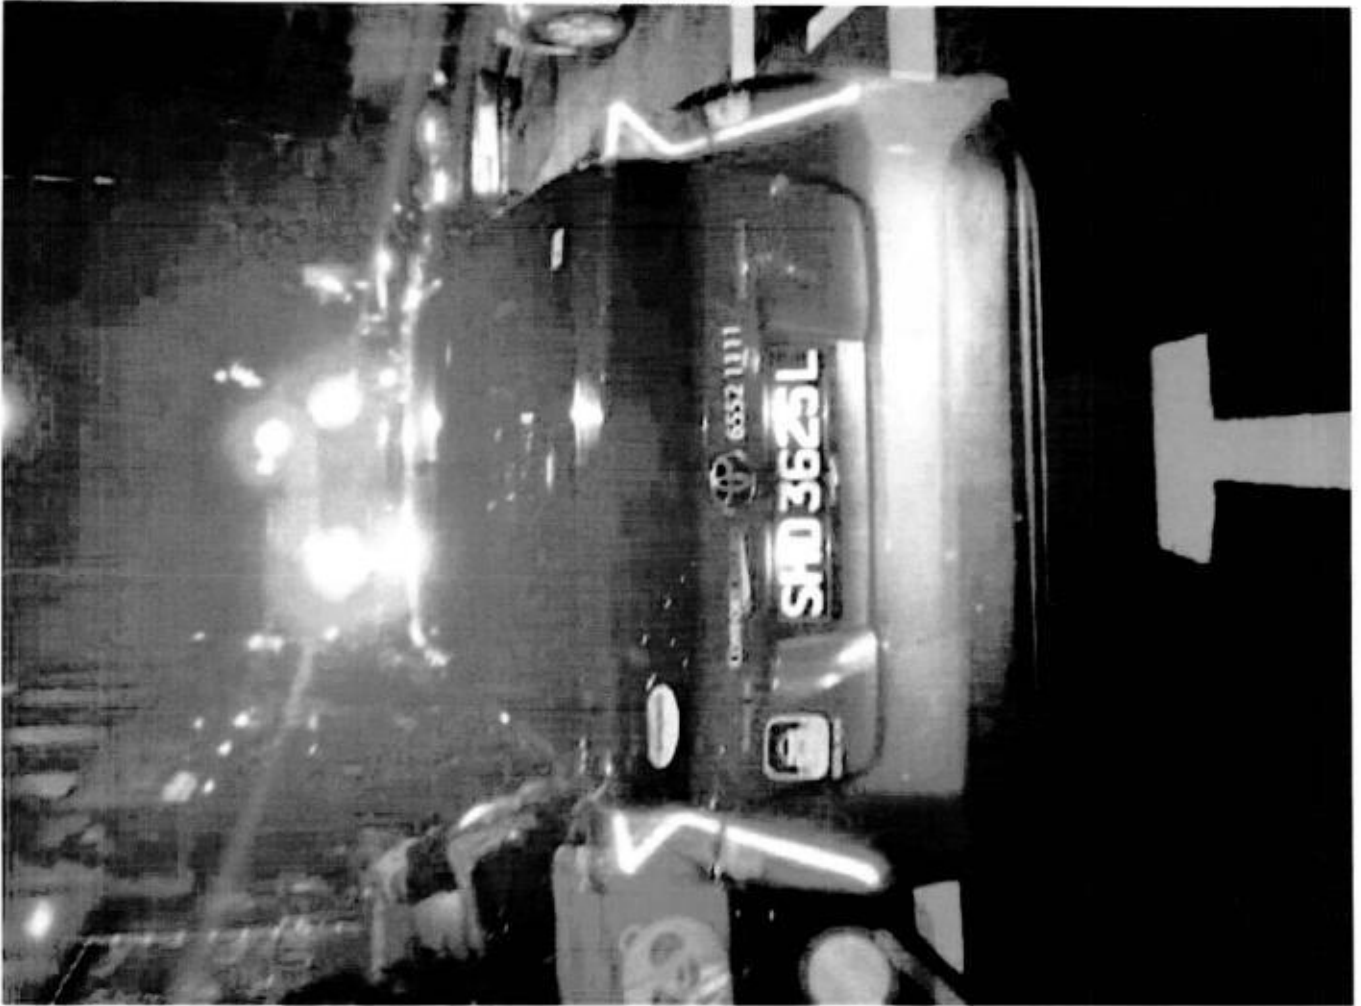
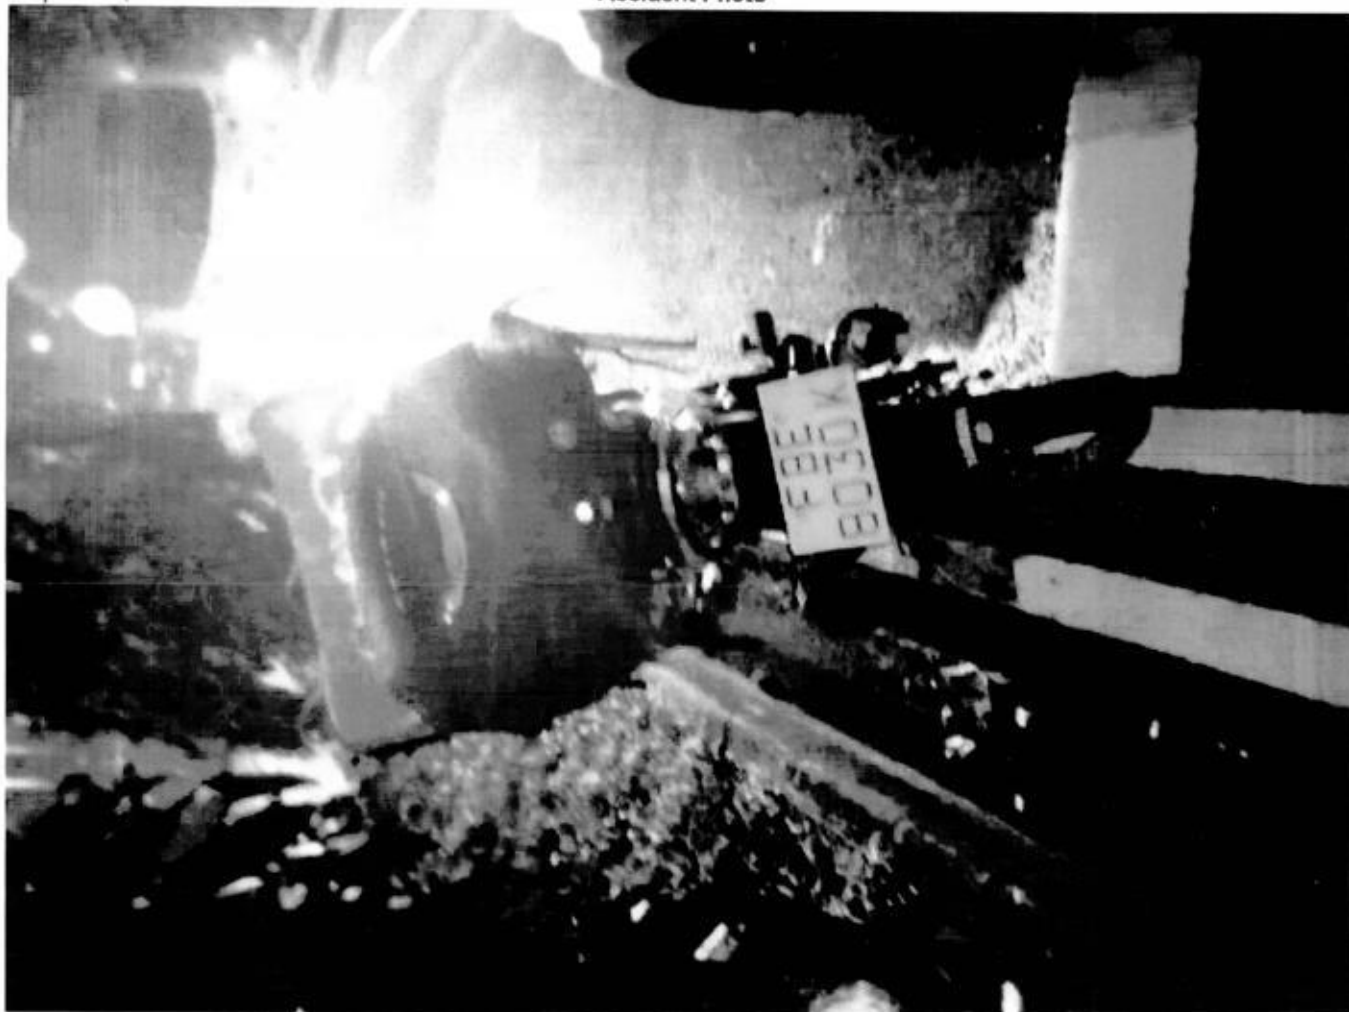
The impact damages sustained on the vehicle at the time of inspection is on the n/s portion.
(Details refer to the photographs attached)

4. Description of Damages				
THE VEHICLE WAS KNOCK ON O/S THEN FALL ON N/S.				
DAMAGES SEE DETAILS.				
5. General Information				
Accident Date	01/12/2018	Inspection Date	10/12/2018	
Survey held at	GP MOTORING PTE LTD 282 MACPHERSON ROAD SINGAPORE 348607			
5a. Remarks				
A)THE INSPECTION WAS CONDUCTED ON A"WITHOUT PREJUDICE" BASIS. B)IN ACCORDANCE TO YOUR INSTRUCTIONS, WE HAVE NOT AUTHORISED REPAIRS.				
5b. Estimate Days of Repair				
ESTIMATED NORMAL PERIOD FOR REPAIR:		3 Working Days

The repairer has agreed to undertake the job at a **Lump Sum of \$ 2,500.00** on a contractual basis.

The repairer has agreed to undertake the repair under a Lump Sum Basis. We have further adjusted the amount to a **Lump Sum Repair Contract of : \$ 2,500.00**
