## SURVEY

To inspect Vehicle No: SLA SL45P

## VEHICLE APPRAISAL REPORT

### PARTICULARS OF INSPECTED VEHICLE

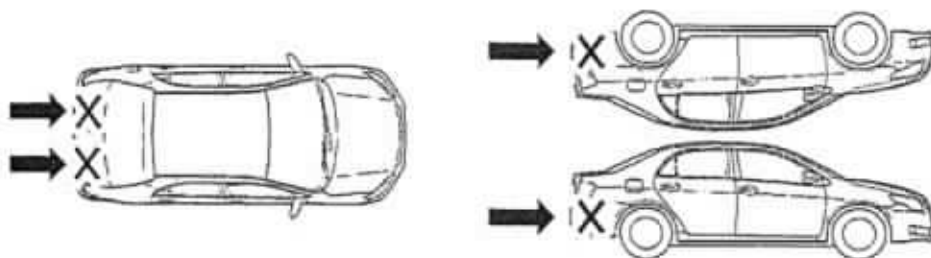
Damages sustained were consistent with the subject vehicle being involved in a collision with another vehicle and the impact was delivered

Squarely to the Rear

portion of the vehicle.

The general area of damages is at the

Rear portion

The estimated repair costs submitted by Messrs **Weng Fatt Motor Engineering** is \$ 12,328.95 .  
We have adjusted the cost to \$ 8,595.39 and the repairer has agreed to undertake the repairs at a  
**Contract Lump Sum of \$ 6,900.00** to a acceptable quality and standards.  
However, we have not given authorization and instruction to the repairer to proceed with the repairs.

The repairs should be completed within a reasonable period of 8 working days.
