Preliminary Advice

Insured Vehicle No	: SLK4766Y	Accident Date	: 23/06/2019
TP Vehicle No	: SHC6802C	Assignment Date	: 25/06/2019
Make	: KIA OPTIMA	Est. Duration of Repair	: 2.00
Date of Inspection	: 25/06/2019		
Inspection At	: PREMIER AUTOMOTIVE SERVICES PTE LTD (CHANGI) 23 CHANGI SOUTH AVE 2 #01-02 SINGAPORE 486443

VEHICLE DAMAGE INSPECTION REPORT

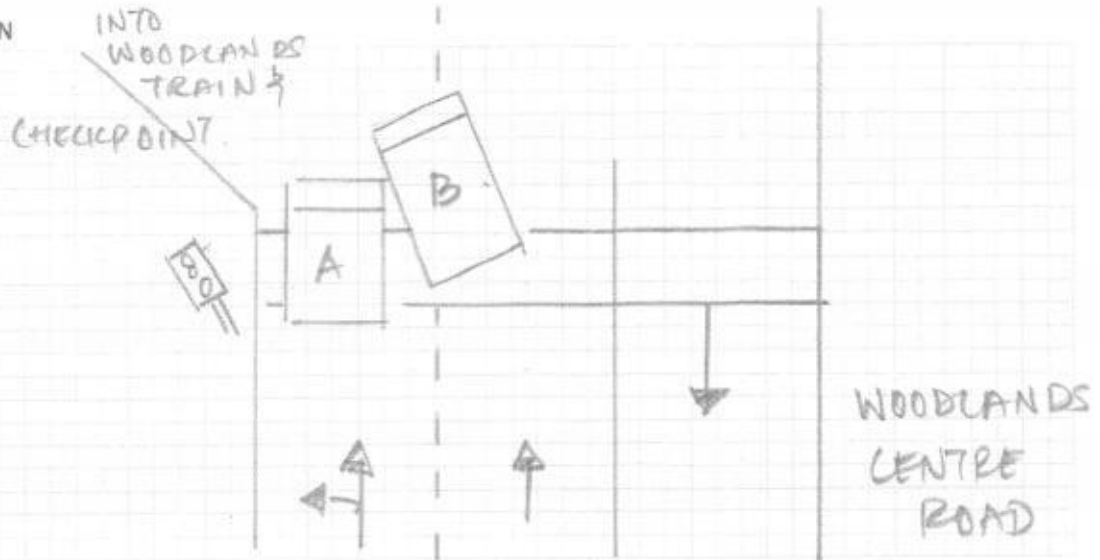
SKETCH PLAN

WHILE I WAS MOVING STRAIGHT AHEAD – WITHIN MY LANE, SUDDENLY VEHICLE B (SLK 4766 Y – SUBARU FORESTER) WHICH WAS FROM THE RIGHT - FAILED TO KEEP FOR PROPER LOOK OUT, HAD ENCROACHED ONTO MY PATH ON MY RIGHT ABRUPTLY.

DUE TO THE IMPACT, MY TAXI HAD DAMAGES ON THE RIGHT FRONT PORTION & VEHICLE B HAD DAMAGES ON THE LEFT FRONT PORTION.
