Preliminary Advice

Insured Vehicle No	: YN2755Y	Accident Date	: 20/06/2019
TP Vehicle No	: YP6906S	Assignment Date	: 26/06/2019
Make	: ISUZU NQR75UL5A	Est. Duration of Repair	: 3.00
Date of Inspection	: 25/06/2019		
Inspection At	: FASTECH AUTO PTE LTD (HQ) 1 KAKI BUKIT AVE 6, #01-46/48/50 AUTOBAY SINGAPORE 417883

Point of Impact / General Description of Damages

VEHICLE DAMAGE INSPECTION REPORT

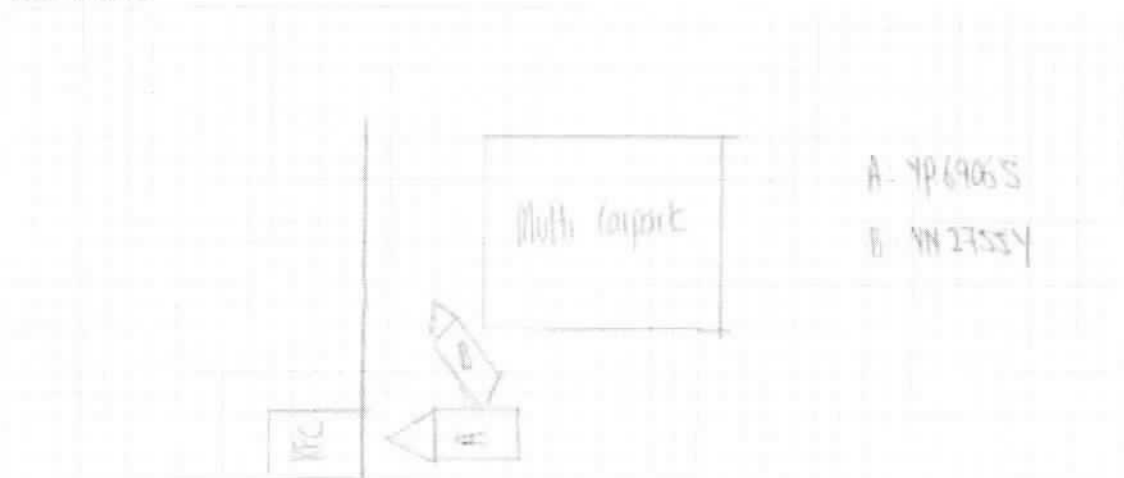
SKETCH PLAN

On 20.06.2019 at about 11:45am, I stop my Vehicle A behind KFC.

Suddenly Vehicle B hit on my rear right side portion.

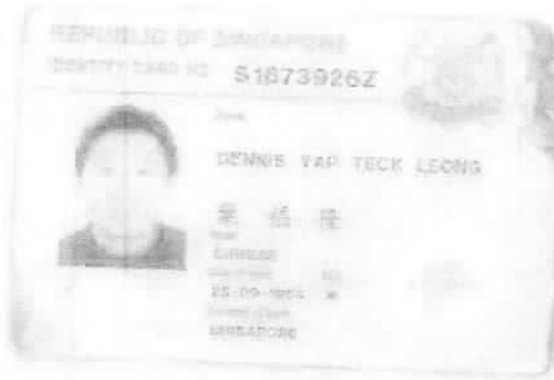
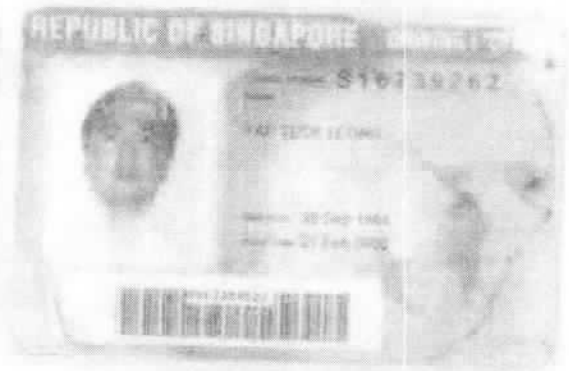
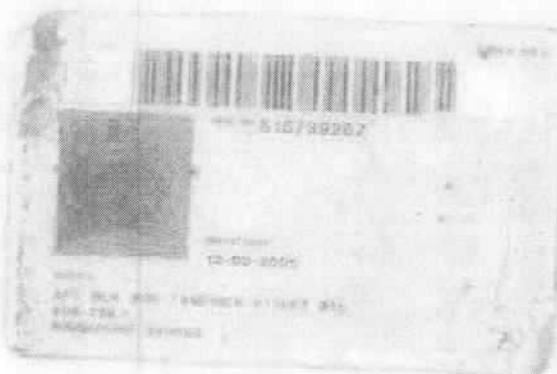
The vehicle sustained impact / damages o/s rear portion and parts claimed are consistent to the accident.

No.	Qty	Part No.	Particulars	Condition	Repairer's	Amount
1	1		*REAR CARGO BOX PANEL REAR I & STRUCTURE PILLAR O/S	Distorted/Cracked	1,800.00 FS	*1,200.00 FS
2	1		*REAR CARGO BOX PANEL REAR I O/S	Distorted/Cracked	1,800.00 FS	*800.00 FS
					Total Parts (S\$)	3,600.00 2,000.00

No	Particulars	Lab.Type	Repairer's	Amount
Labour Items				
1	LABOUR FOR PANEL BEATING & REPLACING PARTS	New	500.00	400.00
2	TO PUTTY & SPRAY PAINTING	New	600.00	0.00
Gross Labour Cost (\$\$)			1,100.00	400.00

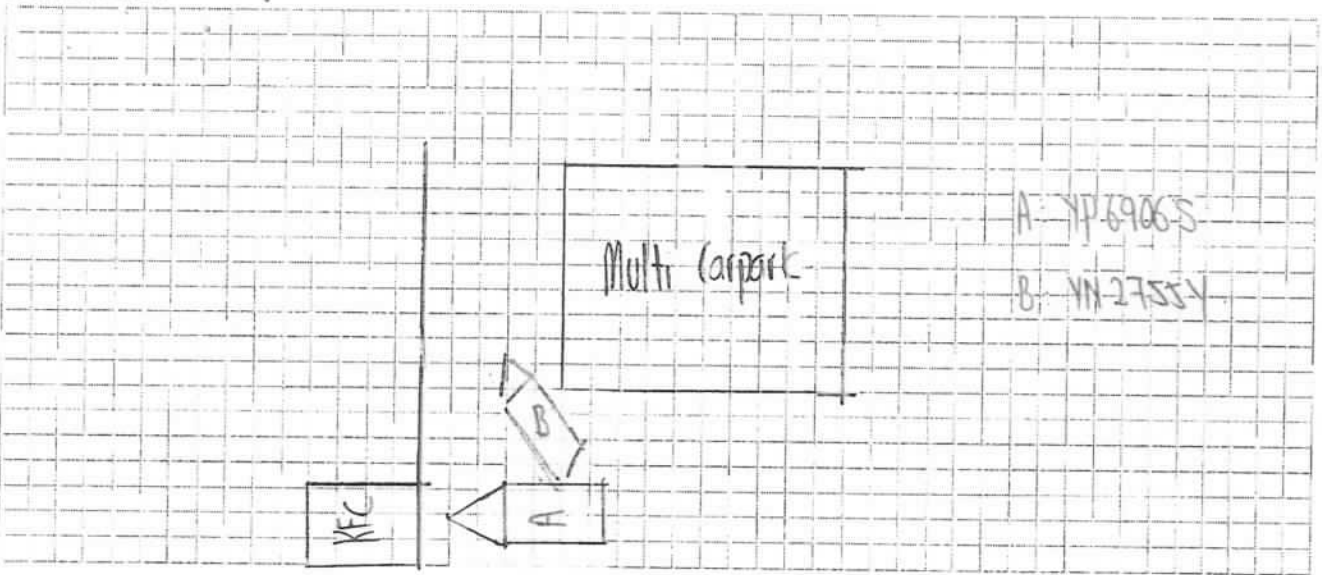
SKETCH PLAN

On 20.06.2019 at about 11.45am, I stop my Vehicle A behind KFC.

Suddenly Vehicle B hit on my rear right side portion.
