VEHICLE DAMAGE INSPECTION REPORT

Our File No: CS/SMO19011238/AQD3N2

Handling Insurer:	Sompo Insurance Singapore Pte. Ltd.	Policy No:	D19MTPCVE001506
Claimant Vehicle No :	SJE3232H	Insured Vehicle No :	YN5333L
Date of Loss:	25/06/2019	Nature of Claim:	TP
		Claim No:	CMTD1903020

Reg No:	SJE3232H	Engine No:	3ZRB580138
Make & Model:	TOYOTA HARRIER, 2.0 ELEGANCE CVT (A)	Chassis No:	ZSU600048295
Reg. Date:	06/08/2015 (Man. Year: 2015)	Odometer:	47625 km
Colour:	Black		
Engine Capacity:	1986 cc		
Market Value/New Car Price:	N/A		
Sum Insured (\$\$):	Market Value/New Car Price

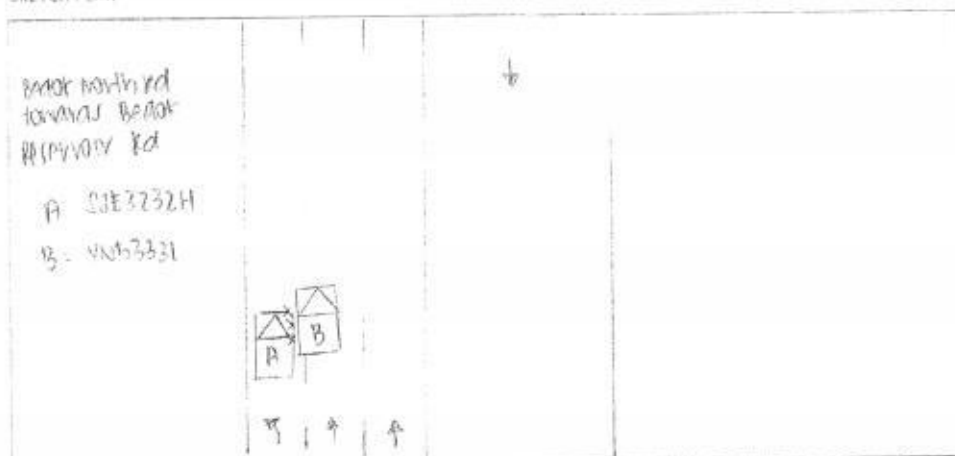
Sketch Plan #2 Pg. 1

I was travelling straight along Bedok North Rd towards Bedok Reservoir.

Suddenly, vehicle B encroached into my lane and hit on the right portion of my vehicle.
