ASS. REC. BY: Surveyor REF: CS3/LPC18017729/R1v13-1 <sup>n2</sup> 24.6.2019  
 Surveyor: Reisel ASSIGNMENT (Office)  
 From (Person): Gerald poh of LPC Date/Time: 24.6.2019  
 Estimated Cost: \_\_\_\_\_ Bill to: \_\_\_\_\_  
 OD / TP / WS / TP RES / OD RES / EVA / INV / MV / CS  
 To Inspect Vehicle No: SDT 8209K Insured: SJR 2439S  
 at Workshop m/s: TME AUTOMOTIVE Tel: 6898 1533  
 of: 7 Soon Lee St # 01-34  
 Policy No: \_\_\_\_\_ Claim No: 18/18/18/VPOS/020953  
 Sum Insured: \_\_\_\_\_ Excess: \_\_\_\_\_  
 Make of Veh: \_\_\_\_\_ D.O.A. 27.9.2016  
 (Client's Record) 02/10/18 2 Moring  
 CA / REV / REP. / REV 24 HRS up H.O.D. Endorsement: \_\_\_\_\_  
 Date/Time: 2:43pm 11/10/18 Person Contacted: Ah Kaw Vehicle: IN OUT

### REPAIR BILL FOR VEHICLE NO. SDT 8209 K

### ADJUSTMENT ON REPAIR COST FOR VEHICLE NO. SDT 8209K

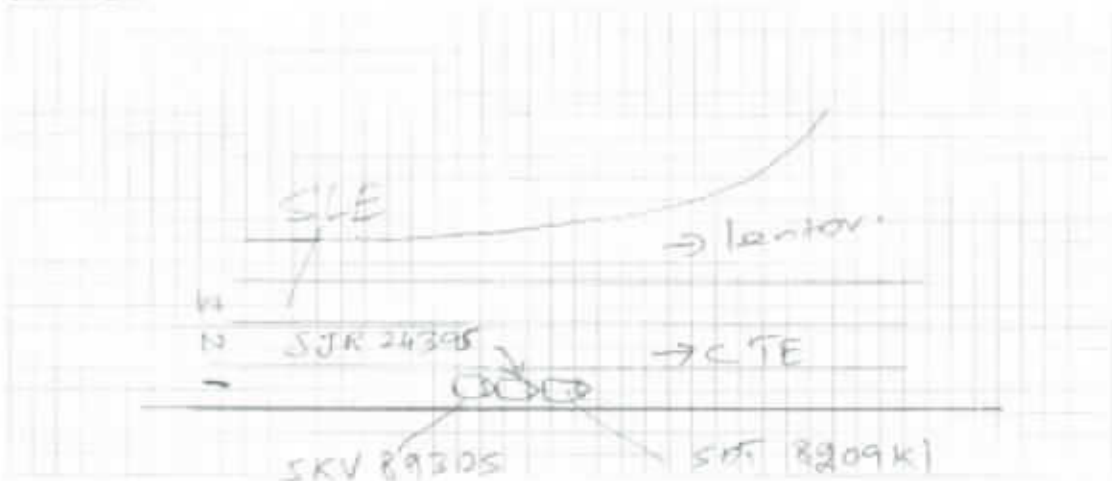
## SKETCH PLAN

When I drive my car SJR 24395 to meet my customer in changing near to the Lentor exit I reduce my car speed due to my front car (SFR 8209K) reducing their speed. At the same time my car was knocked by behind car (SKV 89305) and my car hit my front car.

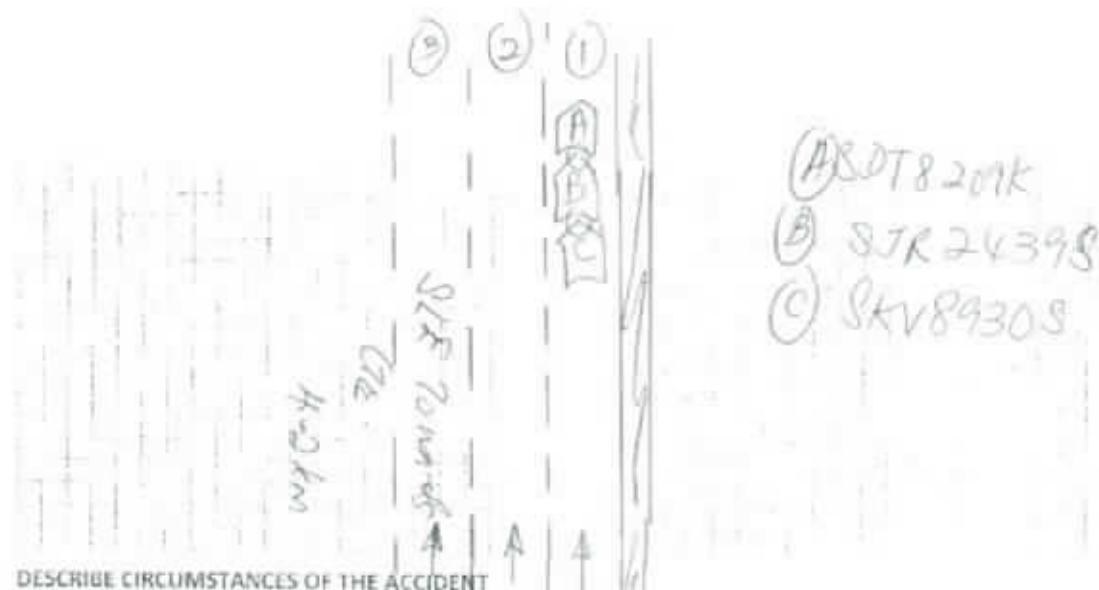
# Sketch Plan

I am the Driver and driving at the first lane suddenly I felt a big bang on my vehicle. I stop and came out and saw two vehicles behind me. Total 3 vehicles were involved and damaged to 3 vehicles

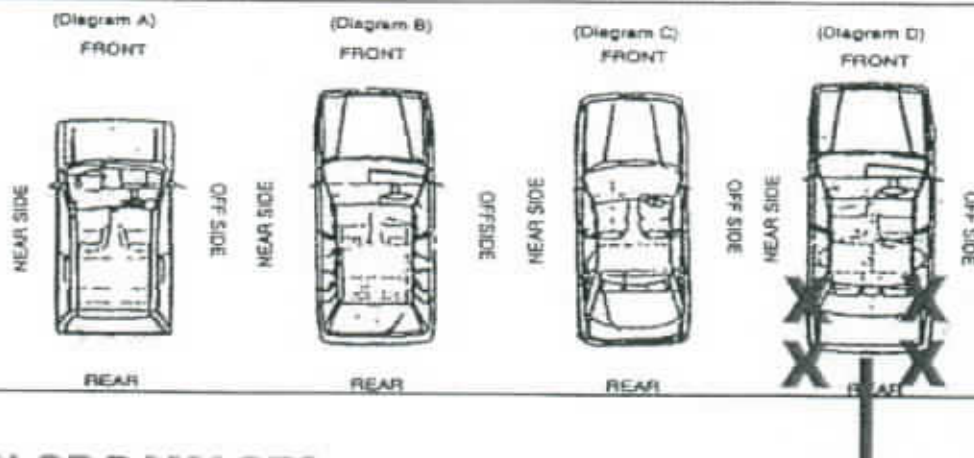
Direction of impact/damage marked (→) (X)

**The vehicle sustained impact on its Rear Portion. (see Diagram D)**

| Affiliated to Federation Internationale Des Experts En Automobile | | | | |
|---|---|---|---|--|
| THE VEHICLE SUSTAINED DAMAGES AT THE REAR N/S PORTION.<br>DAMAGES SEE DETAILS. | | | | |

A static inspection was carried out on 28/09/2018 & our report is here with enclosed for your perusal. The Repairs Estimate submitted by M/s TMF AUTOMOTIVE PTE LTD as per attached Appraisal Schedule have been revised and scrutinised thoroughly by us & in our opinion, we consider it to be fair and reasonable. The repairer has agreed to effect repairs to the owners satisfaction & to roadworthy condition on an agreed Lump Sum Repair Basis of \$ 12,650.00 after deducting the Policy Excess Clause of \$ NA. As instructed, we have not authorised any of the repairs on your behalf.
