SLF 7216A

# ASSIGNMENT

### DAMAGE ASSESSMENT REPORT

## ADJUSTMENT ON REPAIR COST FOR VEHICLE NO. SLF 7216A

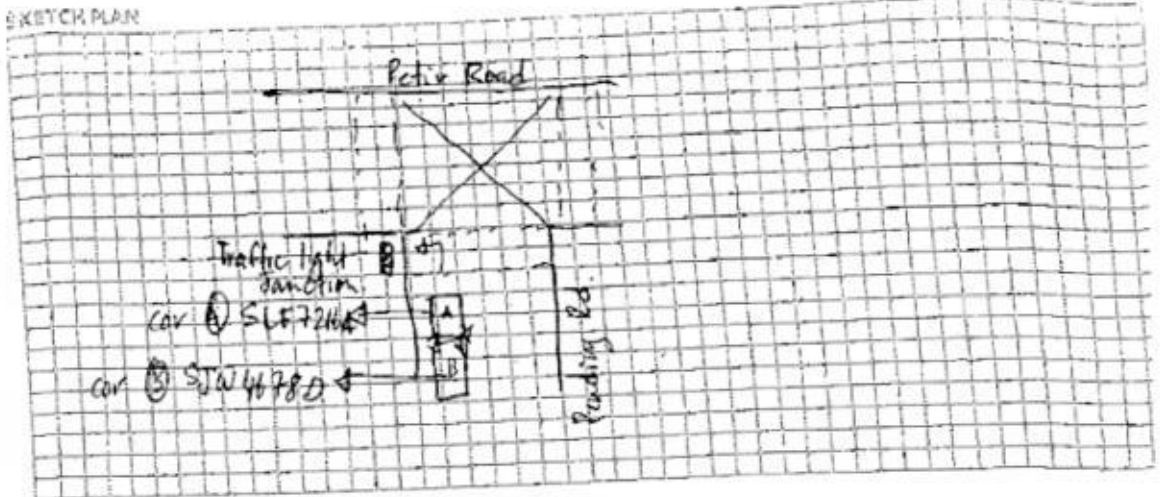
SKETCH PLAN

On 24/6/19 @ 10.30am, I was stopping at traffic junction along Petir Rd while waiting traffic change to green and for me to turn right to make my way to office. Suddenly a Hyundai Avante black colour with reg. no SJW 4678D hit back portion of my car. My ~~back~~ <sup>car</sup> back portion involved quite bad damage with rear boot, rear bumper & etc. (refer photos attached). The other party mentioned their vehicle was a long term rental car. Both particular, hire and driver have been noted and taken for reporting purpose. (refer attached)
