## AUTOMOBILE ASSESSMENT REPORT

**ASSESSMENT OF VEHICLE NO. GBG 2087 B**  
**DATE OF LOSS: 21-Aug-2018**

**ASSESSMENT REPORT FOR VEHICLE NO. GBG 2087 B**

## ADJUSTMENT ON REPAIR COST FOR VEHICLE NO. GBG 2087B

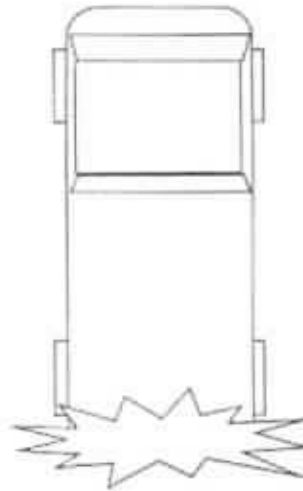
At the time of the inspection, the vehicle sustained damages to the REAR portion.

Pursuant to your instruction, we have **NOT AUTHORISED** repair.

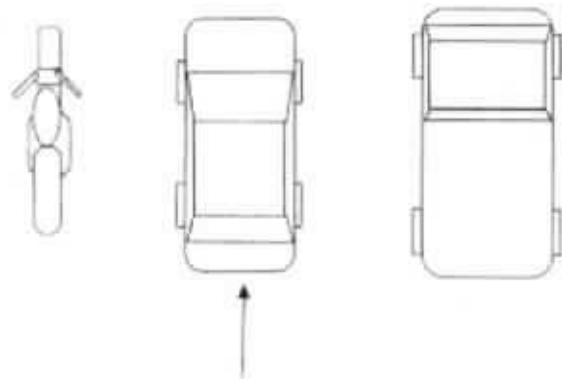
At the time of inspection, this vehicle sustained damages to the **Rear** portion. Please see attached scheduled for details.

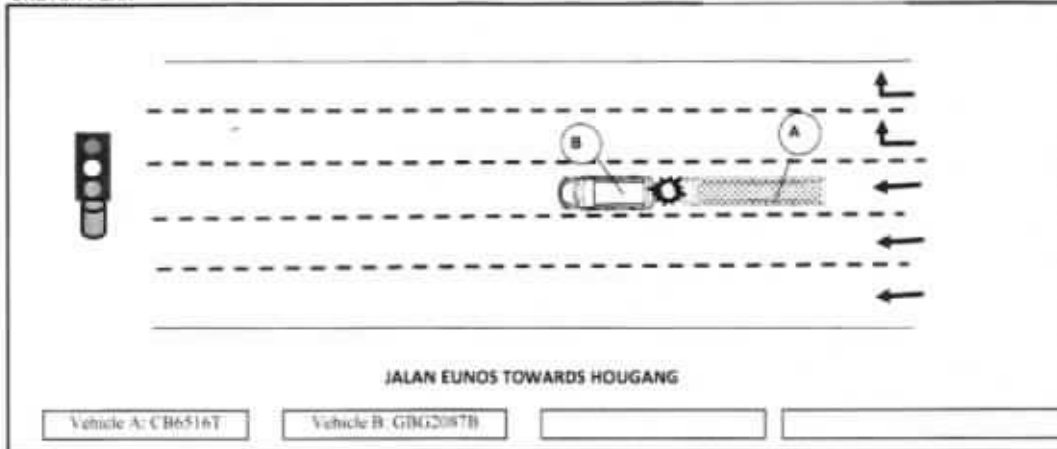
SKETCH PLAN

TRAFFIC TURNED GREEN. VEHICLE B MOVED OFF AND I FOLLOWED SUIT. SUDDENLY, VEHICLE B JAMMED BRAKE CAUSING ME NOT ABLE TO BRAKE IN TIME AND HIT INTO THE REAR PORTION OF HIS VEHICLE.
