Insured Vehicle No	: SMD1297D	Accident Date	: 12/06/2019
TP Vehicle No	: SGS2717U	Assignment Date	: 28/06/2019
Make	: TOYOTA RUSH	Est. Duration of Repair	: 2.00
Date of Inspection	: 11/07/2019		
Inspection At	: SAN TEE AUTO PTE LTD (HQ) BLK 1019 #01-388 YISHUN INDUSTRIAL PARK A SINGAPORE 768761

RE: 3RD PARTY CLAIM VEHICLE NO. SGS2717U AND SMD1297D AT SPC PETROL STATION

VEHICLE DAMAGE INSPECTION REPORT

Our File No: CS/SMO19011463/ETD3N2

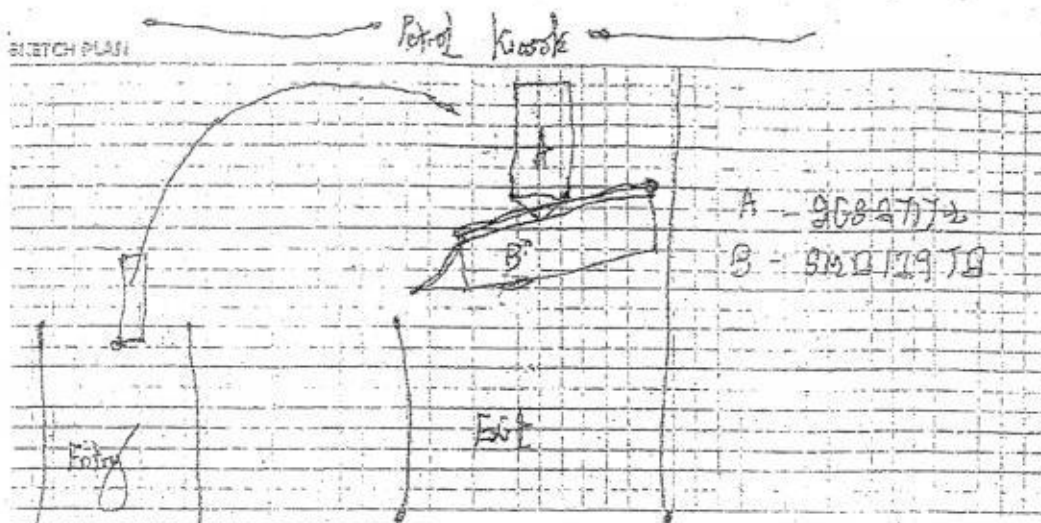
Sketch Plan Pg. 2

After pumping petrol, I drove to exit the petrol station, then there was a vehicle parked in front, as such I parked and waited + then suddenly she reversed her car and hit the front part of my car.
