Preliminary Advice

Vehicle No	: FBN5048H	Accident Date	: 13/06/2019
Make	: YAMAHA XABRE	Policy No.	: D18MTMC01006709
Assignment Date	: 28/06/2019	Excess	: S\$600.00
Date of Inspection	: 3/7/2019	Est. Duration of Repair	: 3
Inspection At	: BIKE PRODUCTION PTE LTD

ASSESSMENT FOR REPAIR: YAMAHA XABRE TFX150 - FBN5048H

VEHICLE DAMAGE INSPECTION REPORT

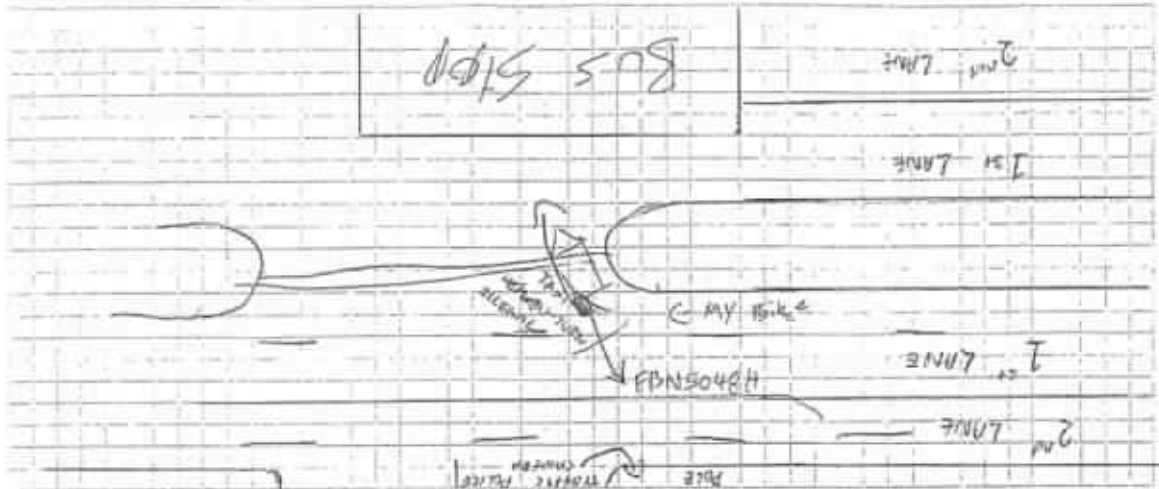
SKETCH PLAN

DESCRIBE CIRCUMSTANCES OF THE ACCIDENT

I WAS RIDING MY BIKE AT THE FIRST CHANG WHEN SUDDENLY RED TAXI ILLEGALLY U-TURN AND I DIDN'T MANAGED TO BRKE ON TIME AND HIT THE SIDE OF THE TAXI.
