OD ~~TP~~ WS / TP RES / OD RES / EVA / INV / MV / CSTo Inspect Vehicle No: 8JS 9026Z Insured: SML 2845Zat Workshop m/s Kien Cheong Tel: 81259406 Kellyof Blk A Sin Ming Ind Est #01-26Policy No: 1900098589 Claim No: 9272408963SG

Subject: [EXTERNAL] ACCIDENT INVOLVING SJS9026Z AND SML2845Z ON 25 JUNE 2016

VEHICLE DAMAGE INSPECTION REPORT**Our File No:** CS3/AIG19011509/KCD3S2
Date: 25/07/2019**REFERENCE**

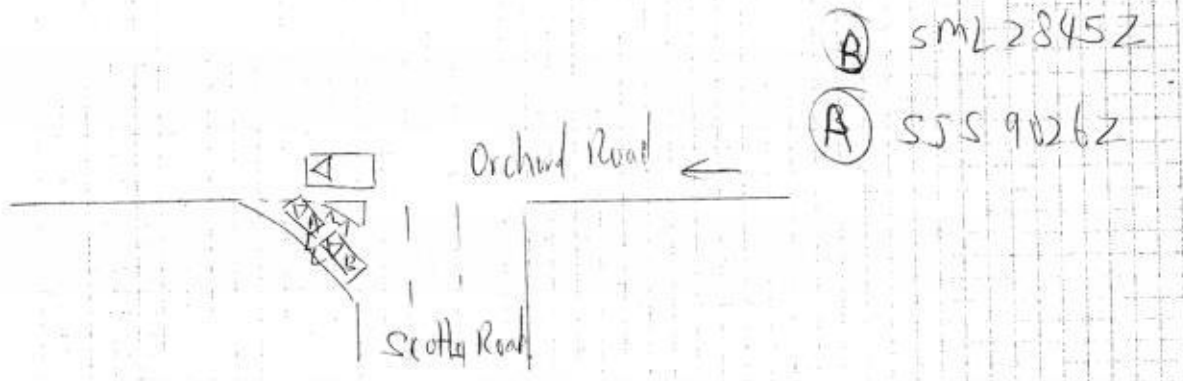
SKETCH PLAN

While I was stopped my vehicle (A) along the slip Road of Scotts Road with 3 passengers. Suddenly the vehicle (B) unable to stop her car and hit onto rear portion of my vehicle (A)
