SLS 8918 H

Make: Pugeot 3008 c.c. 1598Colour: Blue A/C: Insured / Std / NI / NASp. Reading: 14942 T/Radio: Insured / Std / NI / NAEng/No: VF3M456EW.HS270286

TO CONDUCT TP CLAIM AGAINST SKN3190K (CHINA TAIPING
INS) DOA:19/06/2019

VEHICLE DAMAGE INSPECTION REPORT

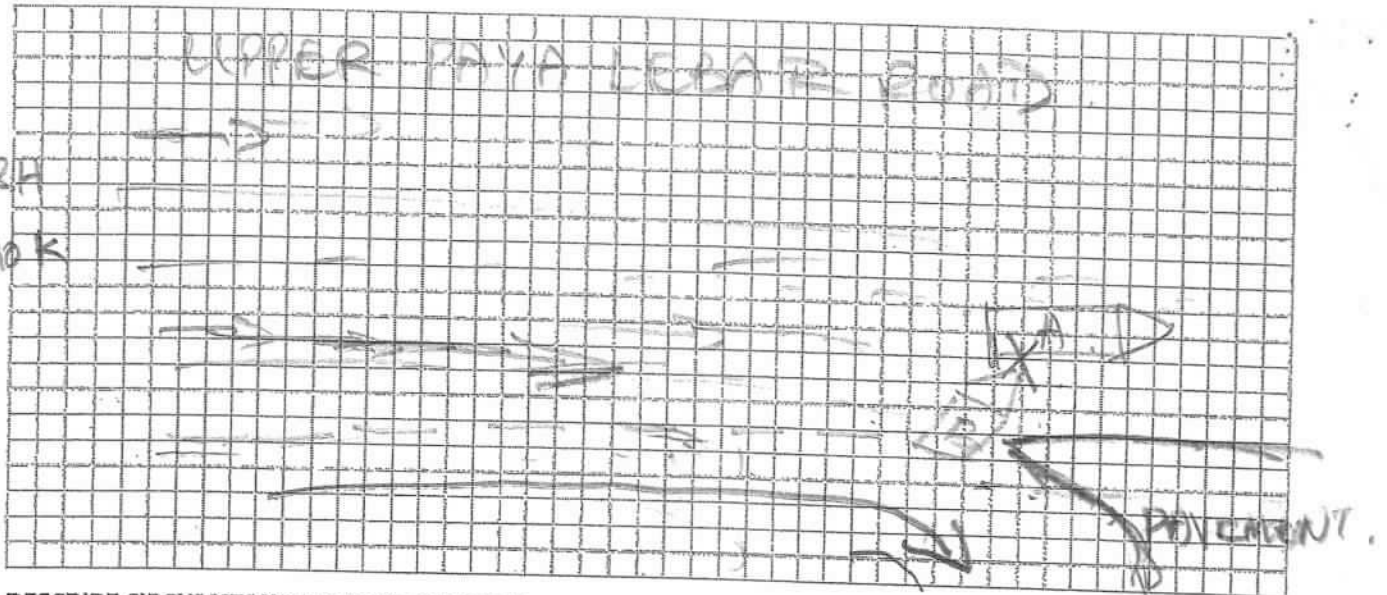
SKETCH PLAN

An accident had taken place on 19 Jun 2019 at around 7.00 pm along Upper Paya Lebar Road. [Opposite Tai Feng Garden] going towards Lorong Ah Soo.

I was (A: 3LS 8918H) was travelling straight towards Lorong Ah Soo and the other vehicle (B: 3KN 3190K) which was in the extreme right to make an U-turn.

Out of the blue, ~~she~~ she suddenly filtered left which hit my rear right.
