# LKK Auto Consultants Pte Ltd

| Affiliated to Federation Internationale Des Experts En Automobile | | | | |
|---|---|---|---|---|
| Insured Veh. | | Veh. Inspected | | SKS 6076L |
| THE VEHICLE SUSTAINED DAMAGES AT THE REAR PORTION.<br>DAMAGES SEE DETAILS. | | | | |

## ADJUSTMENT ON REPAIR COST FOR VEHICLE NO. SKS 6076L

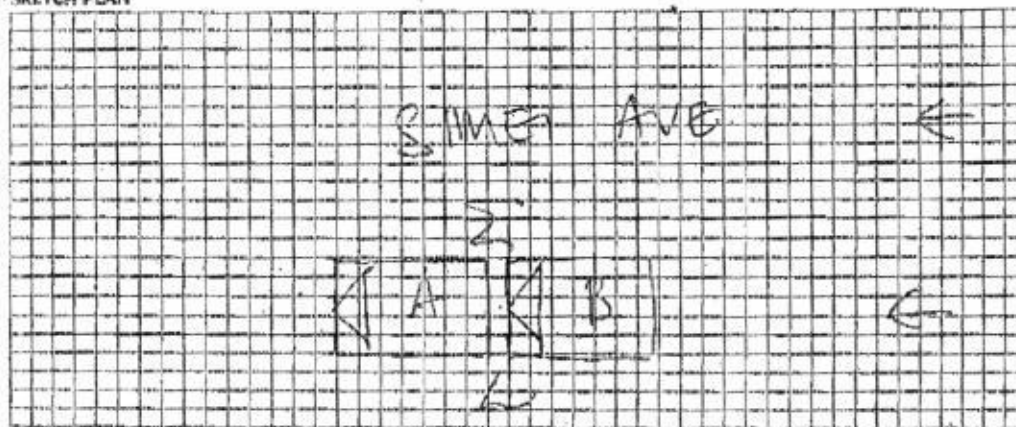
## SKETCH PLAN

On 28/6/19 at about 1035am, I was driving along Simei Ave on the left lane when suddenly Car B hit my car from behind.
