OD/IP Re-inspection Evaluation

MC SUIT NO. 10326 OF 2018 – CLAIMANT: RUDY ASMARA BIN ABDUL SAMAD ACCIDENT INVOLVING FBG 1135C & SFN 330C ON 21.08.16 ALONG TAMPINES AVE 9

ASSESSMENT REPORT FOR VEHICLE NO. FBG 1135 C

ADJUSTMENT ON REPAIR COST FOR VEHICLE NO. FBG 1135C

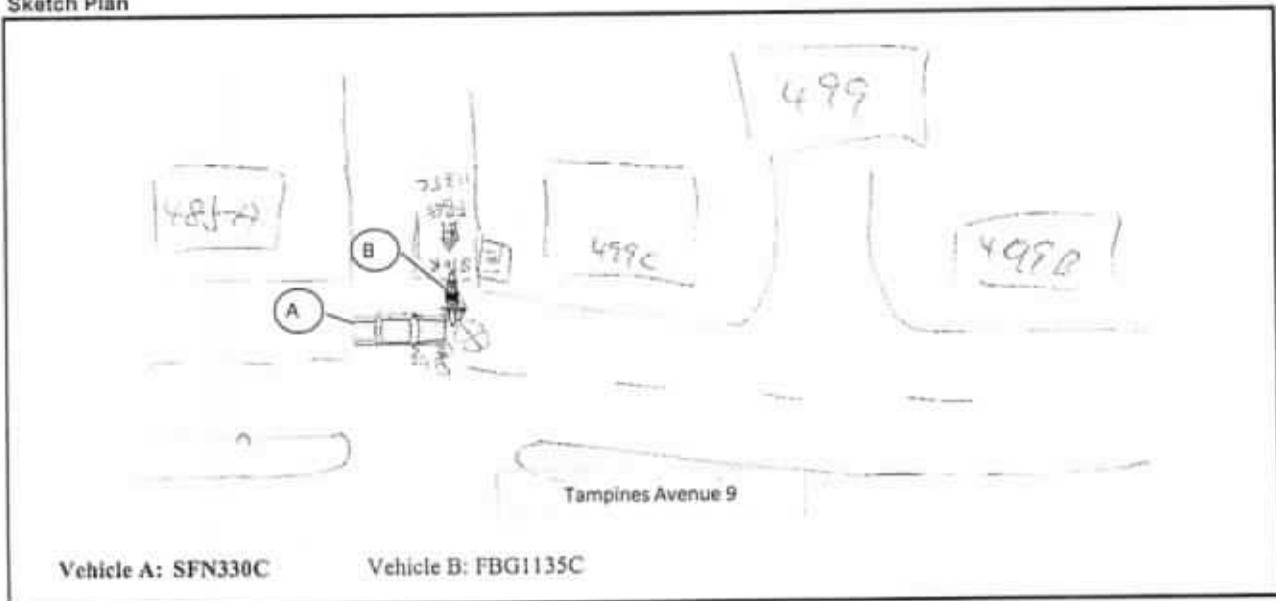
Sketch Plan

Vehicle A: SFN330C

Vehicle B: FBG1135C

On the 21/08/2016 at about 2015hrs, I was driving my car bearing license plate no.SFN330C along the right lane of Tampines Ave 9 when I approached the entrance to carpark of Blk 485A Tampines Ave 9. I had turn on my left signal but I had intended to filter to the left to prepare to turn into the Blk 499 Tampines Ave 9 multi story carpark which is further down the road however, just as I was filtering to the left, a motorcycle bearing license plate no.FBG1135C had went out of open carpark between Blk 485A and 499C and as a result, his motorcycle had collided with my vehicle's left front portion. As a result, the motorcycle went into the grass patch beside the road and as such, the rider and his pillion fell off the motorcycle. As the rider and his pillion who is pregnant had sustained some injuries, the rider had called for ambulance. Ambulance and traffic police soon came and attended to the rider and his pillion and conveyed both of them away. As a result of the accident, my left front bumper had scratches and my left headlight is broken.

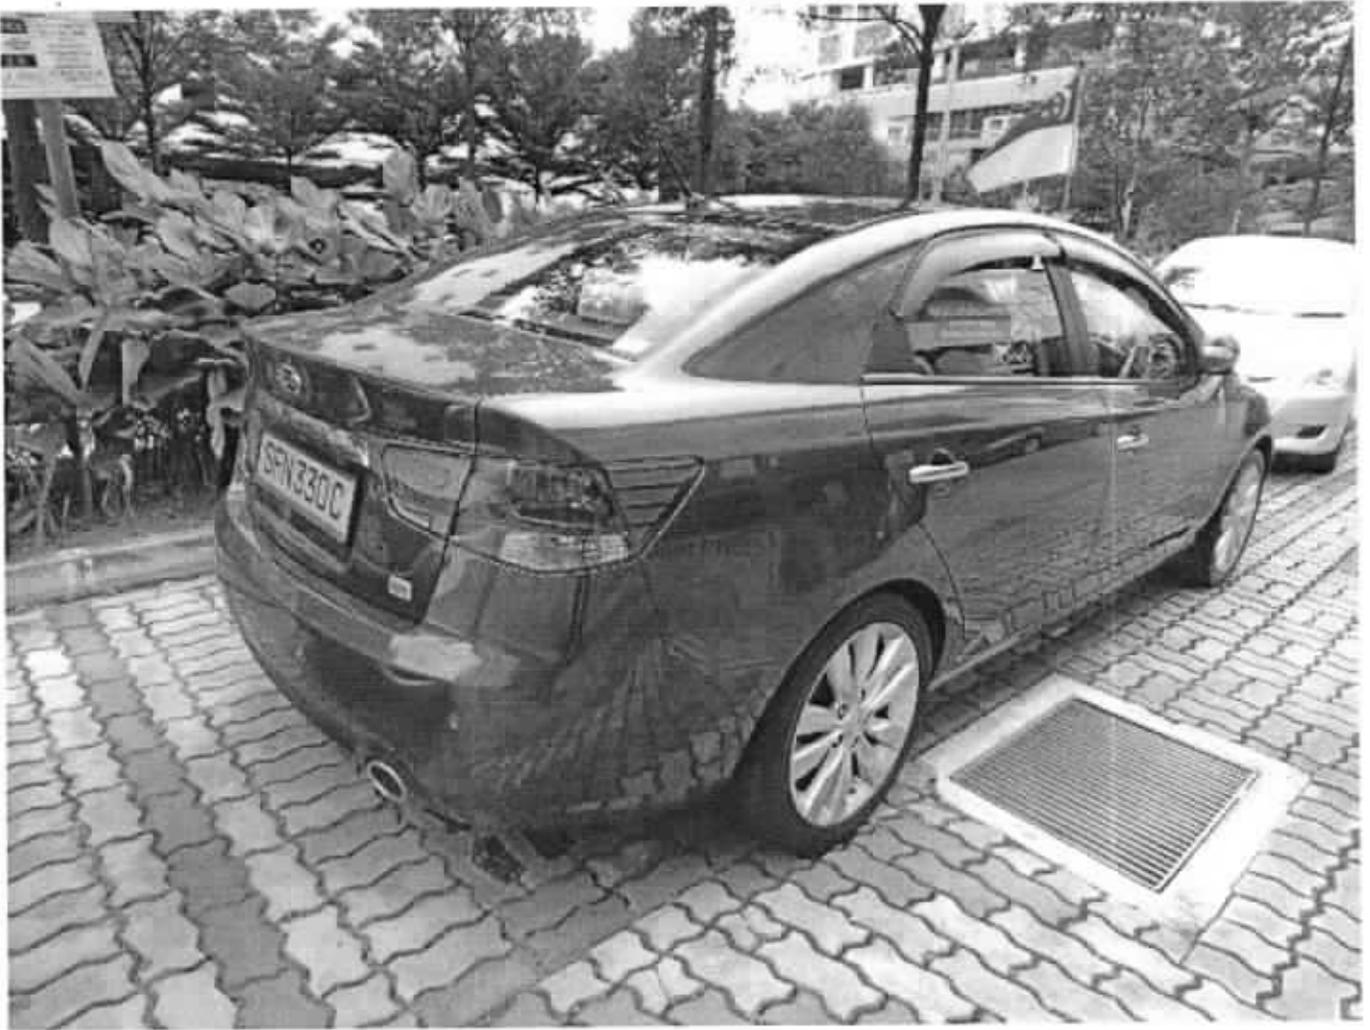
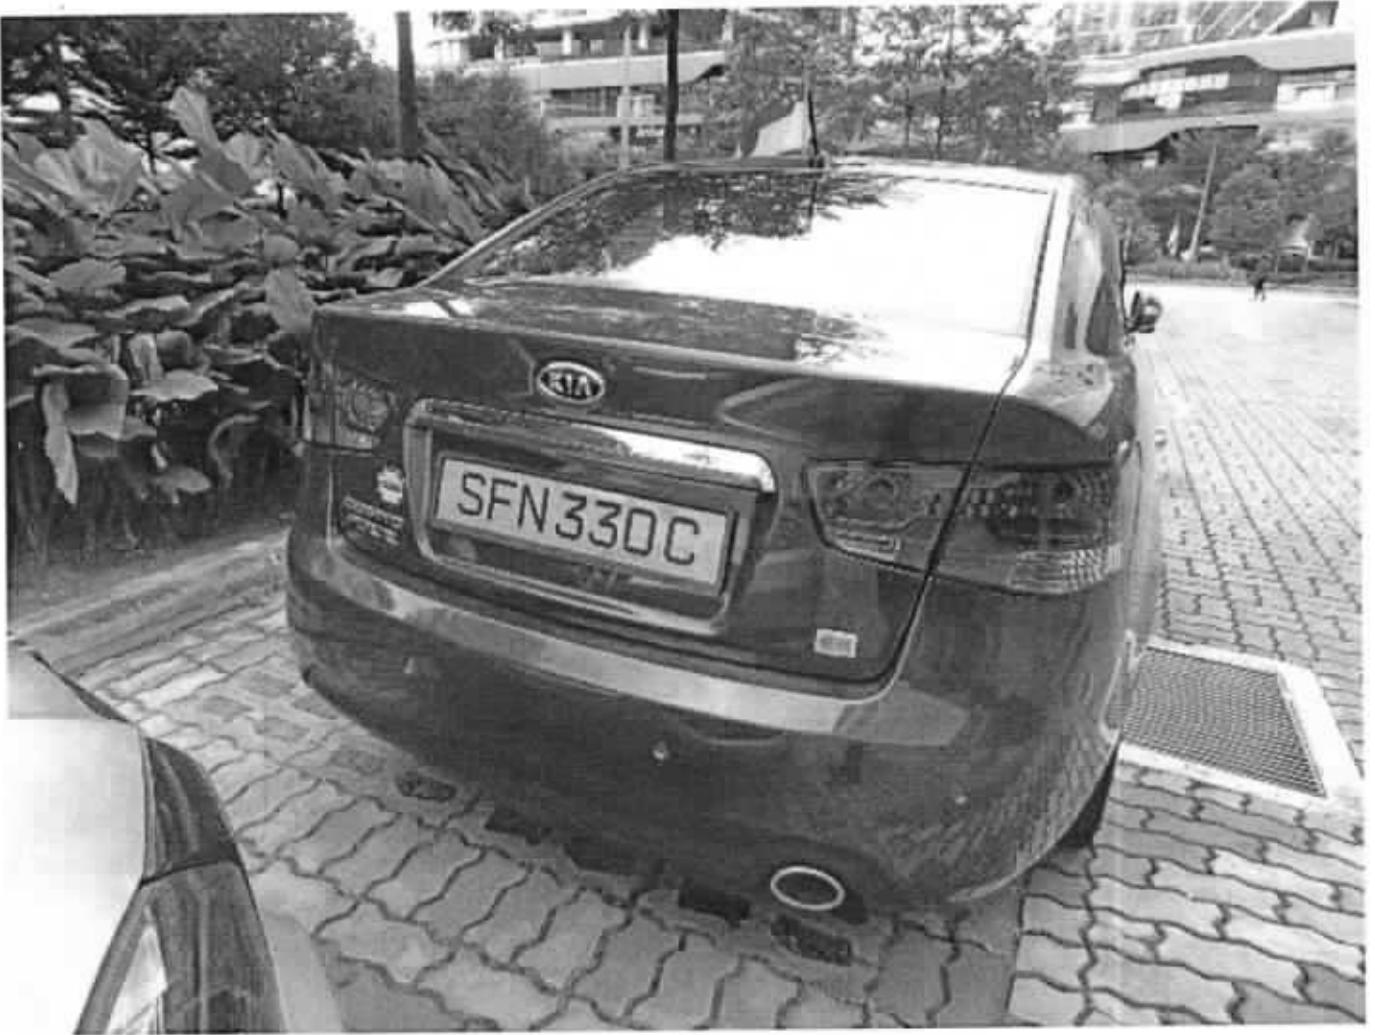
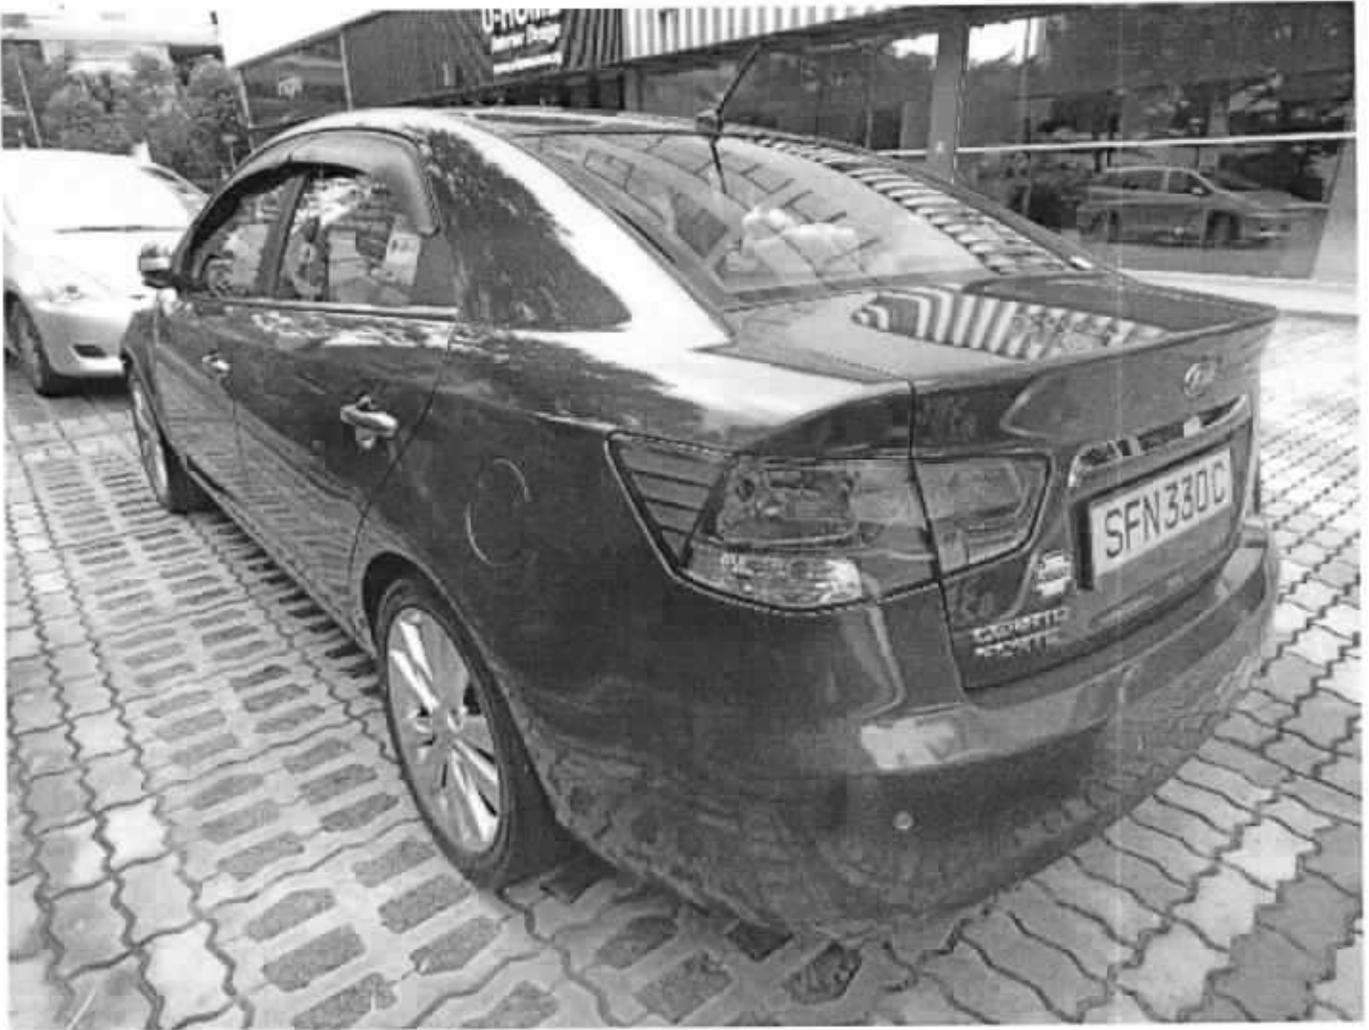
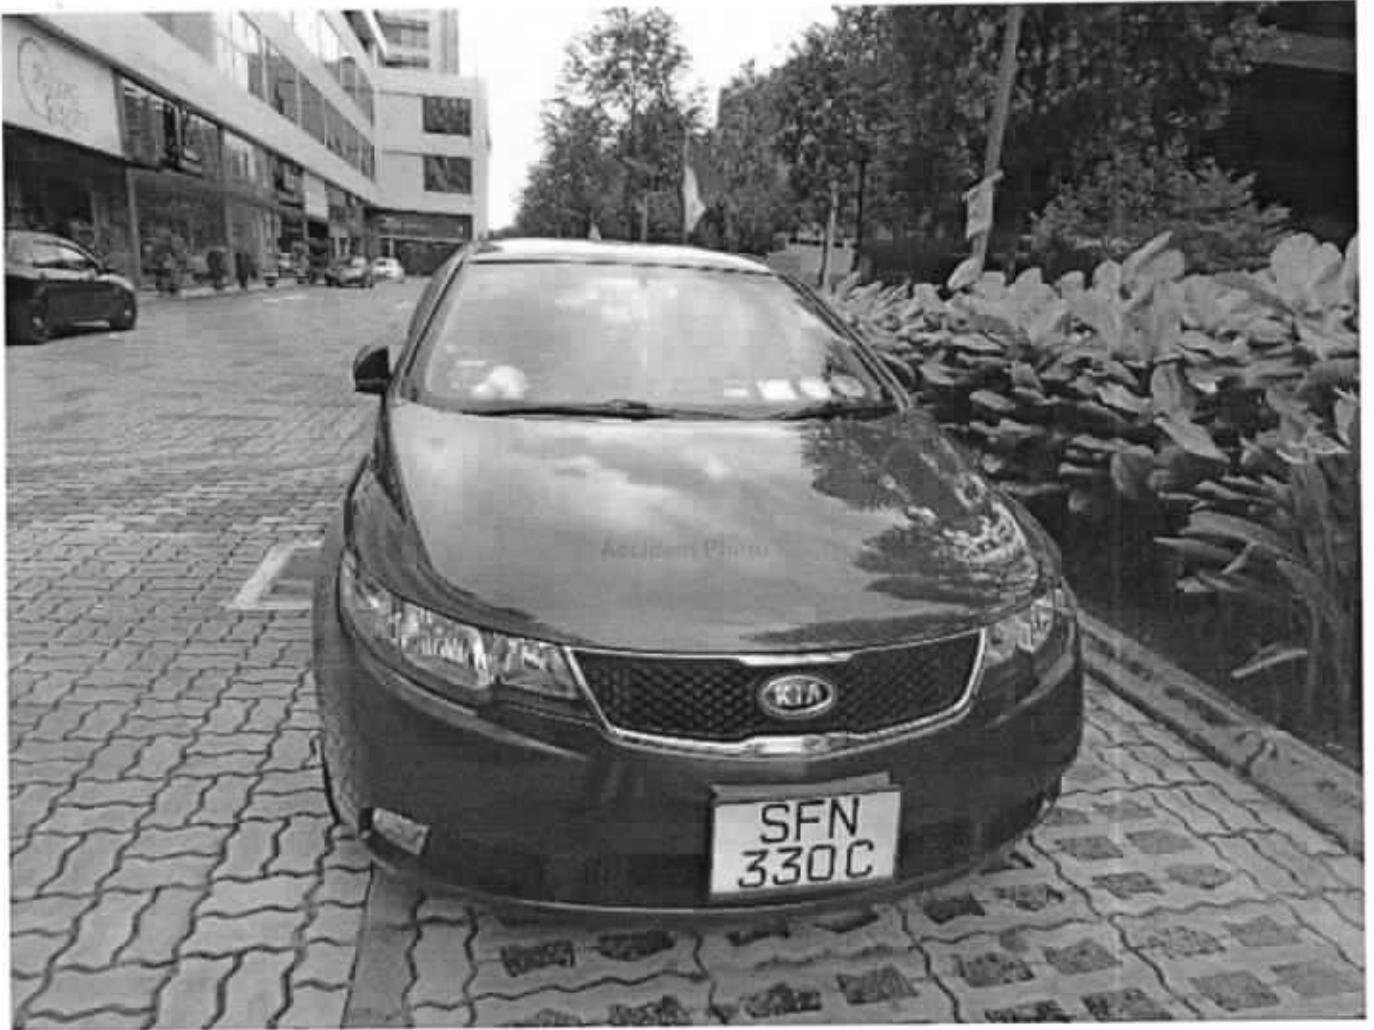
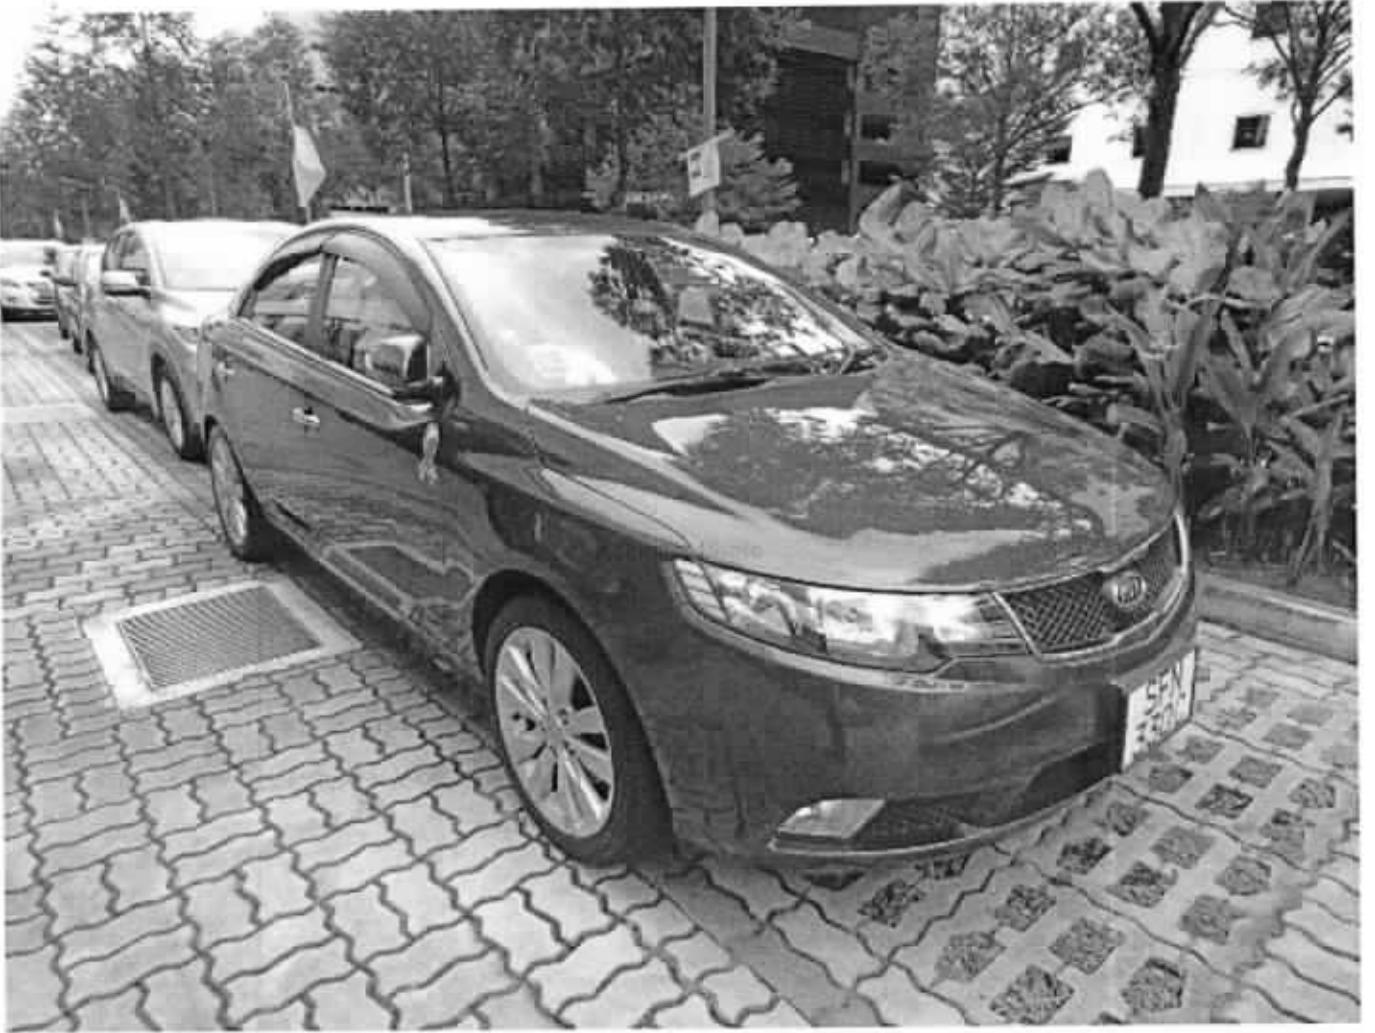
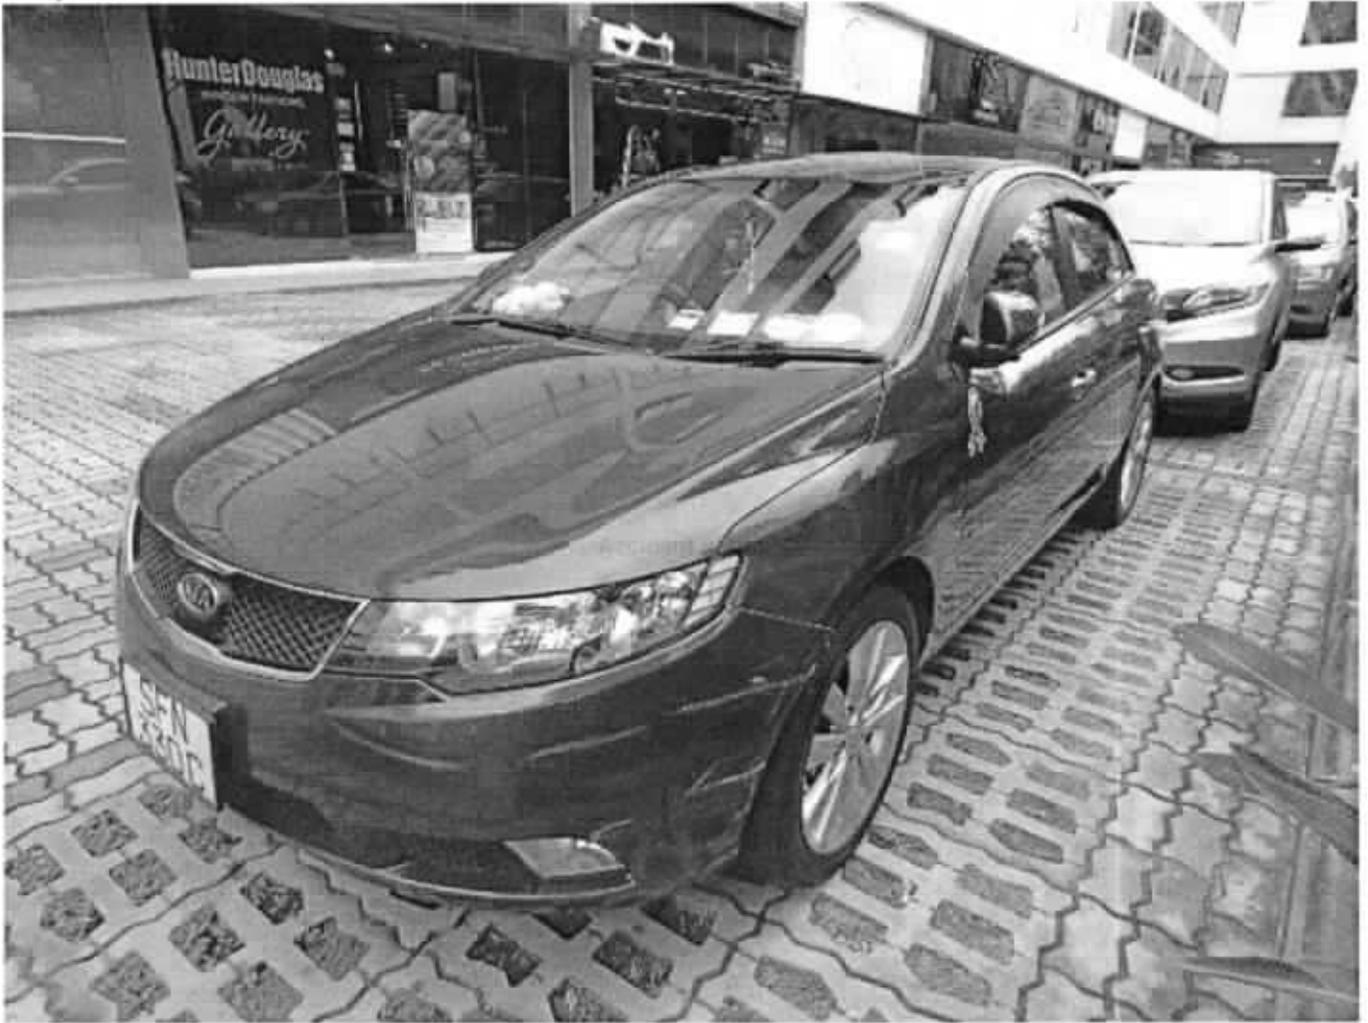
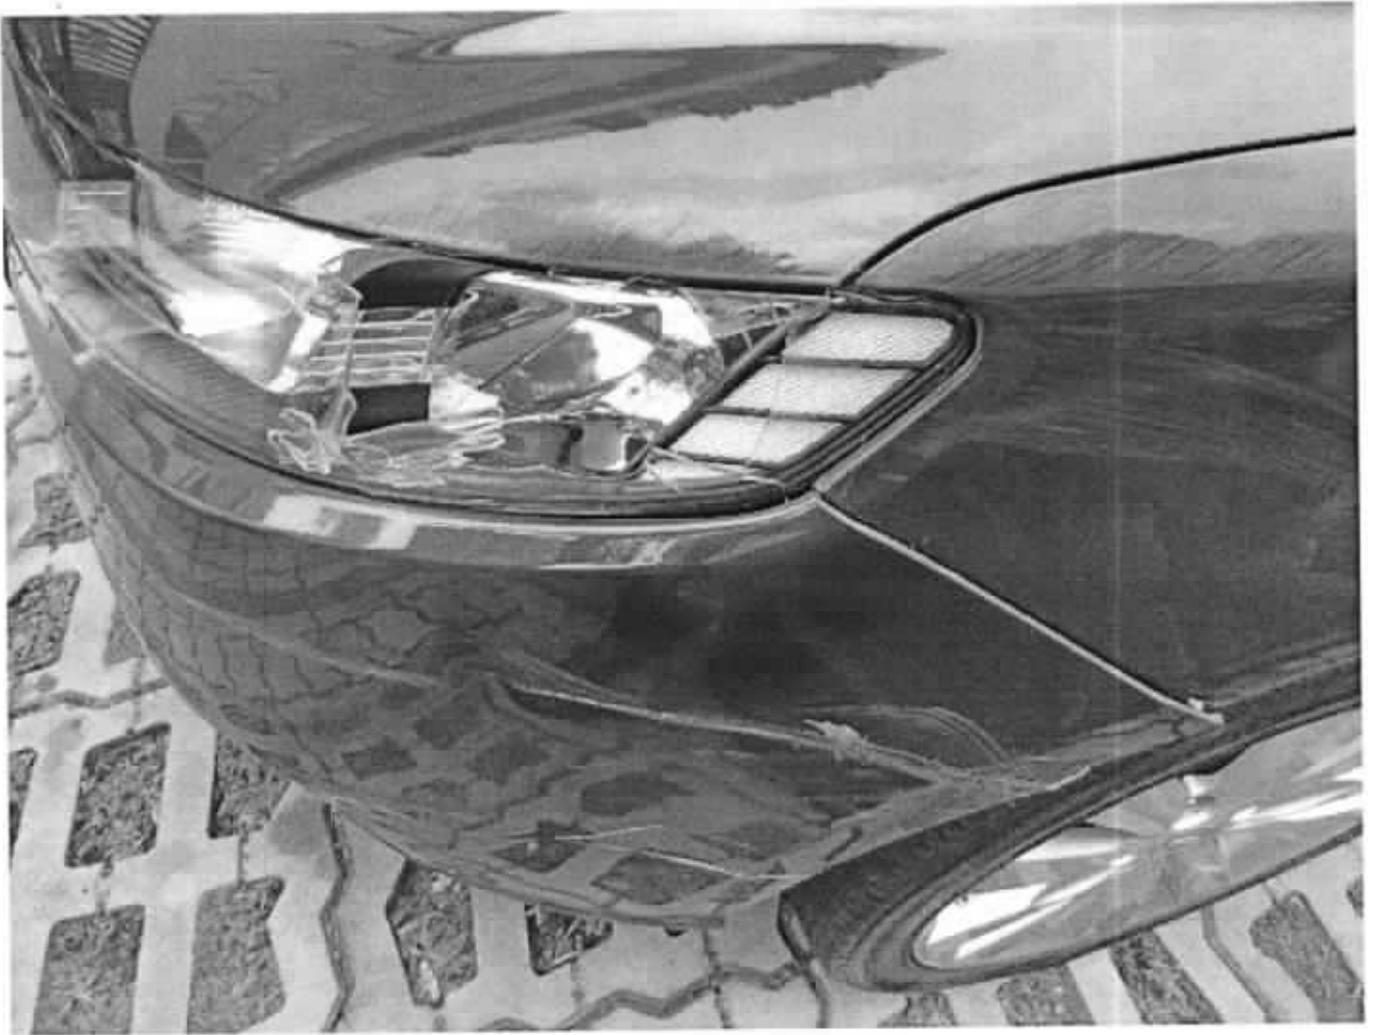
Accident Photo
