Preliminary Advice

Insured Vehicle No	: SDW797R	Accident Date	: 29/06/2019
TP Vehicle No	: SHA6992Y	Assignment Date	: 03/07/2019
Make	: TOYOTA PRIUS	Est. Duration of Repair	: 2.00
Date of Inspection	: 02/07/2019		
Inspection At	: COMFORTDELGRO ENGINEERING PTE LTD (LOYANG) 59 LOYANG DRIVE SINGAPORE 508969

VEHICLE DAMAGE INSPECTION REPORT

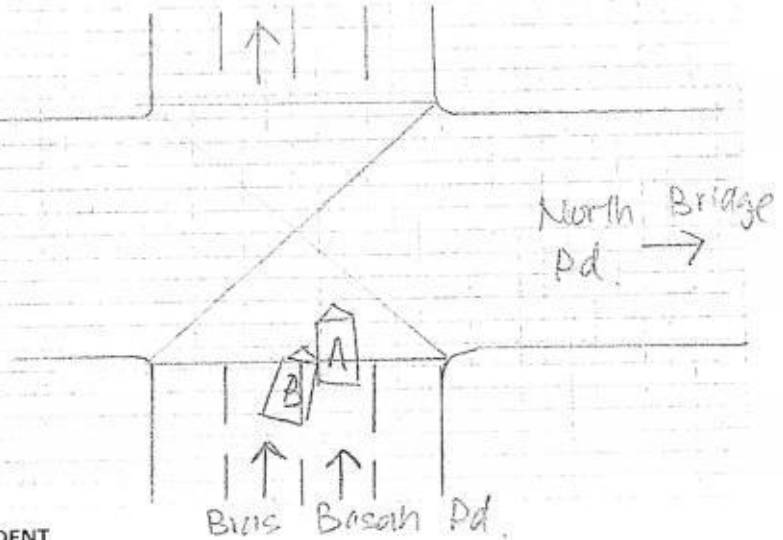
SKETCH PLAN

A: RHA 6992Y

B: SDW 797R

On 29/6/19 at about 11:00 hrs, I was driving straight at above said location with a male pax onboard. Suddenly veh B cut into my lane and it right front portion hit & grazed onto the left rear portion of my taxi. Both of us then alighted to take photo. No injury at the point of accident.

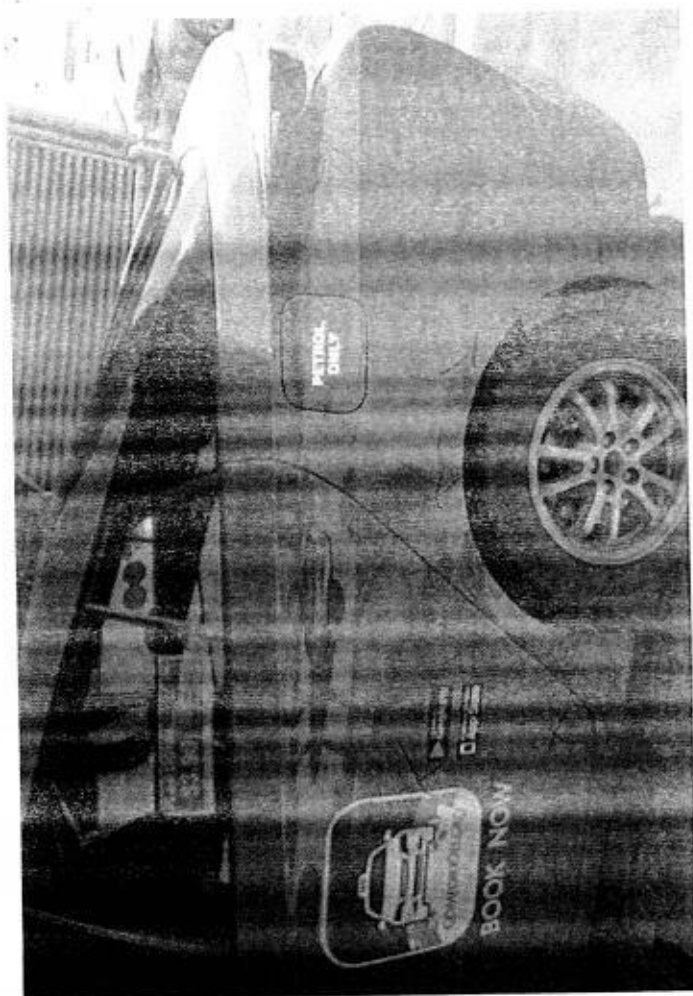
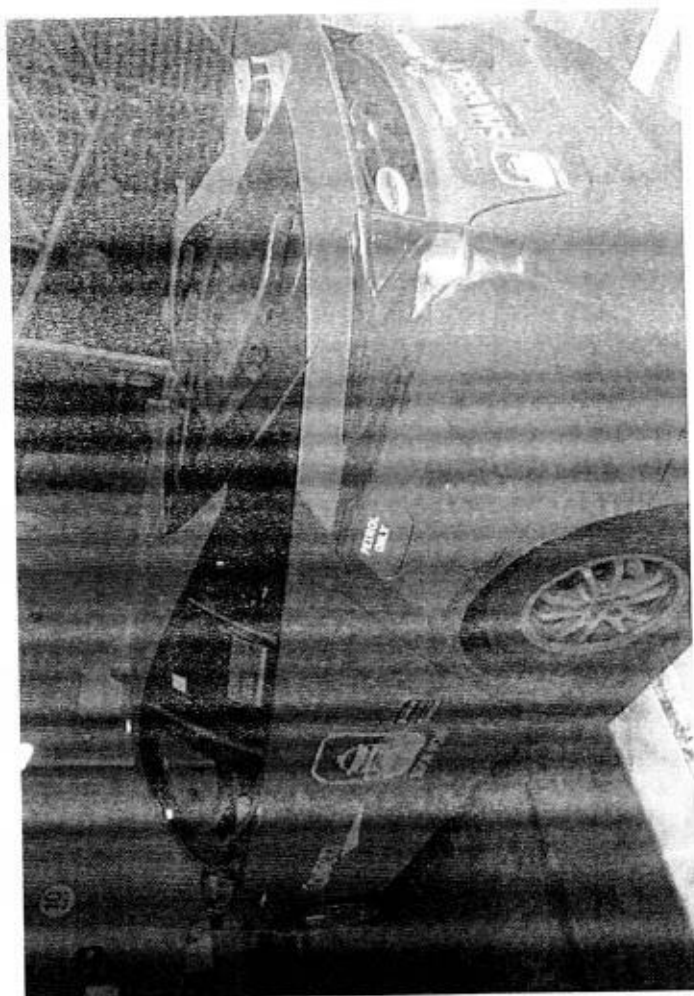
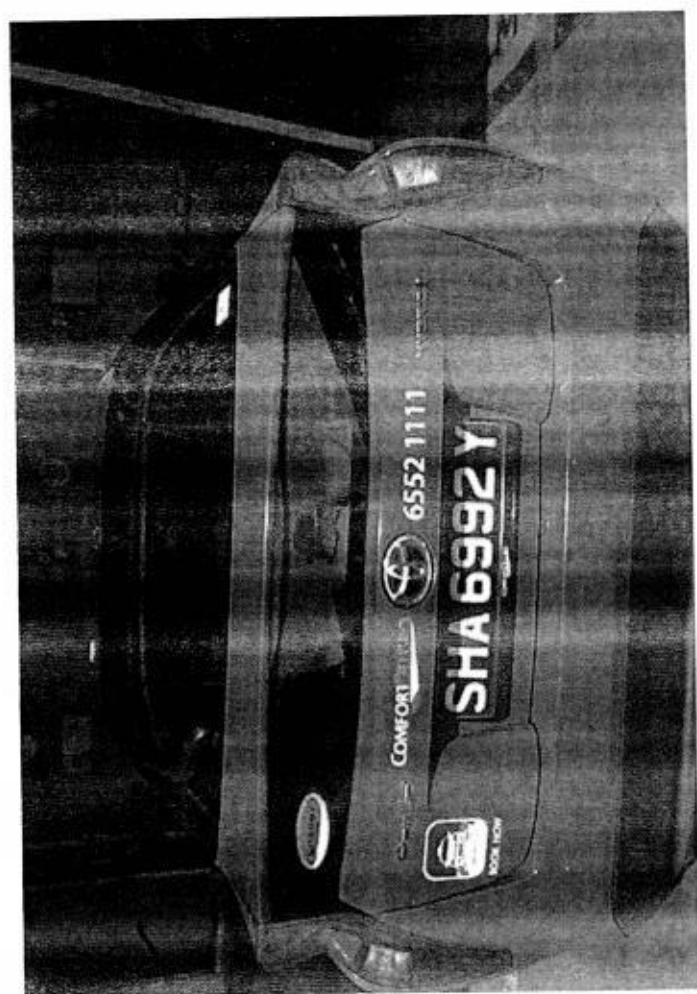
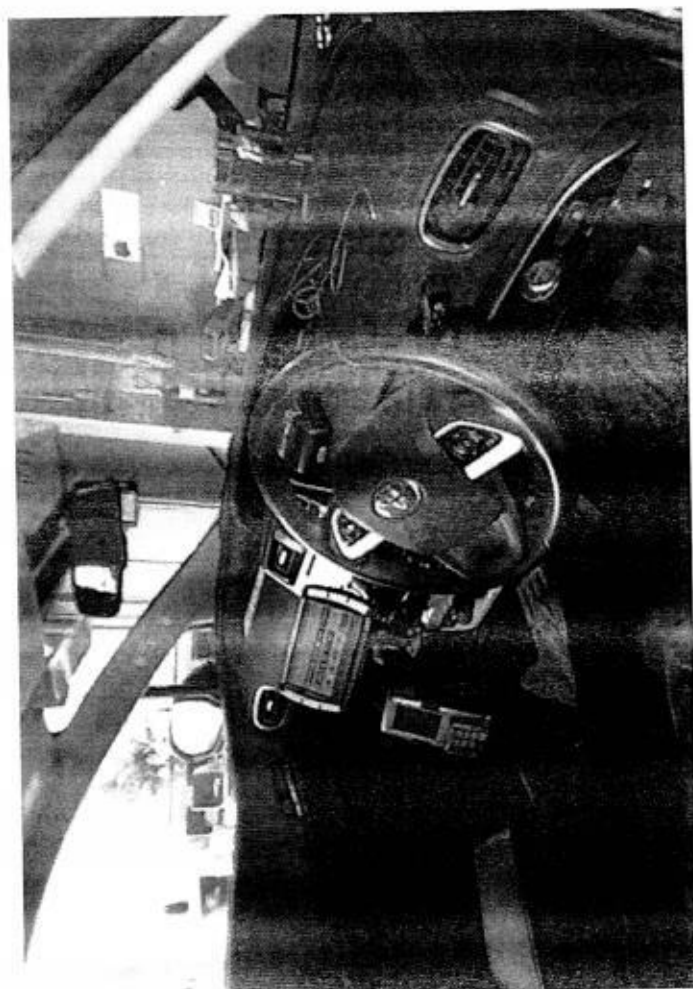
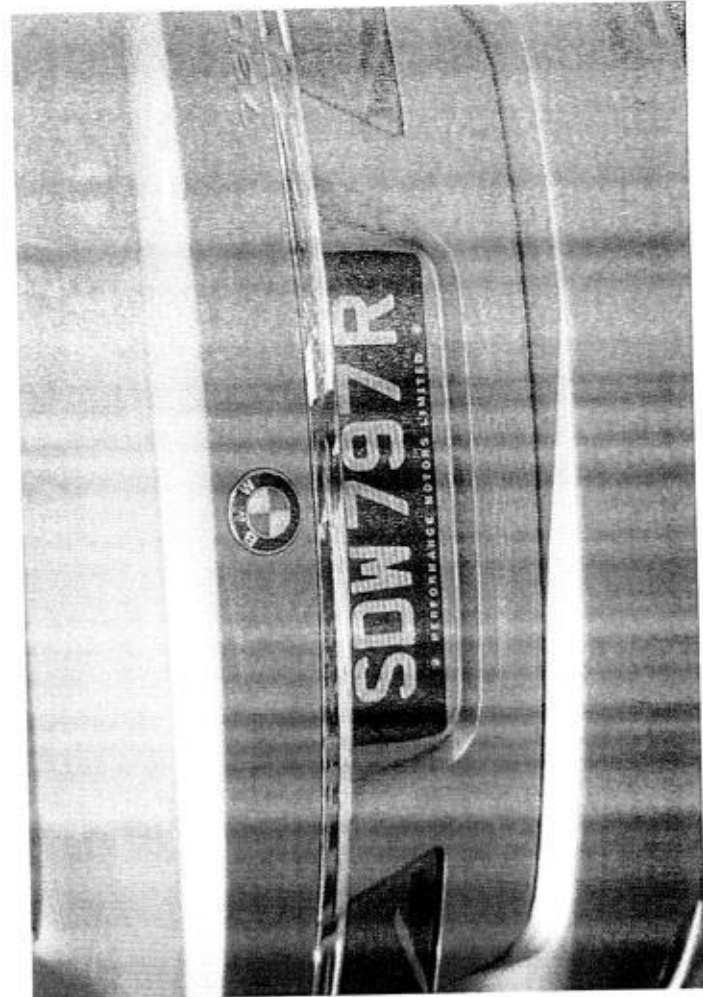
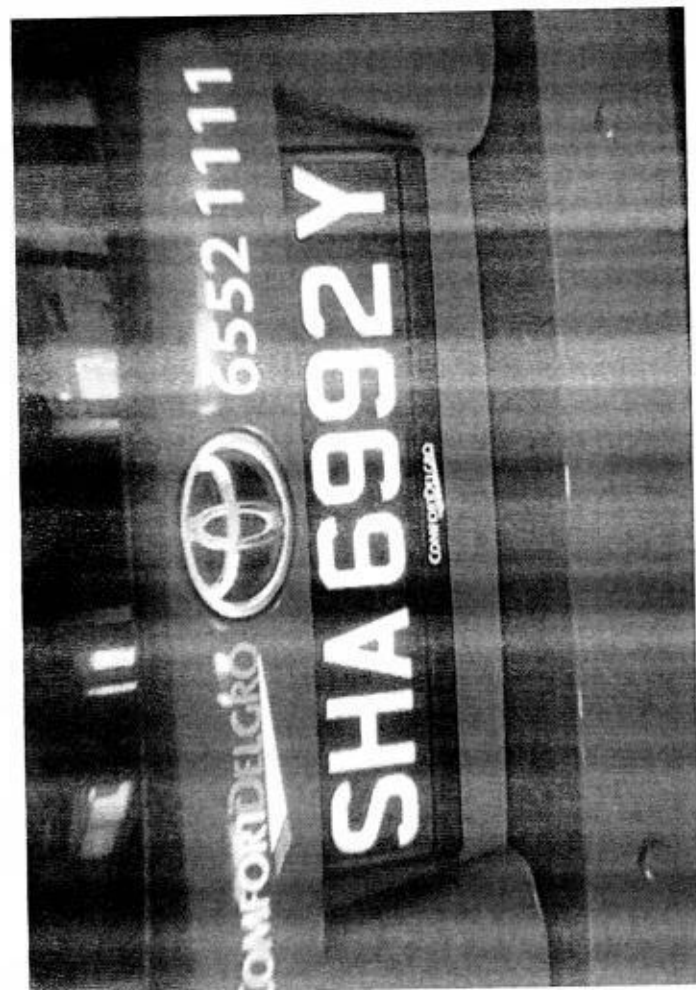
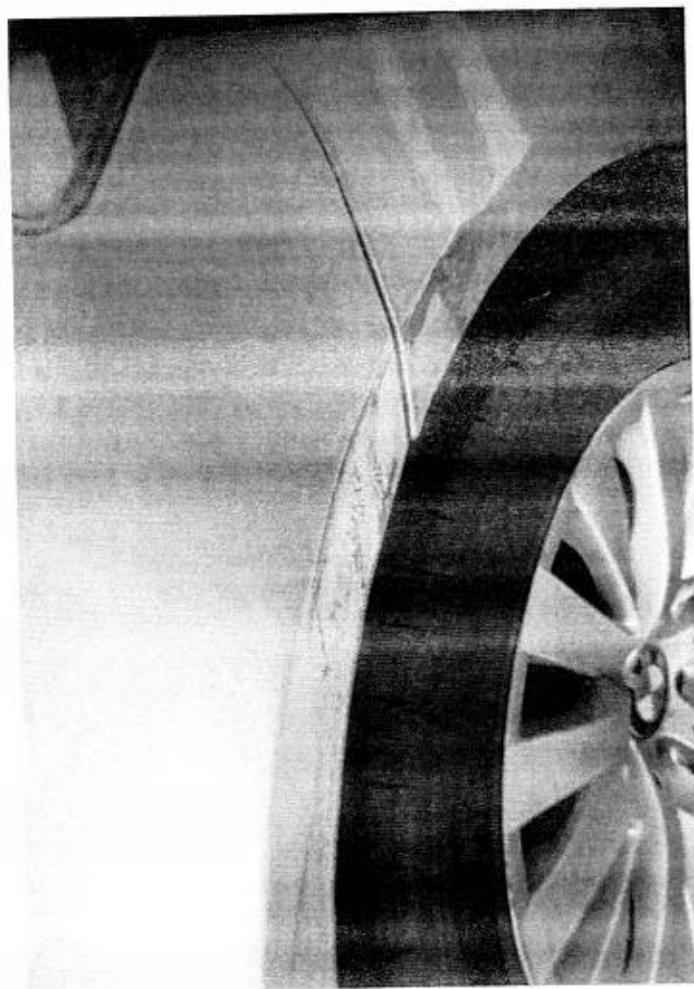
The vehicle sustained impact / damages n/s rear portion and parts claimed are consistent to the accident.

(a) Spare Parts after List discount	\$213.28
(b) Labour Charges	\$600.00
Total for Part-By-Part Repair Cost	\$813.28
(c.) Lumpsum Repair (if applicable)	
Total for Lumpsum repair cost after Less: 20%	
Final Lumpsum Repair cost	
3. Estimated normal period for repairs: 2 working days.
4. We shall treat the above amount as Correct and Confirmed if there is no reply from you within 7 working days
5. Thank you for your assistance.
