**Preliminary Advice**

| Vehicle No | : SKF550S | Accident Date | : 28/06/2019 |
| Make | : AUDI A5 | Policy No. | : 1700081585 |

## VEHICLE DAMAGE INSPECTION REPORT

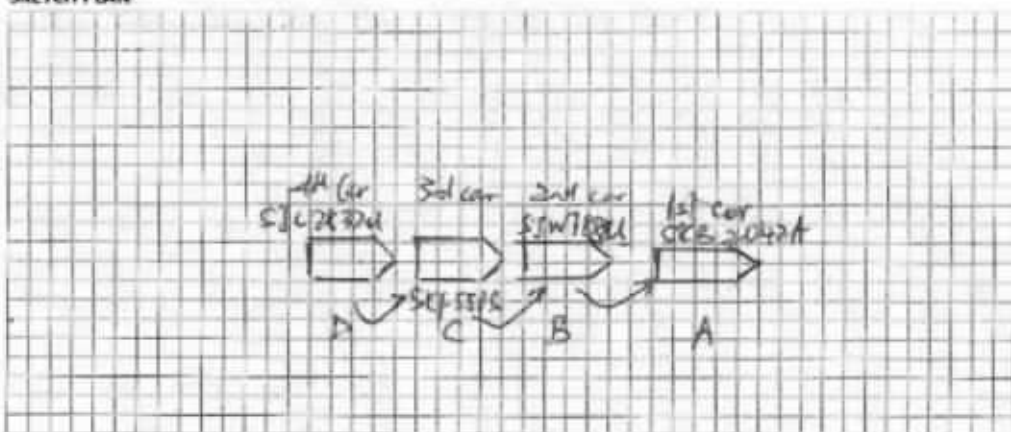
## SKETCH PLAN

Please refer to police report and attach video/pic footage leading to the chain collision.

The owner B highlighted that after the accident, a group of men approached from nowhere to offer assistance by taking us to send our vehicle to their workshop to repair. However, we didn't accede to their offer as they do not look trustworthy. Surprisingly, one of them hopped into the first vehicle and drove off the vehicle instead of the driver Mr Lionel Hey Zhen Pan (S8500747E) and this was witnessed by Mr wife. Furthermore, there was a vehicle parked at the side of the road where the accident occurred and according to Mr Lee, the group of men seem to come from the vehicle. In short, it seems to be a setup by some people causing a chain collision.

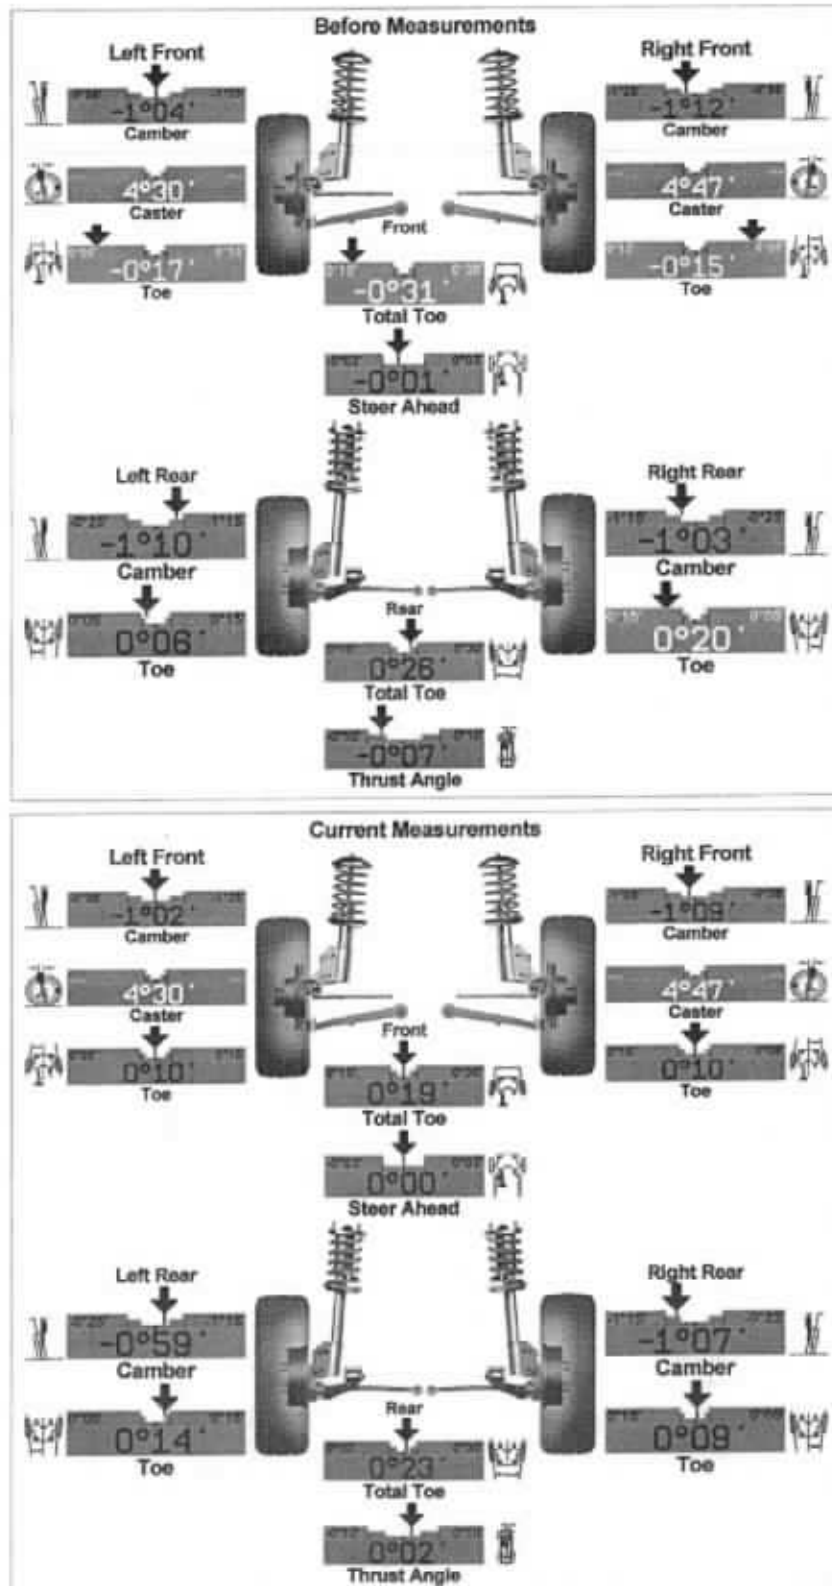
### Audi : A5 : 2016- (F5) : Standard Suspension (1BA)

• One or more values are not within specification. Tire wear, handling and safety problems may result.
