To Inspect Vehicle No: SGG 5419Z Insured: ABG 8499G

## SINGAPORE ACCIDENT STATEMENT

## VEHICLE DAMAGE INSPECTION REPORT

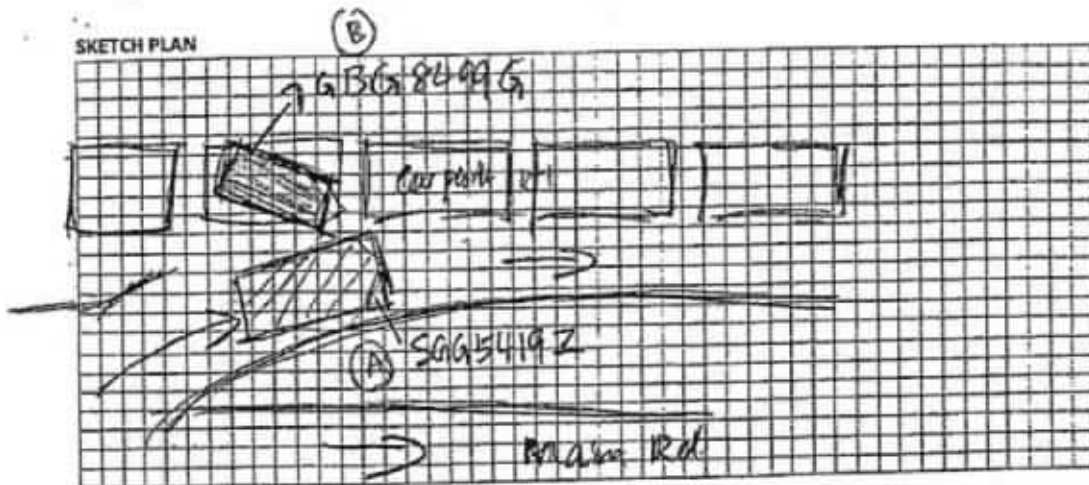
Sketch Plan #2

I was driving along the parking lot of 464 Upper Serangoon Road when suddenly, vehicle B, which was driving out of one of the lot hit the front left portion of my vehicle with a hard impact.

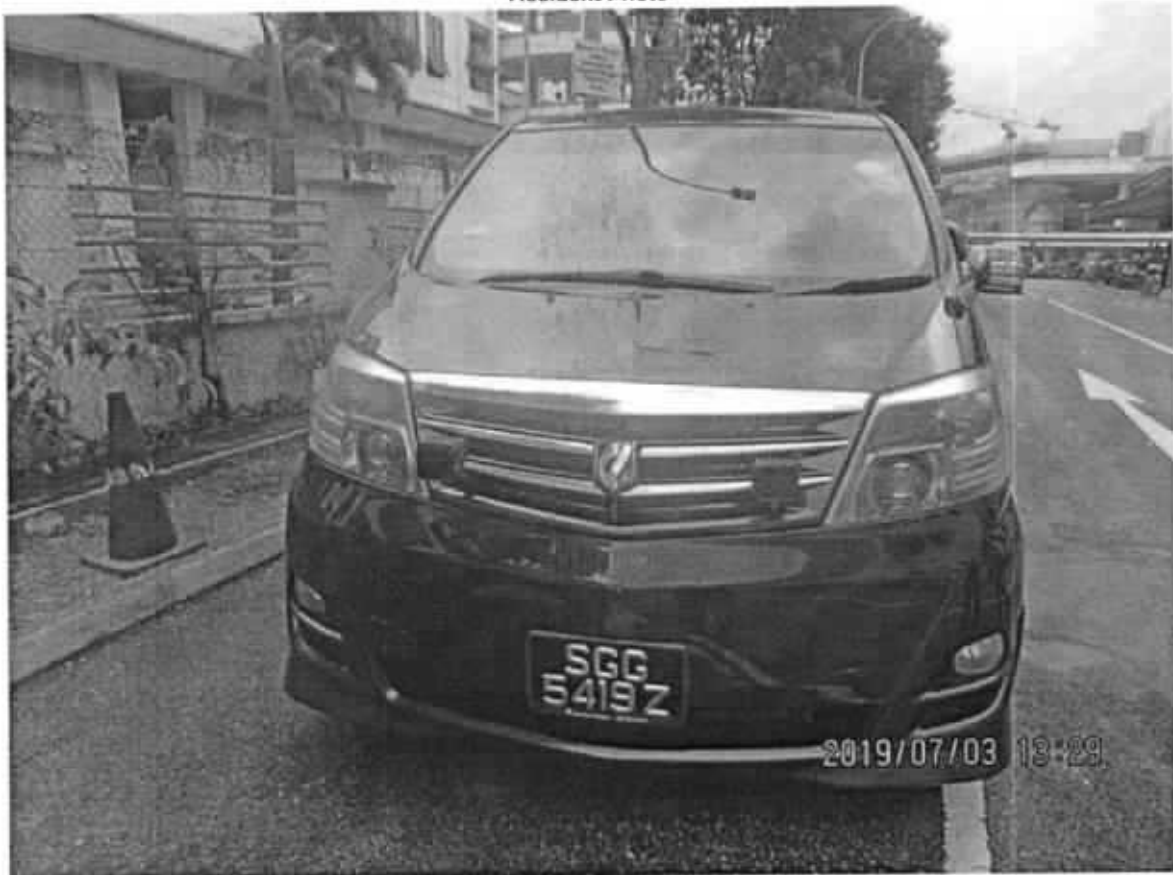
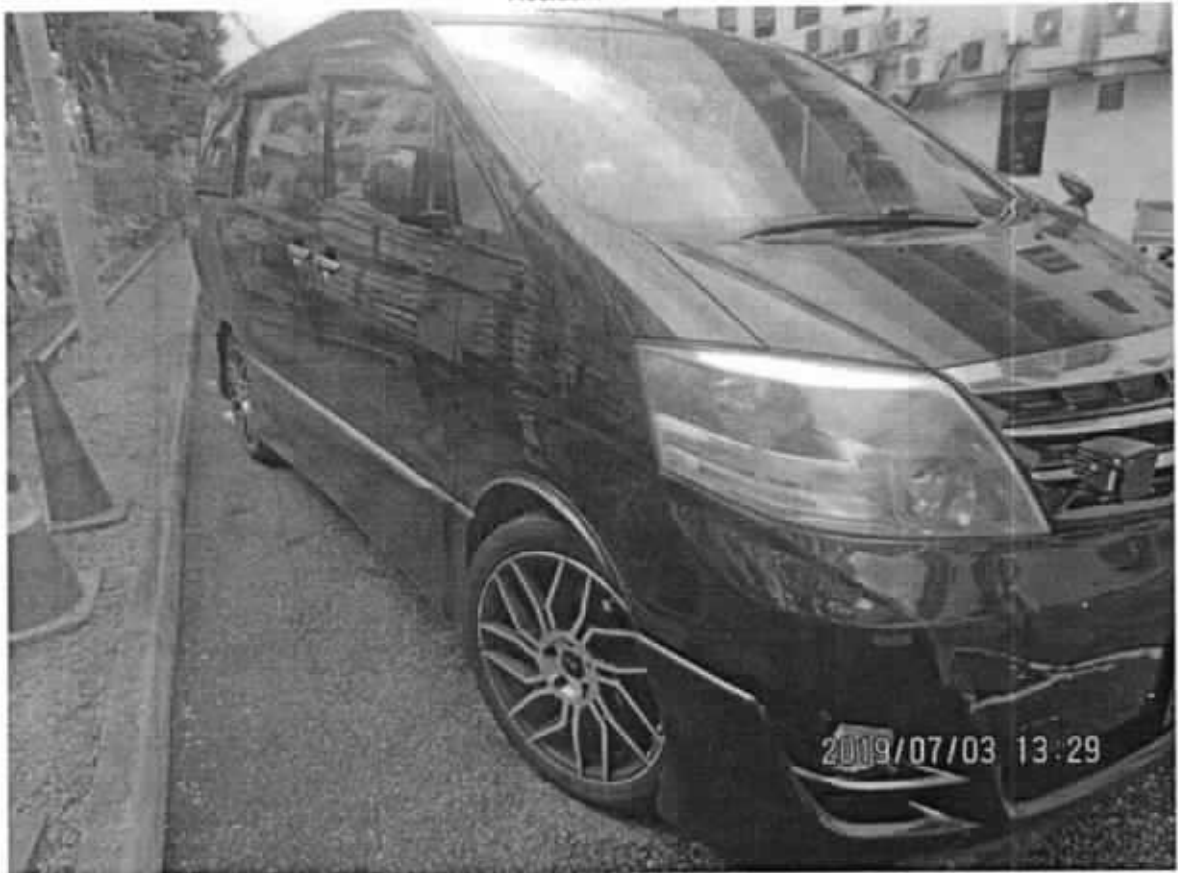
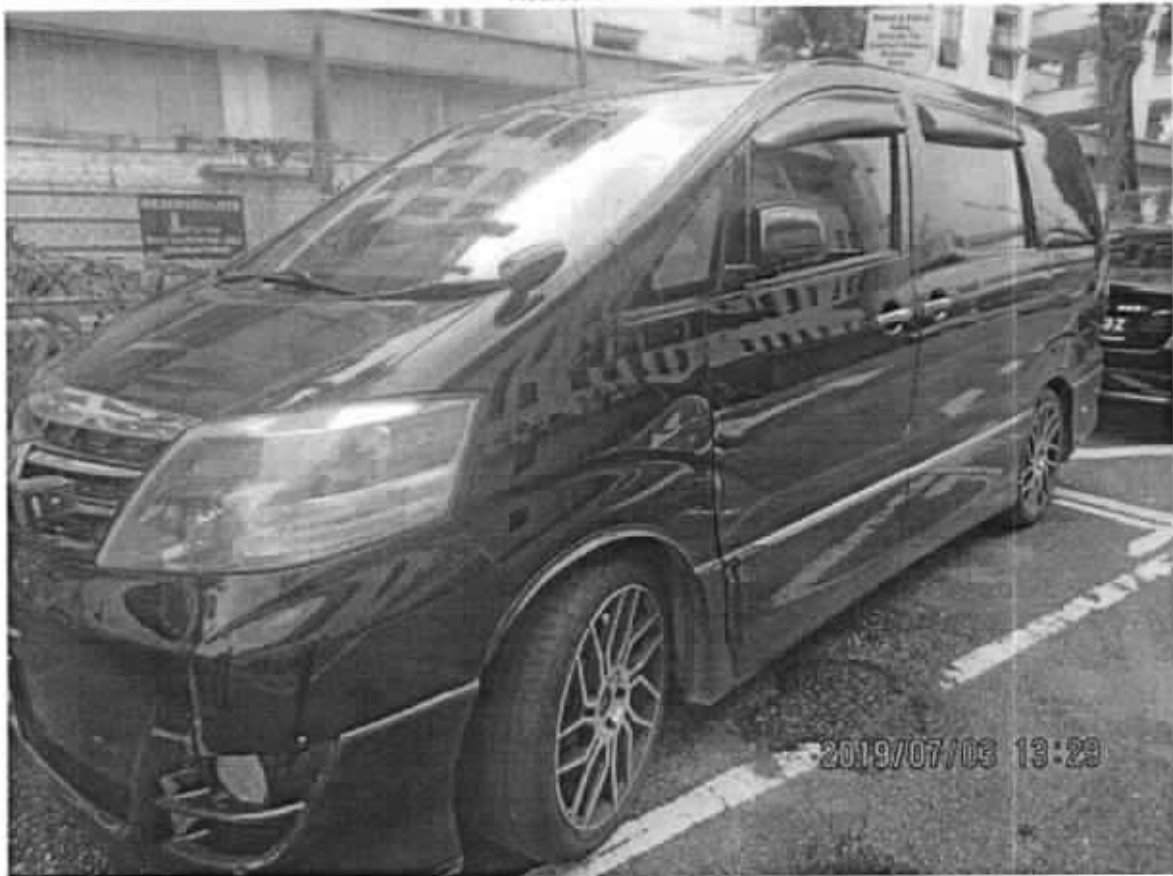
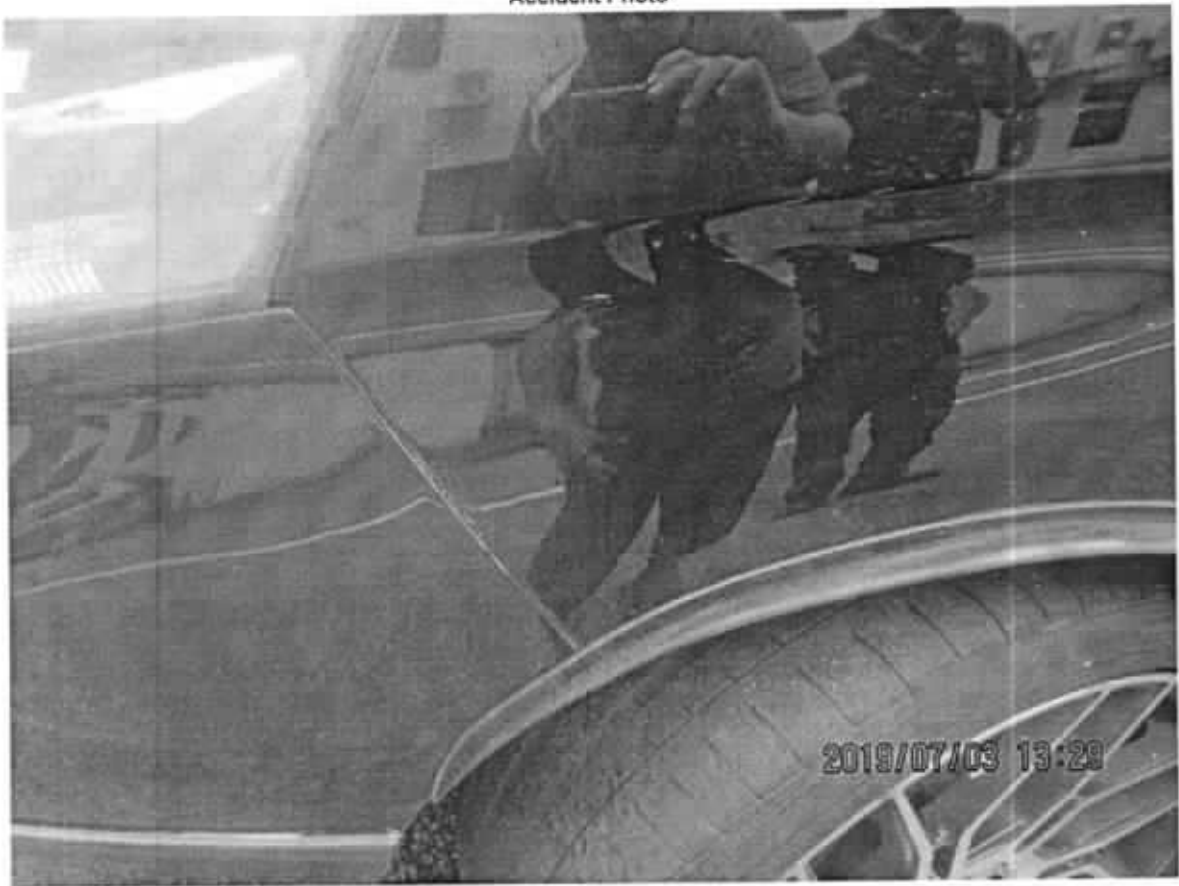
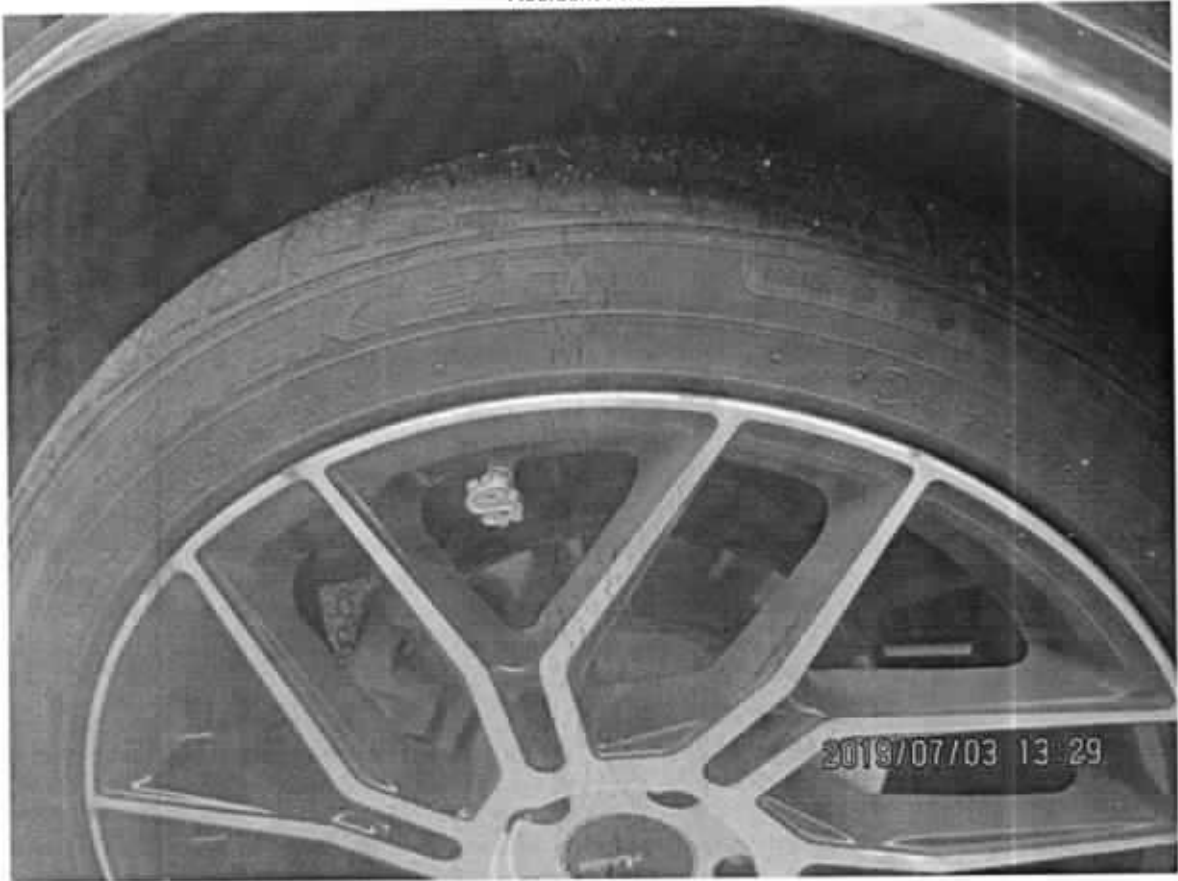
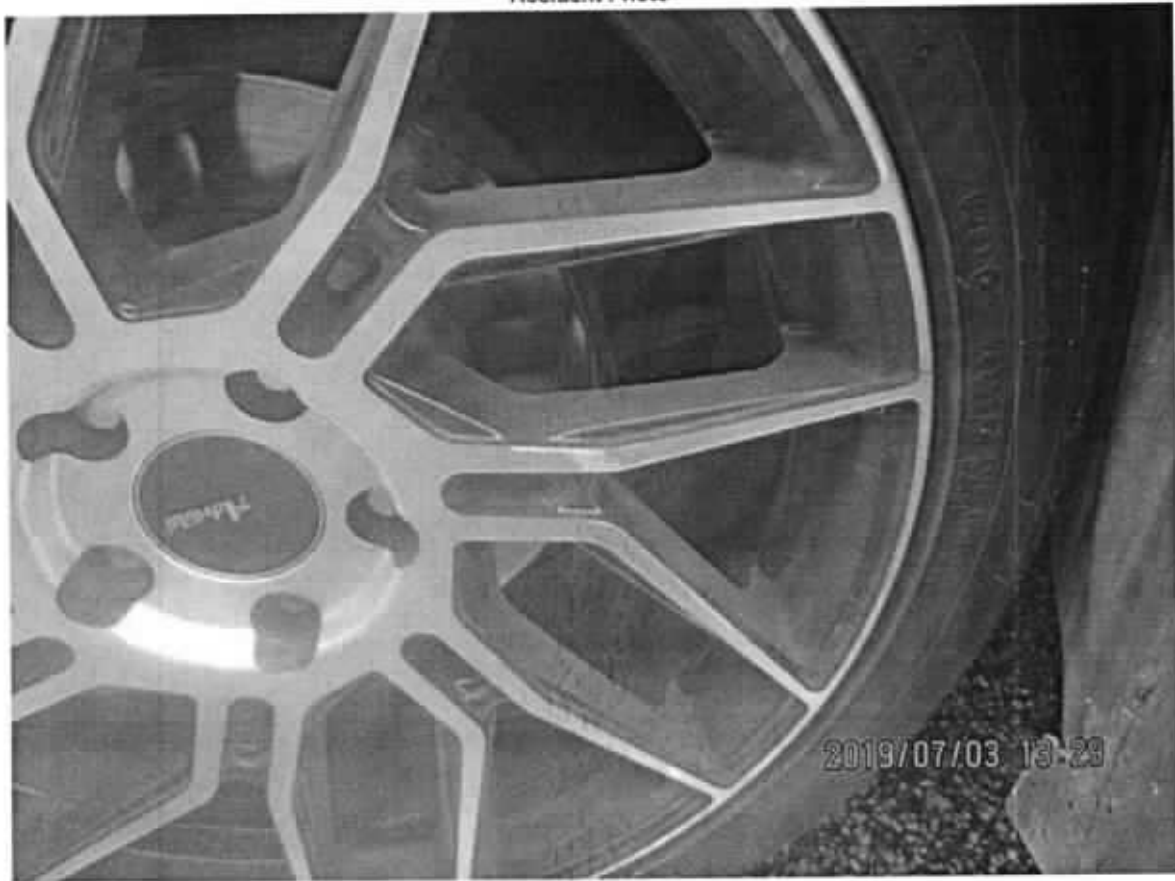
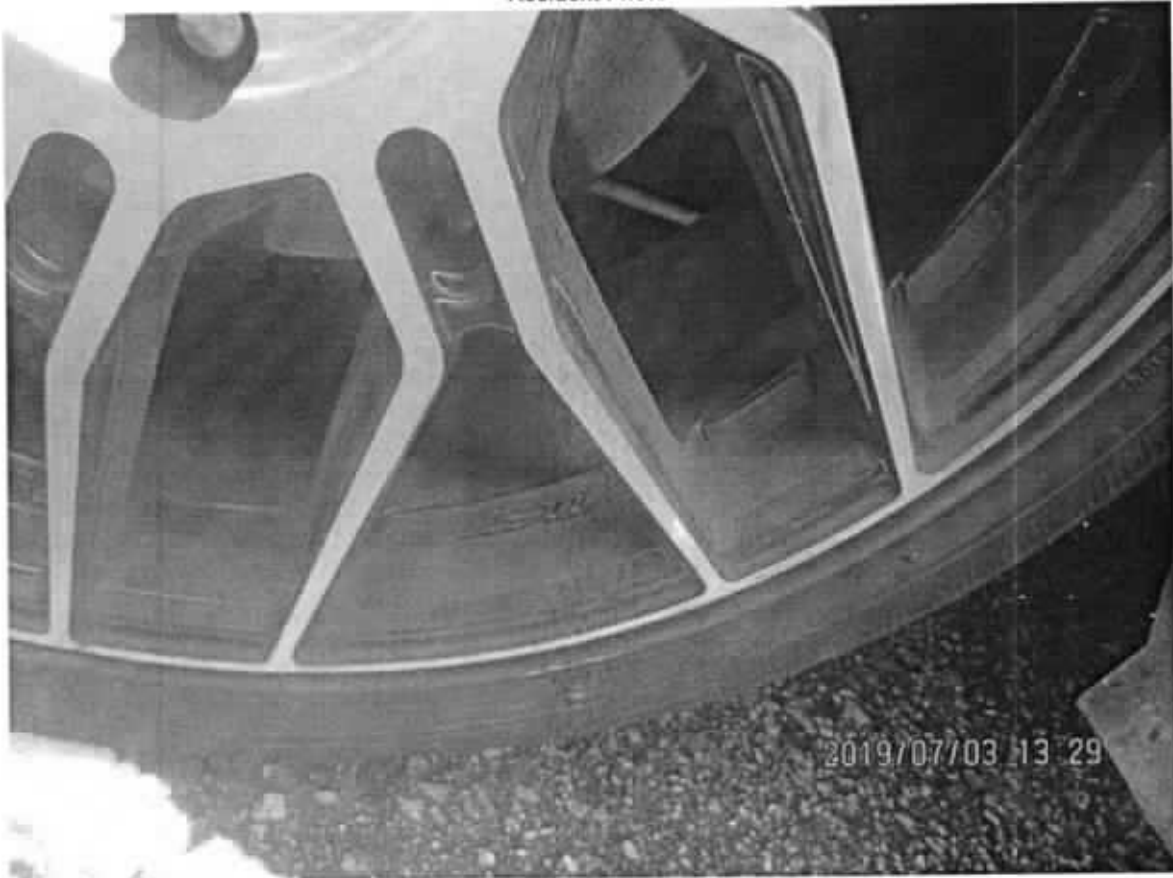
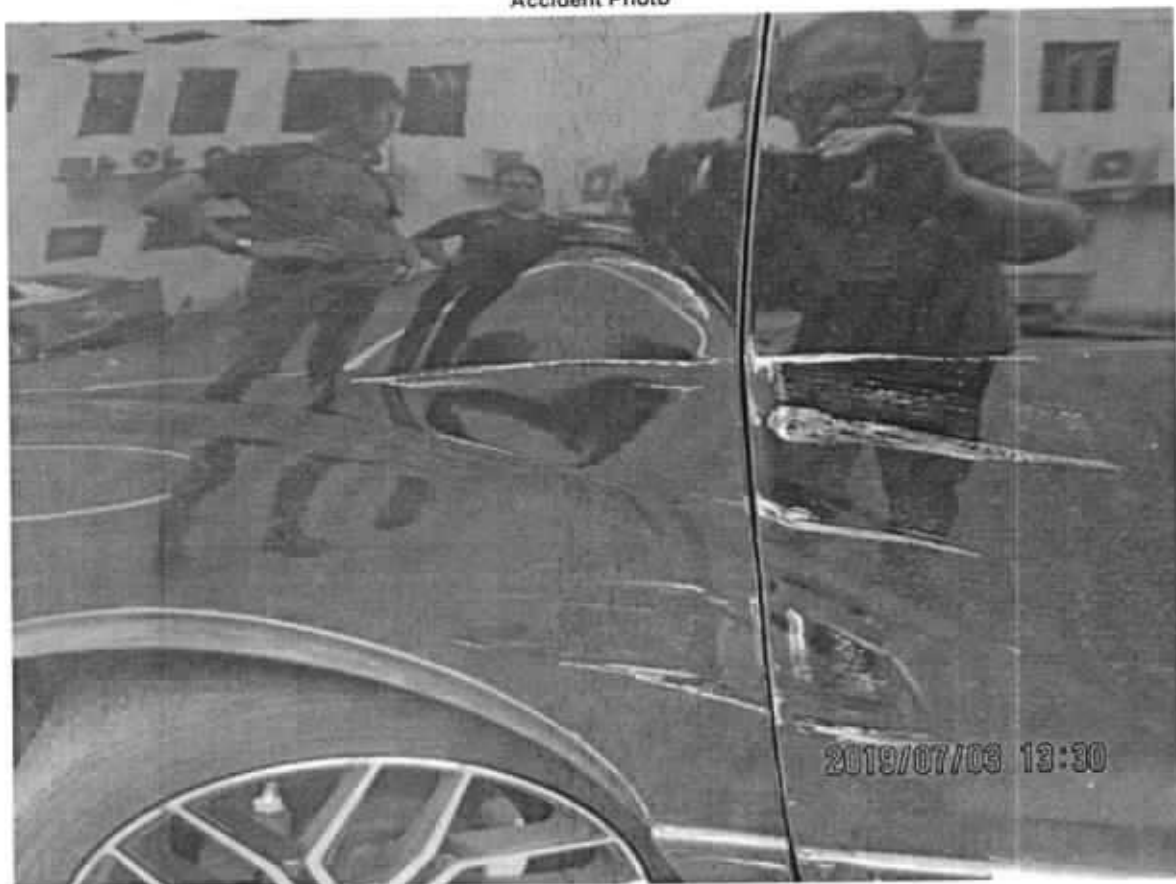
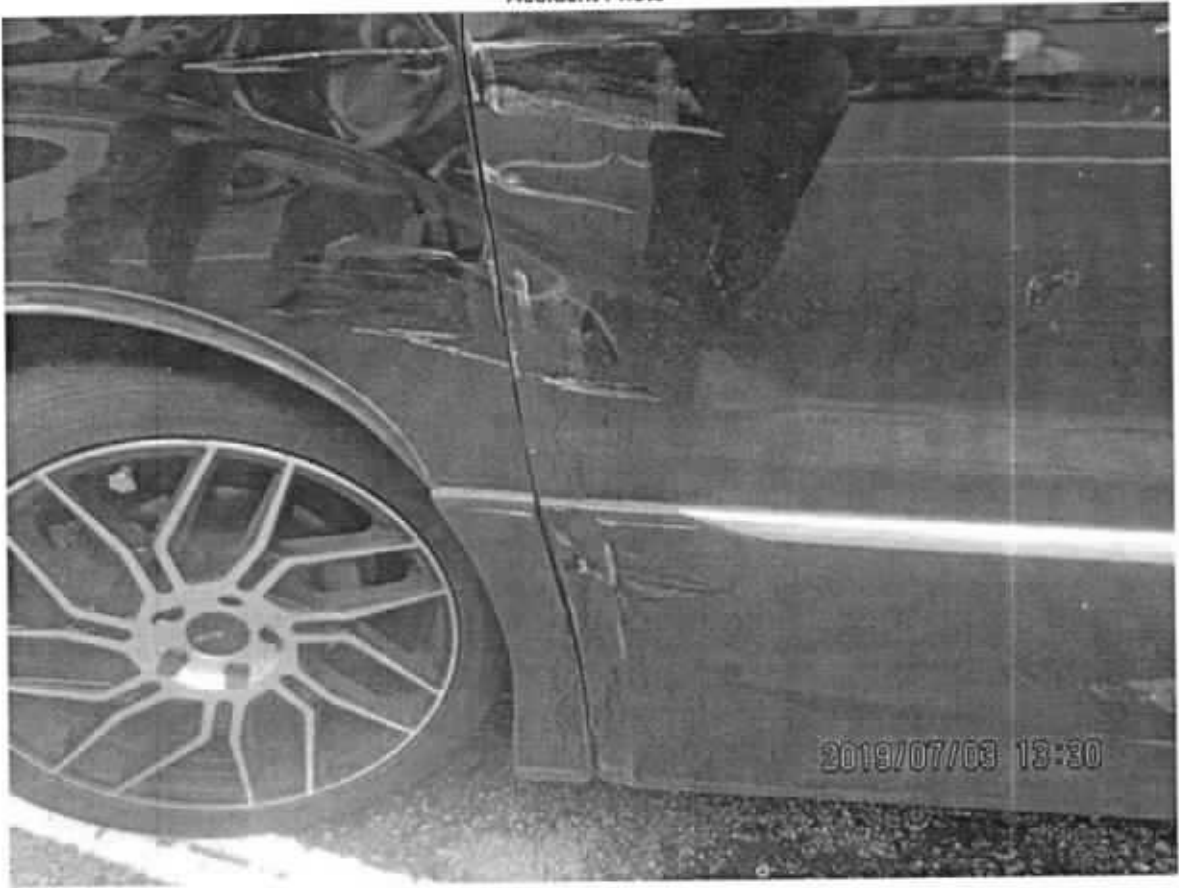
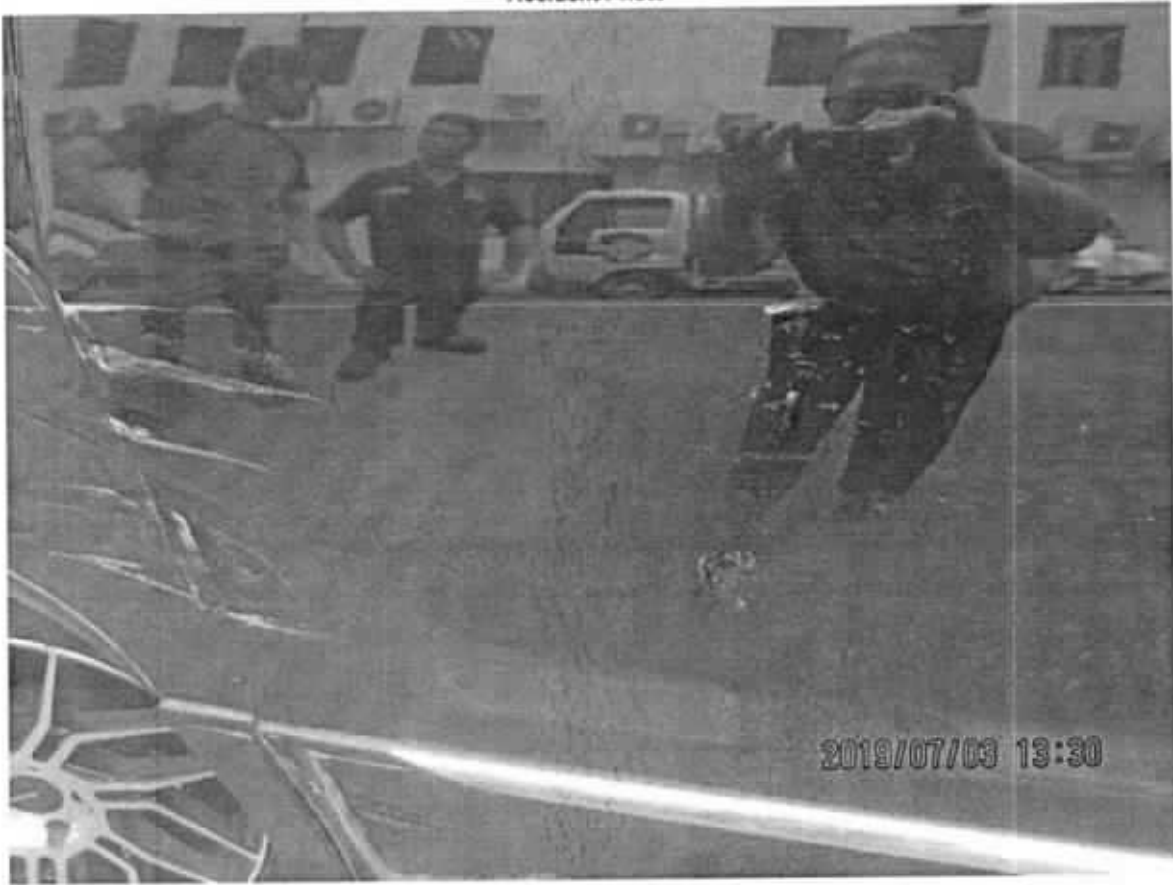
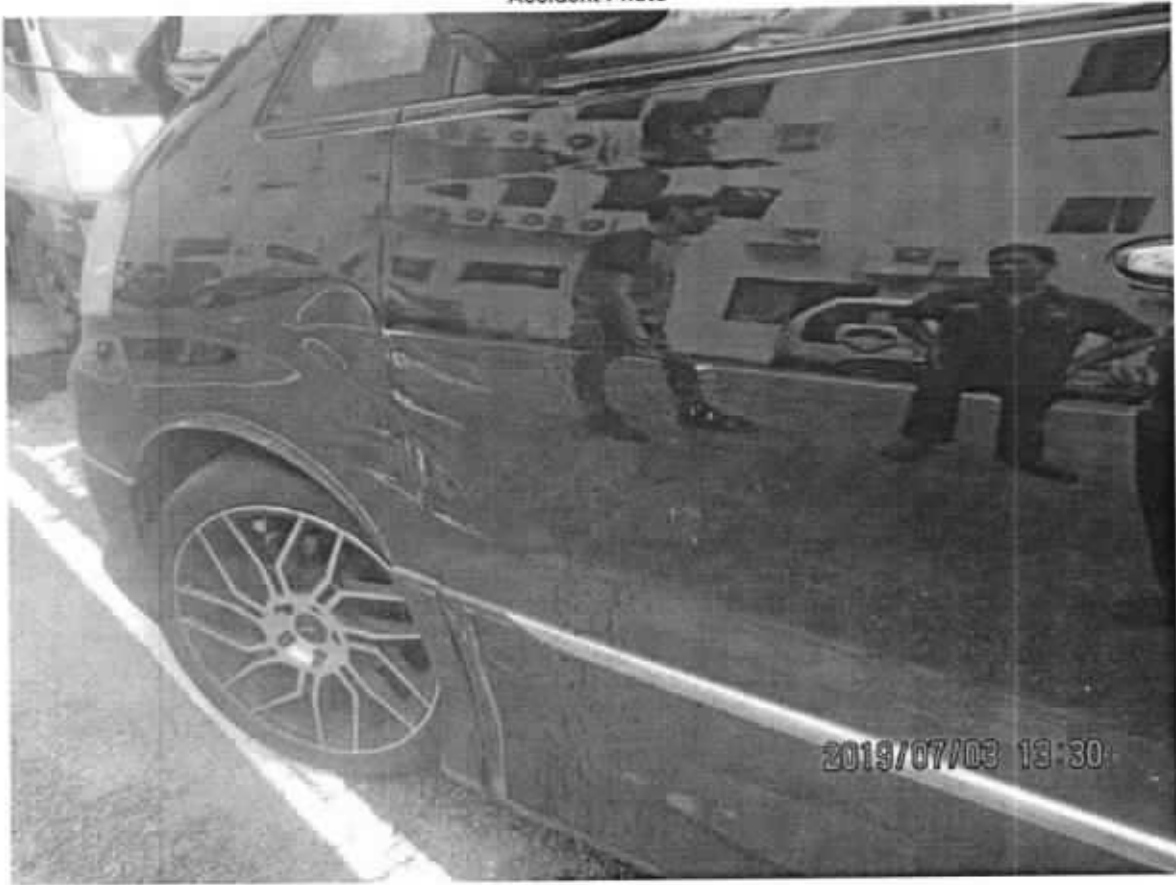
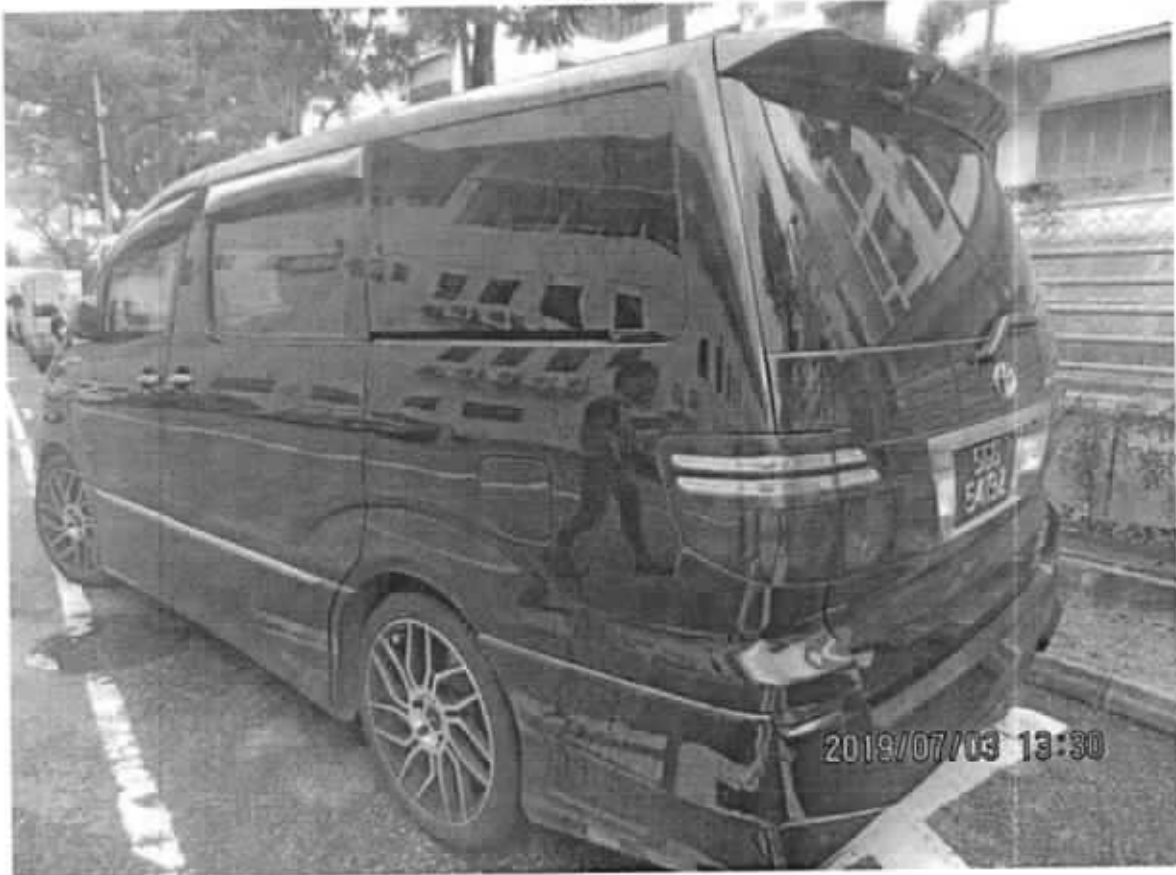
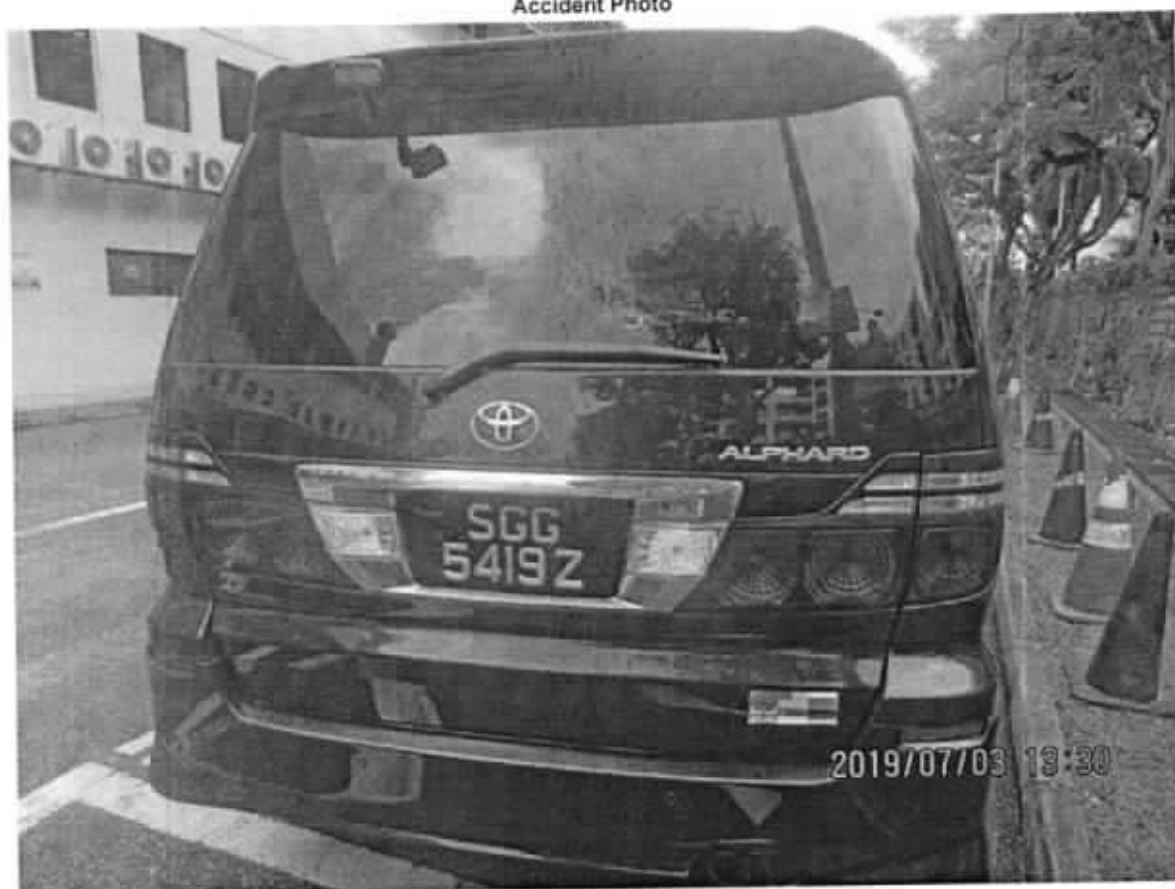
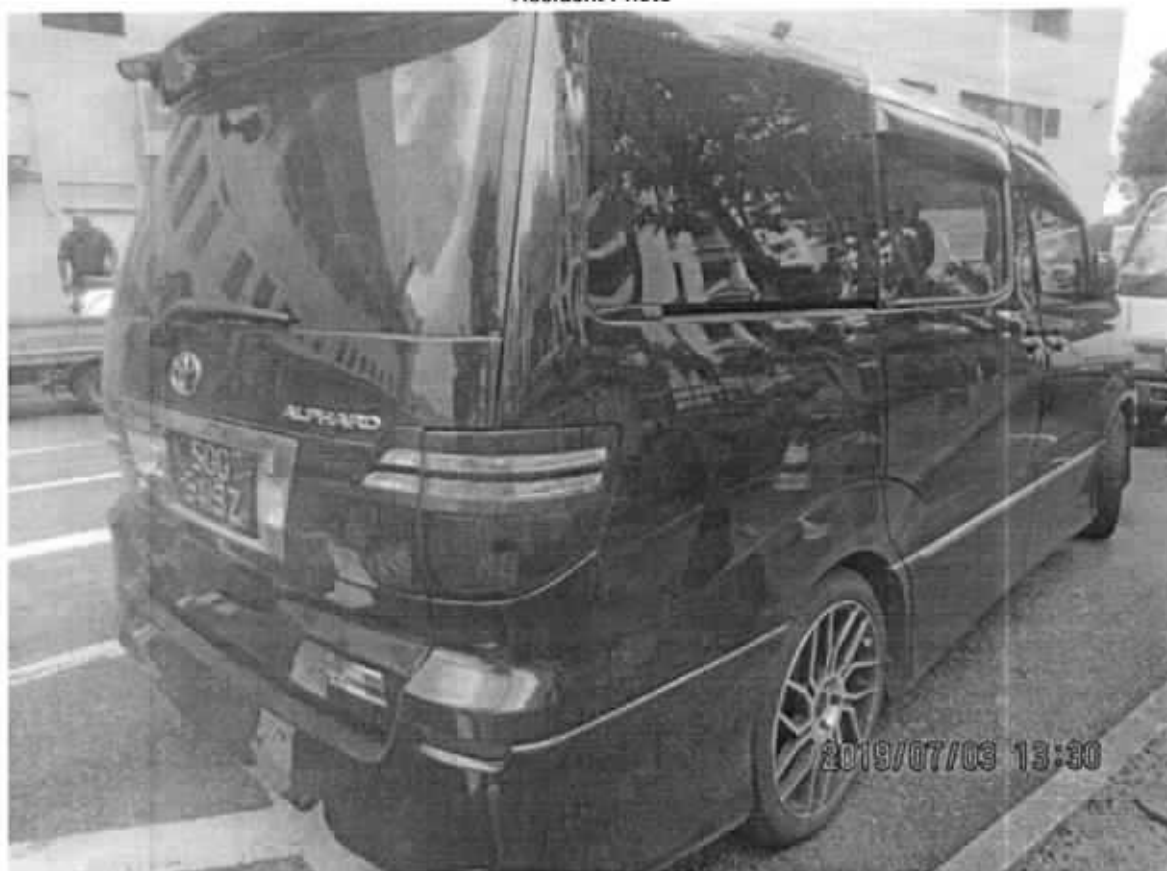
Accident Photo

R/Bal. *6* mmL/Bal. *6* mmD.O.A. *3/7/19*Survey held at *✓*Des. of Damages: *Front* / Rear / O/S / N/S / U/C / Rooftop or*N/S 1st body*

The U/C / Chassis frame / Body Structure affected due to collision.

To remove and replace the parts mentioned above, panel beat and  
realign the necessary affected areas.

To remove and install front undercarriage parts to enable repair.

To replace alloy rims and perform wheel balancing.
