## **Preliminary Advice**

Vehicle No	: SLQ832J	Accident Date	: 02/07/2019
Make	: BMW 523I	Policy No.	: PNPV2018-00015994
Assignment Date	: 04/07/2019	Excess	: S\$800.00
Date of Inspection	: 05/07/2019	Est. Duration of Repair	: 8.00
Inspection At	: VIN'S MOTOR PTE LTD (SIN MING) 160 SIN MING DRIVE, #03-03, SIN MING AUTOCITY SINGAPORE 575722

## VEHICLE DAMAGE INSPECTION REPORT

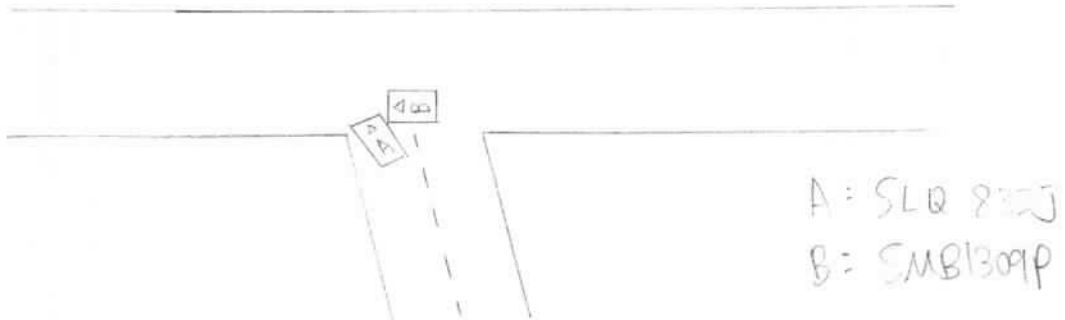
### SKETCH PLAN

On the 02/07/2019, at about 1530hrs, I was along the side road of Girchar Road towards South Bridge Road. As I was edging out my car to look at the oncoming traffic & blindspot I was ~~hit~~ suddenly hit by an oncoming SMART BUS. SMB 1309P. I felt the bus was driving at a fast speed despite there being ongoing construction road works & covering the Middle Lane.
